# Michelin Technical Bulletin

November 14, 2017

## ADDITIVE “BLOOM” ON TIRES

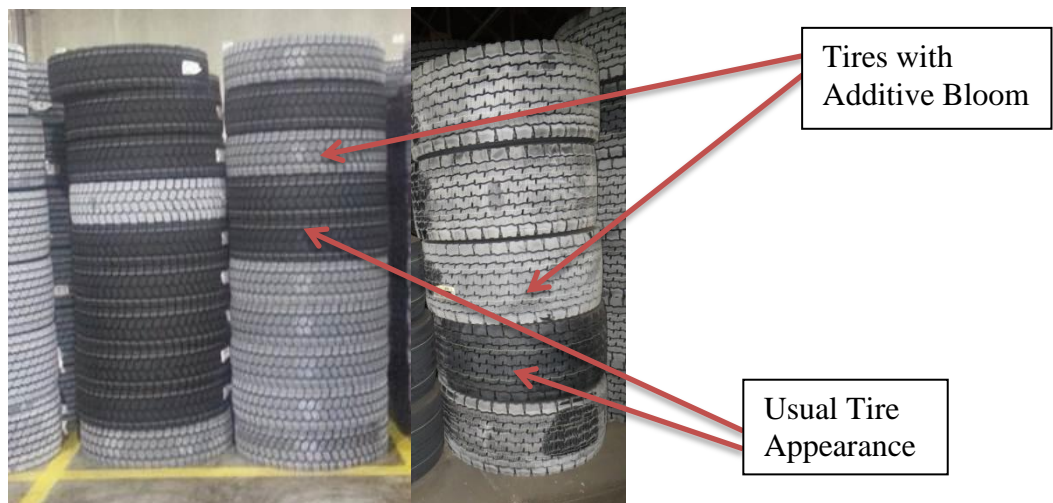
The purpose of this communication is to explain the presence of a milky white discoloration, also known as Additive Bloom, on the surface of certain Michelin tires and treads. This bloom may be seen on tires during cold weather. **The presence of this bloom on the surface of the tread rubber has no impact on the safety or performance of the tire, and presents no hazard during handling of the tire.**

The bloom is a mixture of waxes and other additives used to provide tires with protection against oxidation and ozone degradation and to aid in tire production. The waxes and additives have the ability to migrate to the surface of the tire and back into the cured tire during usage and heating cycles.

The bloomed appearance will diminish when tires are placed in service, as the bloom will wear off the tread surface, and heat generated during the use of the tire will cause bloomed materials to migrate back inside the tire. Washing of the tires or contact with water will wash off water-soluble bloomed materials.
