ADDITIVE "BLOOM" ON TIRES

The purpose of this communication is to explain the presence of a milky white discoloration, also known as Additive Bloom, on the surface of certain Michelin tires and treads. This bloom may be seen on tires during cold weather. **The presence of this bloom on the surface of the tread rubber has no impact on the safety or performance of the tire, and presents no hazard during handling of the tire.**

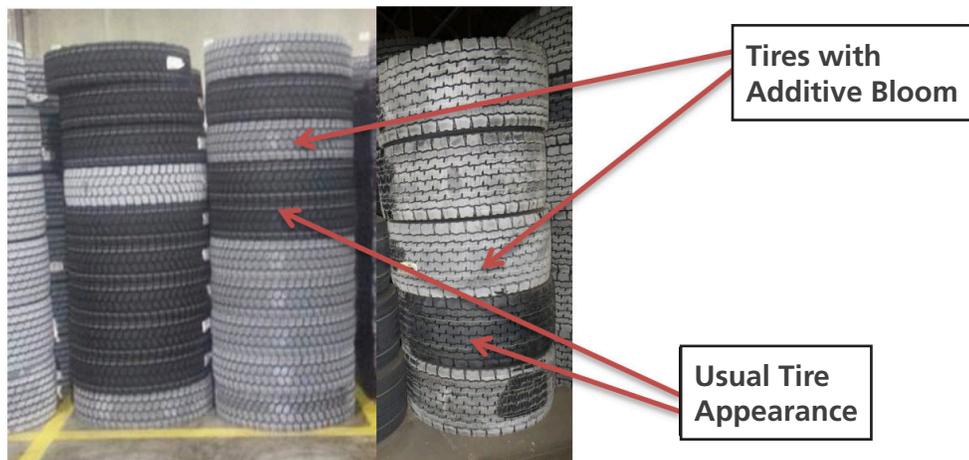
The bloom is a mixture of waxes and other additives used to provide tires with protection against oxidation and ozone degradation and to aid in tire production. The waxes and additives have the ability to migrate to the surface of the tire and back into the cured tire during usage and heating cycles.

The bloomed appearance will diminish when tires are placed in service, as the bloom will wear off the tread surface, and heat generated during the use of the tire will cause bloomed materials to migrate back inside the tire. Washing of the tires or contact with water will wash off water-soluble bloomed materials.
