February 29, 2000

THE USE OF BLOCKS TO LEVEL MOTOR HOMES/RV'S EQUIPPED WITH RADIAL TIRES

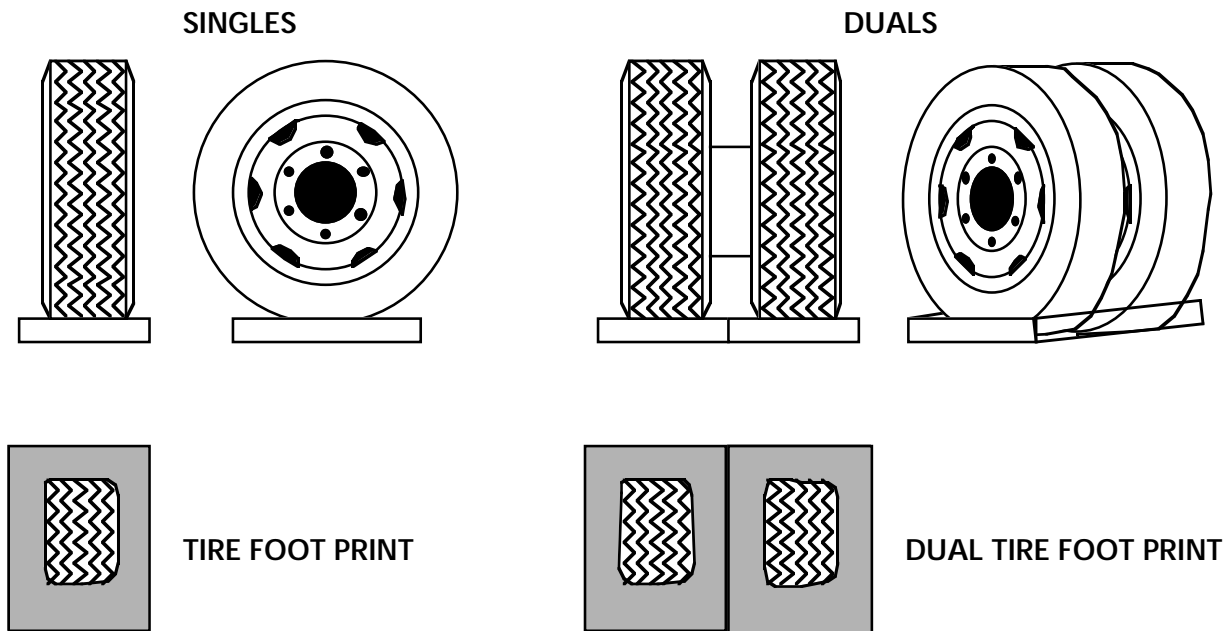
FIGURE 1
CORRECT

The CORRECT methods are shown in Figure 1. Please note that the blocks are wider than the tread and longer than the tire's footprint. This provides maximum support to the tires and assures that the load is evenly distributed throughout the tire's footprint area.

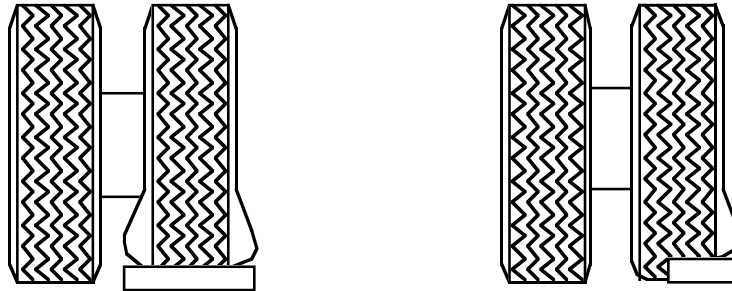
Duals INCORRECT

One tire or a portion of one tire is supporting the full load.

Portion of the two tires supporting the full load.

Tires incorrectly supported, as shown above, may be damaged, which could lead to casing failure resulting in serious injury or property damage. If, on previous occasions, the tires have been incorrectly supported, a hidden damage may be present. Please contact your local Michelin dealer and request an inspection and determination of possible damage.
