February 29, 2000

THE USE OF BLOCKS TO LEVEL MOTOR HOMES/RV'S EQUIPPED WITH RADIAL TIRES

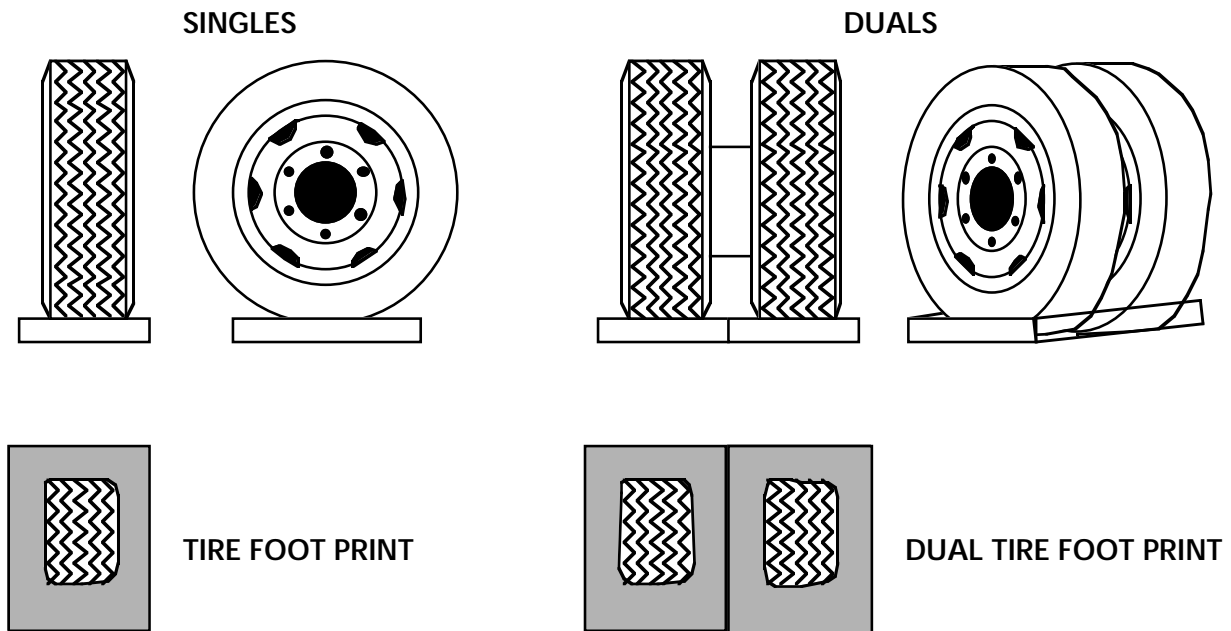
FIGURE 1
CORRECT

The CORRECT methods are shown in Figure 1. Please note that the blocks are wider than the tread and longer than the tire's footprint. This provides maximum support to the tires and assures that the load is evenly distributed throughout the tire's footprint area.

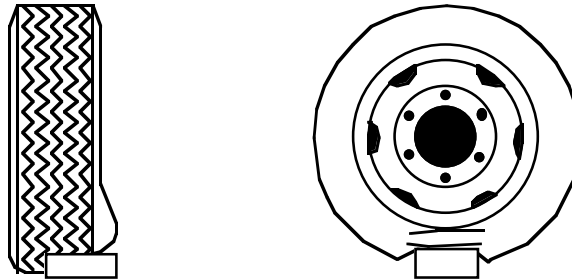
Singles
INCORRECT

Extreme caution must be taken to ensure that the tires are fully supported when using blocks to level motor homes and/or RV's. The load on the tire should be evenly distributed on the block and in the case of duals, evenly distributed on blocks for both tires. If not properly done, the steel cables in the sidewall of the tires may be damaged and could lead to premature fatigue of the sidewall.

Only a portion of the tire is supporting the full load.

Tires incorrectly supported, as shown above, may be damaged, which could lead to casing failure resulting in serious injury or property damage. If, on previous occasions, the tires have been incorrectly supported, a hidden damage may be present. Please contact your local Michelin dealer and request an inspection and determination of possible damage.

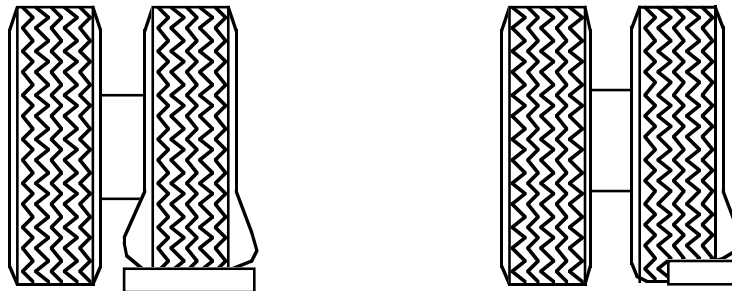
Duals
INCORRECT

One tire or a portion of one tire is supporting the full load.

Portion of the two tires supporting the full load.
