EARTHMOVER TIRE CONDITIONS ANALYSIS GUIDE

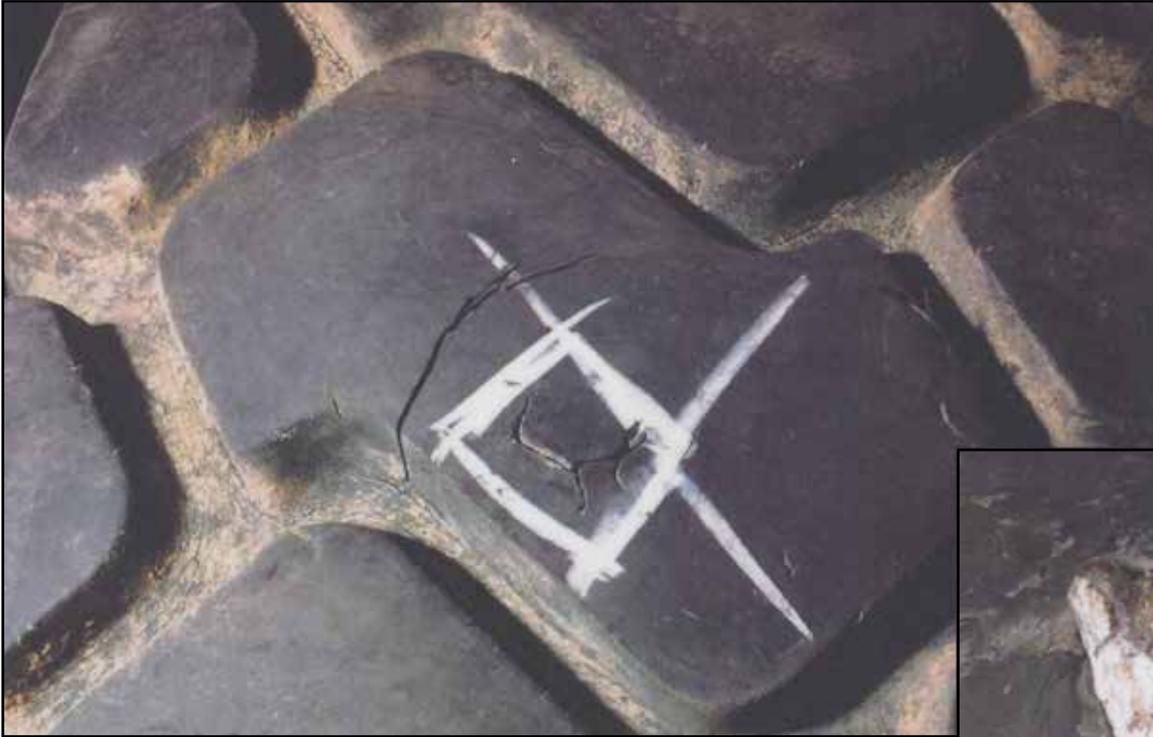
DESCRIPTION	Localized damage to the crown, but not penetrating.
--------------------	--

OBSERVATION	Crown damage not perforating through to interior, possibly affecting the belts.
PROBABLE CAUSES(S)	Accidental damage by a sharp object. High pressure aggravates the situation.
EVOLUTION	Rust, air infiltration, ultimately perforating to interior.
RECOMMENDED ACTION	Repair if the damage is within recommended limits.
PREVENTION	Keep site roads clean and in good condition; maintain using graders or bulldozers. If similar tire damages persist, check for proper (possibly lower) operating pressures, review choice of tire and rubber compound.
DO NOT CONFUSE WITH	Pages 11, 13

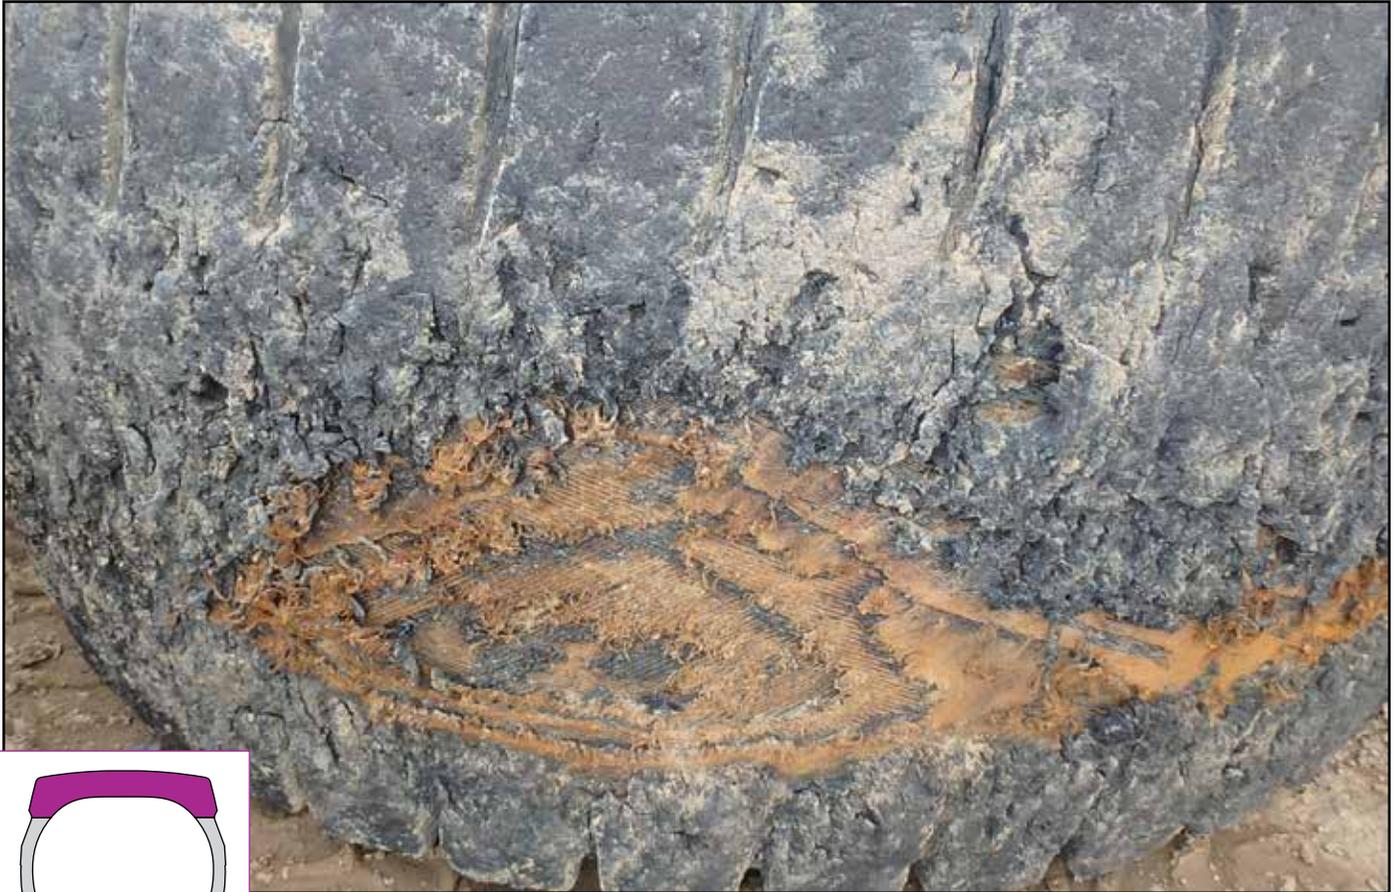
DESCRIPTION	Deep localized deterioration of the crown plies due to oxidation.
--------------------	--

OBSERVATION	Deep localized damage extending to the crown plies, resulting from moisture (rust).
PROBABLE CAUSES(S)	Penetration of moisture resulting from a cut, abrasion, brake skid, or the effects of stone retention. Damage might be accentuated by a high tire operating pressure.
EVOLUTION	Running flat, loss of more tread rubber, generalized separation between the tread band and crown plies, eventually resulting in rapid deflation.
RECOMMENDED ACTION	Scrap.
PREVENTION	Review the choice of tire. Clean and maintain the site roads using graders or bulldozers. Assess the possibility of using a different tread pattern and/or rubber compound. Do not overinflate.
DO NOT CONFUSE WITH	Page 14

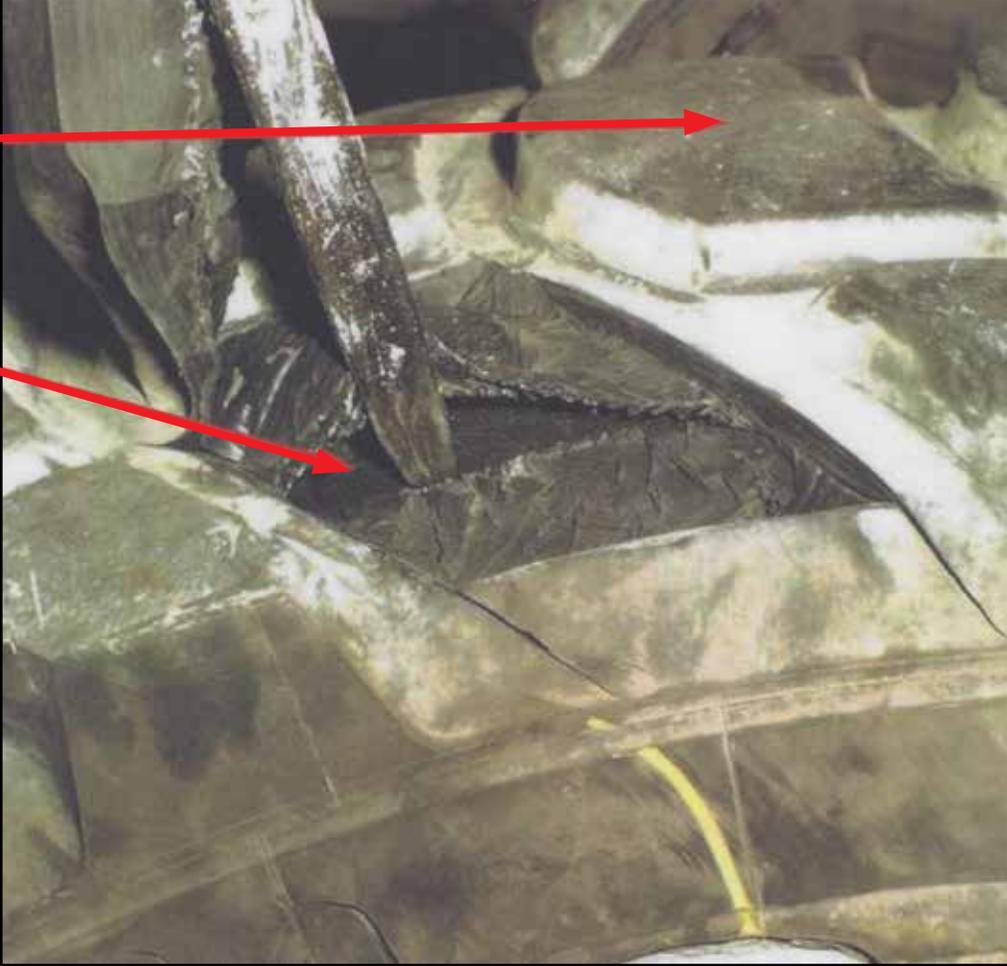
OBSERVATION	Split in the circumferential direction in the shoulder zone and/or bulges and/or deformation of the tread.
PROBABLE CAUSES(S)	For Thermal Separation: Overheating produced by long and numerous cycles with the tire's nominal load being exceeded, exhibited by the appearance of sticky rubber. Large slip angle on front tires (tight turns at high speed), excessive TMPH/TKPH. For Mechanical Separation: Severe lateral scrub recognizable as rubber is not sticky. Insufficient pressure/overload. Mechanical misalignment.
EVOLUTION	Rupture of the casing ply.
RECOMMENDED ACTION	Scrap.
PREVENTION	Study the conditions of use, layout of roads, load and pressures. Make sure that the TMPH/TKPH of the tire is greater than that of the site.

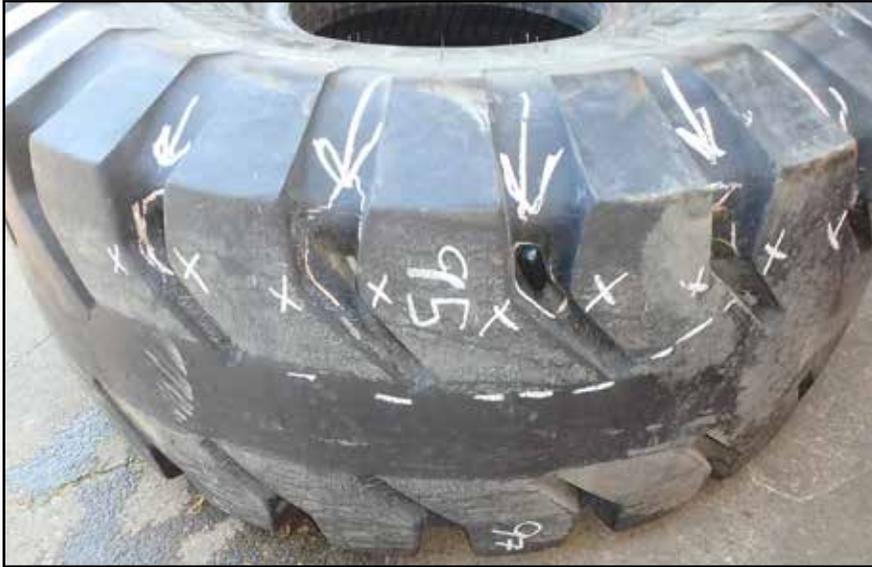
Tread deformation

DESCRIPTION	Deterioration of the rubber product(s) between the tread and the crown plies.
--------------------	--

OBSERVATION	Localized deformation or wear of the tread or splits in rubber at the bottom of the tread grooves. Rubber generally sticky between crown ply and tread.
PROBABLE CAUSES(S)	Build-up of heat resulting from under-inflation or overload (tire's nominal load exceeded), associated with numerous, lengthy cycles. High speed travel over surfaces made up of large stones (hammering). Damage amplified by incorrect setting of toe or camber on machine.
EVOLUTION	Partial tread rubber detachment and splitting.
RECOMMENDED ACTION	Scrap.
PREVENTION	Study the conditions of use, layout and maintenance of roads; check whether machines do reach high speeds on fast roads; make sure that the tire usage is within the site TMPH/TKPH. Be aware of indicators: localized wear, splits in rubber at the bottom of the tread grooves.
DO NOT CONFUSE WITH	Page 14

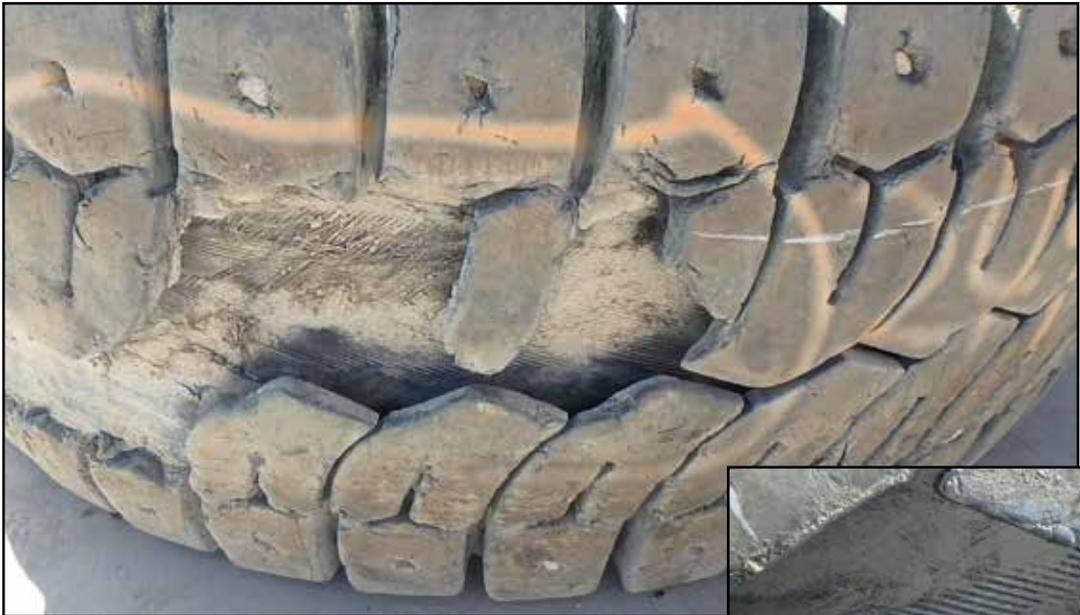
DESCRIPTION	Generalized separation between the tread band and the crown plies.
--------------------	---

OBSERVATION	Generalized separation between the tread band and crown plies without trace of heat.
PROBABLE CAUSES(S)	Repeated aggressions to the tread band. Stone retention. Tread damage.
EVOLUTION	Continued detachment of tread rubber from the crown plies.
RECOMMENDED ACTION	Scrap.
PREVENTION	If possible, weigh the machine and adjust tire pressures accordingly. Check whether there is any hammering. Check haul road maintenance. Consider indicators such as localized deformation or wear on the tread.
DO NOT CONFUSE WITH	Pages 13, 79

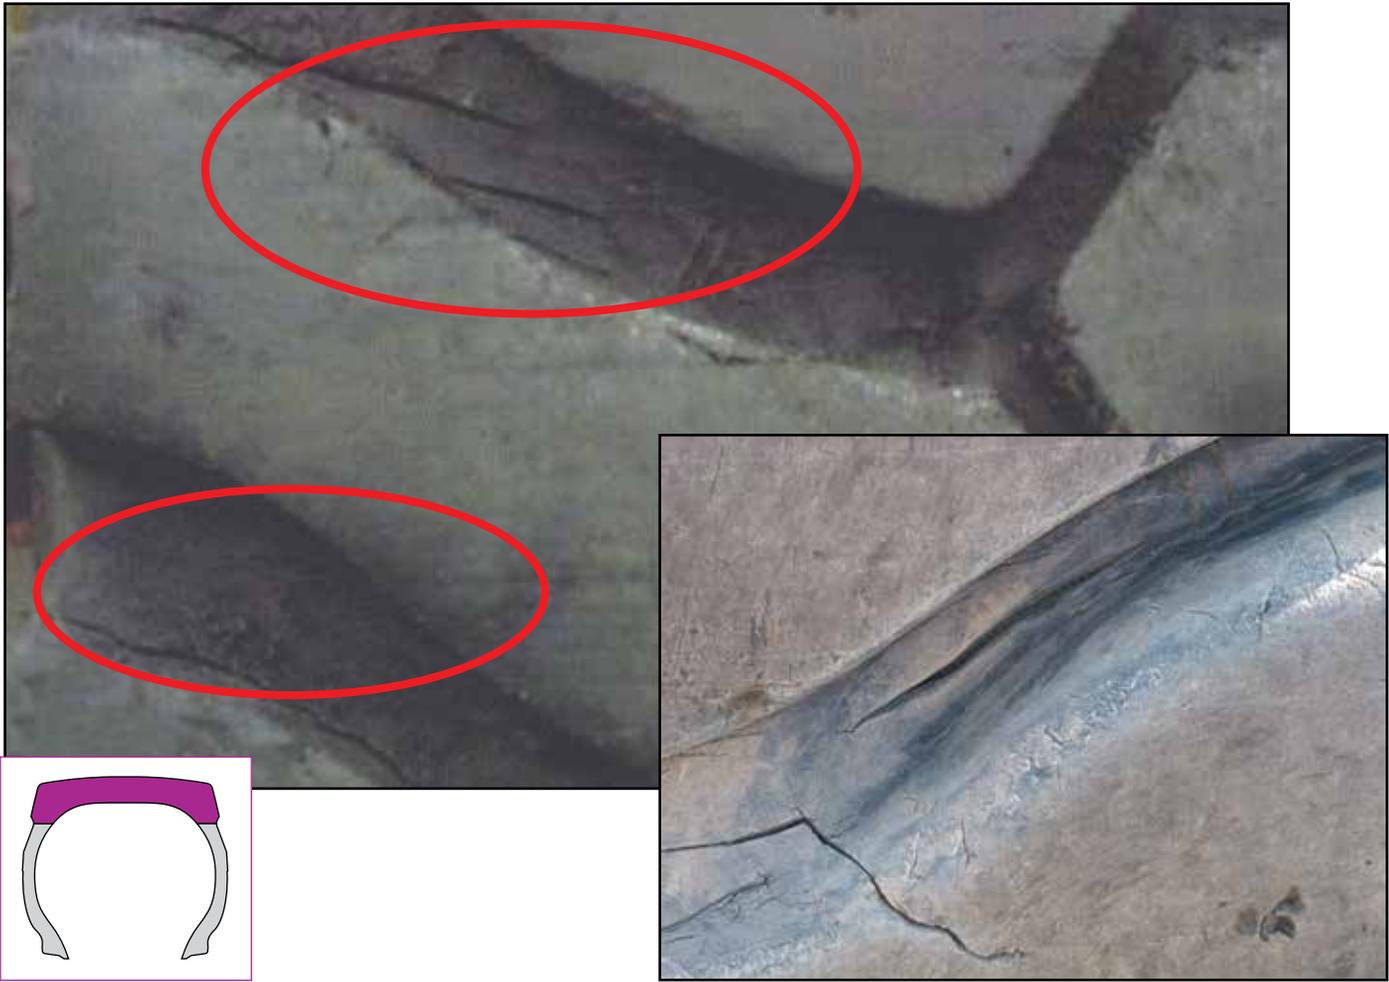
DESCRIPTION	Splits at the base of the tread blocks with or without rubber tearing out.
--------------------	---

OBSERVATION	Splits in rubber at the bottom of tread grooves (between lugs), with or without torn rubber.
PROBABLE CAUSES(S)	If the splits are localized: Running over an obstacle (block, wedge, etc.) creating a lever effect on the edge of the shoulder blocks. If splits are widespread: High torque, or nature of the road (hammering). Misapplication of the tire.
EVOLUTION	Chunking of tread block(s).
RECOMMENDED ACTION	Keep running. If the tire is accepted for retreading, consider removal before the splits reach the structural plies; otherwise scrap.
PREVENTION	If possible, take corrective action on the haul roads to improve surface conditions. Determine if traction is required; if not, re-evaluate tread selection.
DO NOT CONFUSE WITH	Page 20

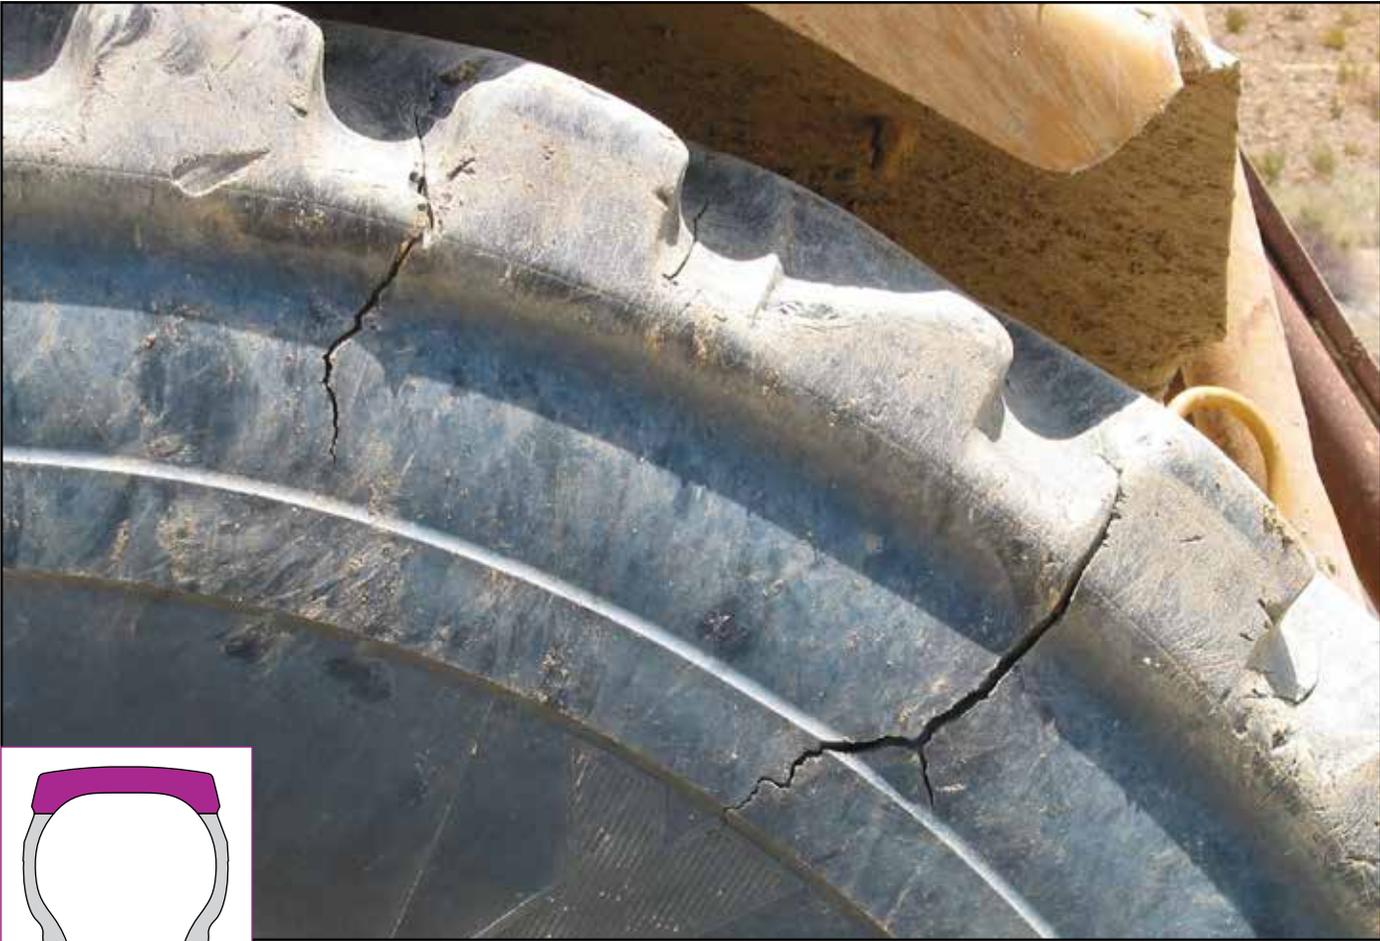
DESCRIPTION	Splits at the base/edge of the sculpture in the sidewall.
--------------------	--

OBSERVATION	Splits in rubber at the bottom or edge of tread grooves in the sidewall.
PROBABLE CAUSES(S)	Cuts in rubber propagating due to over-flexing under high torque, under-inflation or overload and accentuated by frequent scrubbing.
EVOLUTION	Deterioration of the casing ply with or without going through the inner liner.
RECOMMENDED ACTION	Keep running if wear is advanced and the tire cannot be retreaded. On transport machines, if wear is slight and casing ply is visible using the separating tool, have the tire repaired (if possible).
PREVENTION	Monitor cuts on transport machines. If wear is slight, make a spot repair before the plies become visible. Otherwise, leave running and monitor developments.
DO NOT CONFUSE WITH	Pages 20, 42

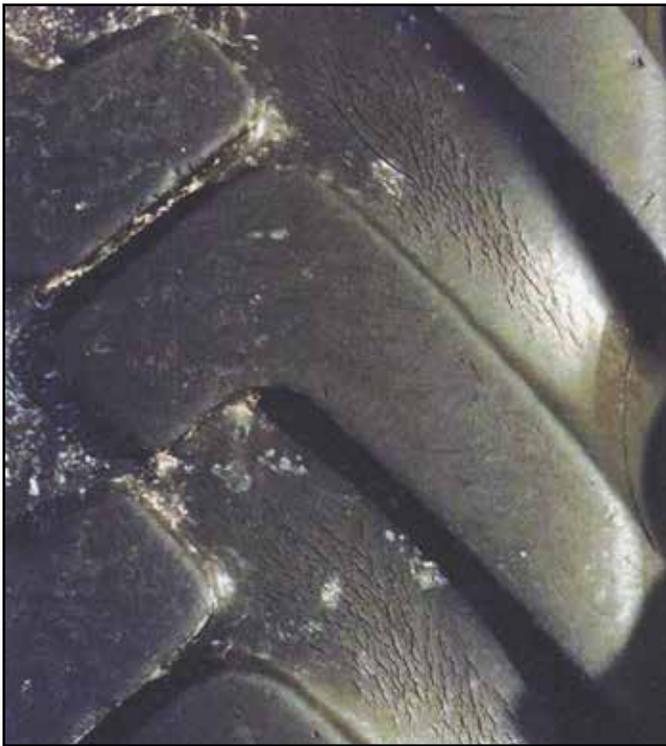
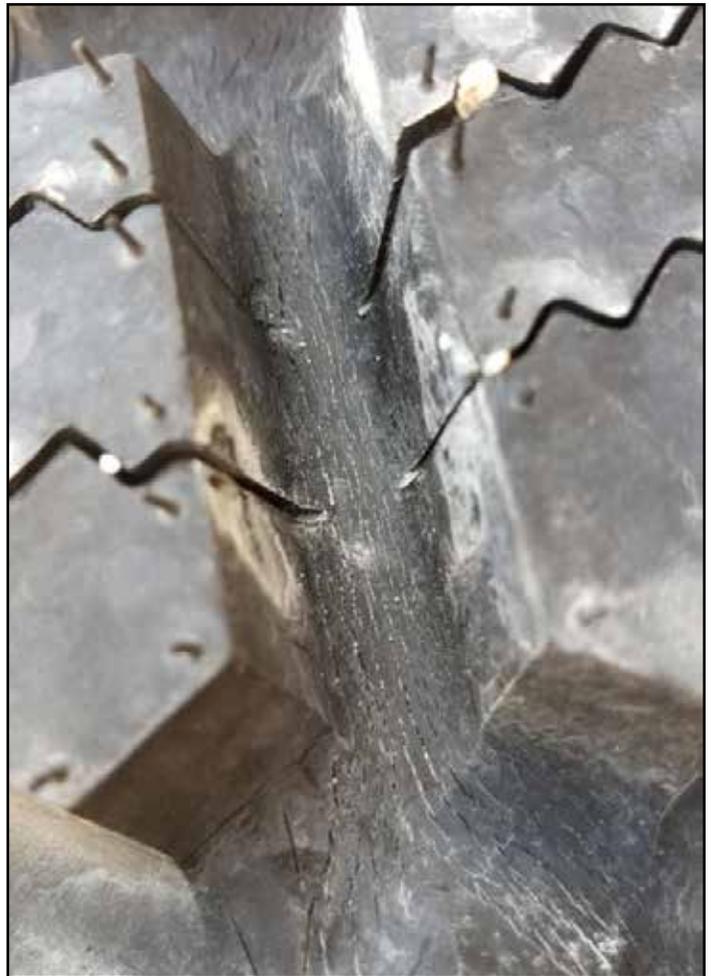
Crazing of the tread rubber in the grooves.

Rubber ozone cracking at the base or on the edge of the tread, which may develop into splits.

Cracks should not affect tire's ultimate life.

If the tire is not accepted for retreading, continue in service on site until the first ply is visible. To avoid loss of the casing for retreading, remove before the tread pattern wears off. If the machine is subject to traffic regulations (e.g. cranes), comply with the legislation in force in that country.

Avoid exposing the tires, even momentarily, near to ozone emissions (e.g. arc welding). Ensure proper storage conditions of new machines and tire equipment.

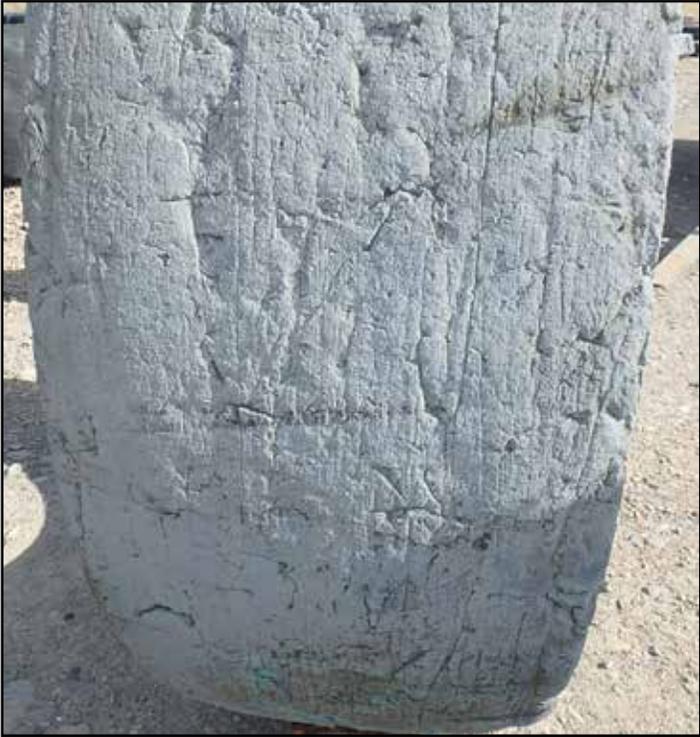
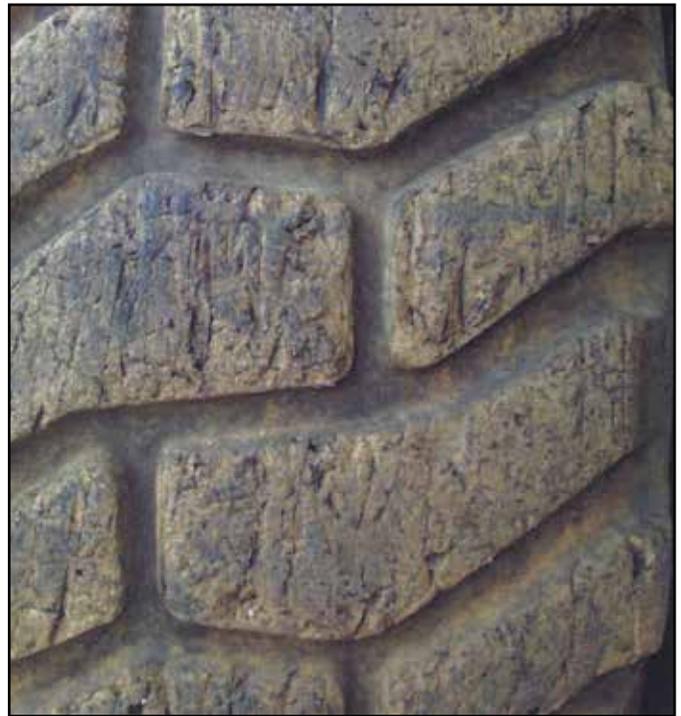
DESCRIPTION	Repeated circumferential cuts/scratches to the tread.
--------------------	--

OBSERVATION	Circumferential cuts and scratches on the tread.
PROBABLE CAUSES(S)	Tire spinning over very rough surfaces; could have contact with the vehicle.
EVOLUTION	Tearing of tread rubber, crown oxidation.
RECOMMENDED ACTION	If wear is advanced and the tire cannot be retreaded, keep running until the protective ply appears. If the tire is accepted for retreading, send it in before the cuts reach the plies at several points.
PREVENTION	Look for the causes of spinning (going uphill empty, loose or soft surface, high torque). Clean and maintain the site roads using graders or bulldozers. Review the balance between load and pressure and reduce pressure if possible. Review the choice of tread pattern and/or type of rubber compound.
DO NOT CONFUSE WITH	Page 24

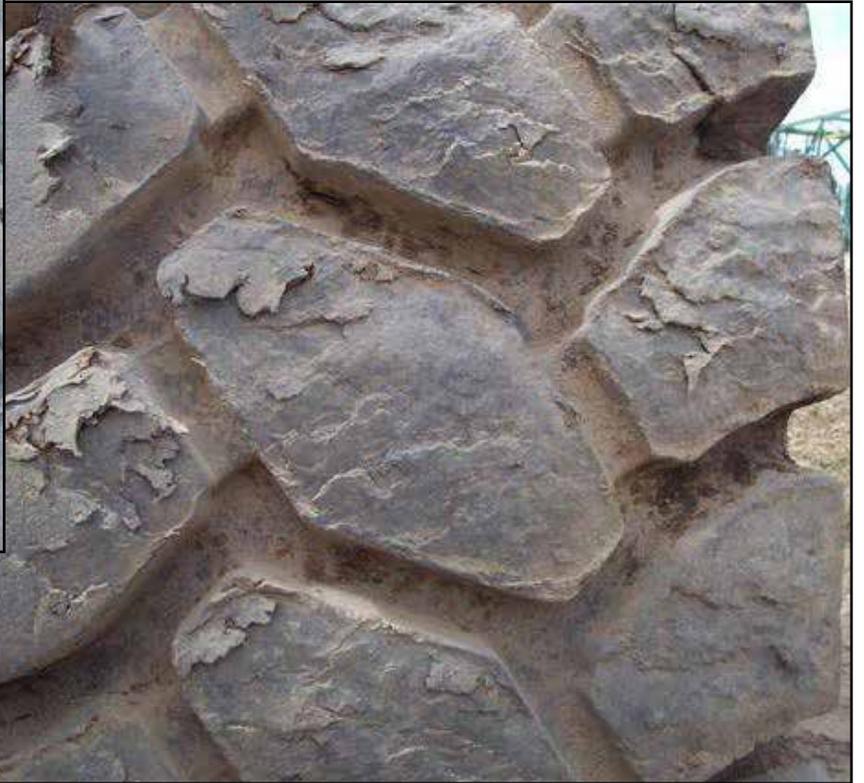
DESCRIPTION	Scaling, or flaking away, of the tread rubber.
--------------------	---

OBSERVATION	Multiple tears in the rubber on the tread, giving a scaly, flaky appearance.
PROBABLE CAUSES(S)	Type of rubber not suited to the surface and conditions of use. More frequent when running on hard tracks covered with very small particles (pebbles, glass, etc.). Accentuated by over-inflation, or by repeatedly changing the direction of travel, and/or by running at high torque, associated with a high average speed.
EVOLUTION	Tearing, deterioration of crown plies and rapid wear.
RECOMMENDED ACTION	If wear is advanced and the tire cannot be retreaded, leave running until the protective ply appears. If the tire is accepted for retreading, send it in before the tears reach the plies at several points.
PREVENTION	Review the balance between load and pressure. Observe the type and diversity of surfaces covered by the machines and redefine the choice of (a harder) rubber compound.
DO NOT CONFUSE WITH	Page 24

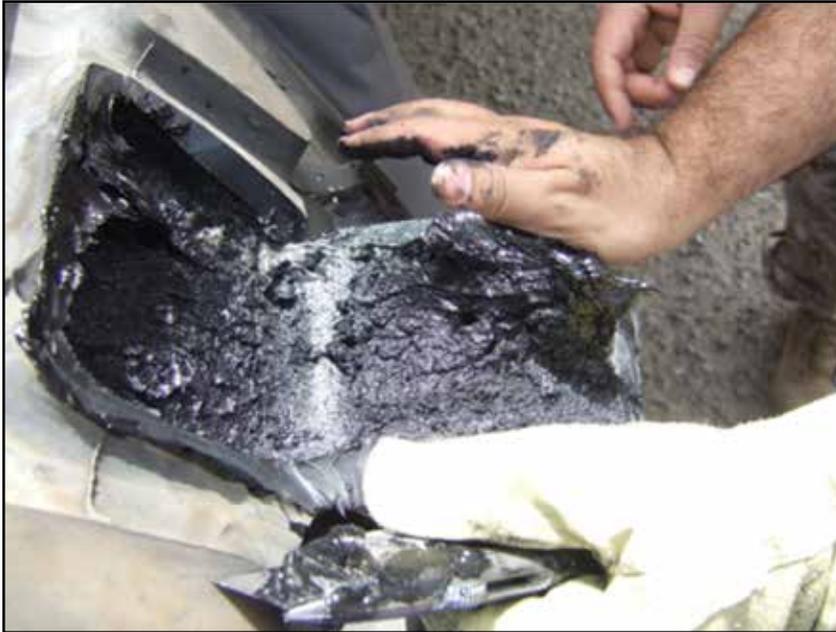
Cavities in the tread band generally in the center. Aspect of the rubber can be blistered, soft, sticky, with or without tearing out. The damage can be localized or appear in several areas.

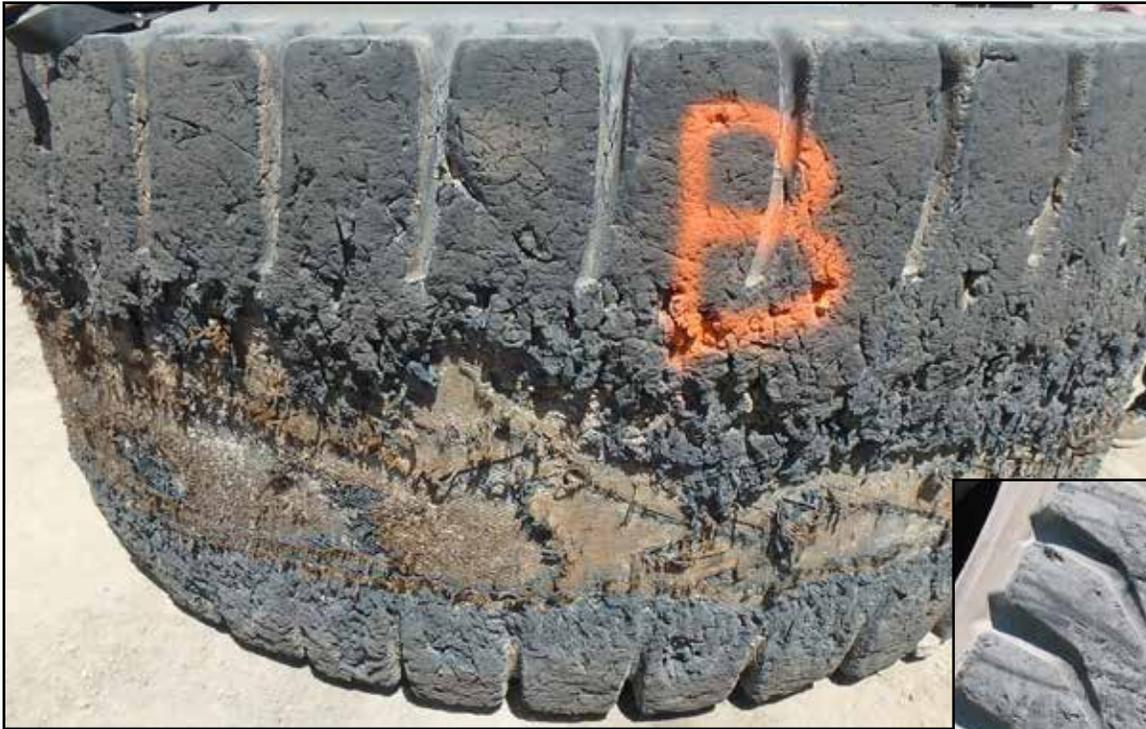
DESCRIPTION	Excessive wear reaching the crown plies.
--------------------	---

OBSERVATION	Excessive wear reaching the crown plies.
PROBABLE CAUSES(S)	NA
EVOLUTION	Wear of protector and working plies.
RECOMMENDED ACTION	Remove from service and scrap according to end user's removal policy.
PREVENTION	Comply with the legislation in force if the machine is subject to traffic regulations (e.g. cranes). If the tire is accepted for retreading, withdraw it from use as soon as the tread pattern disappears.
DO NOT CONFUSE WITH	Page 28

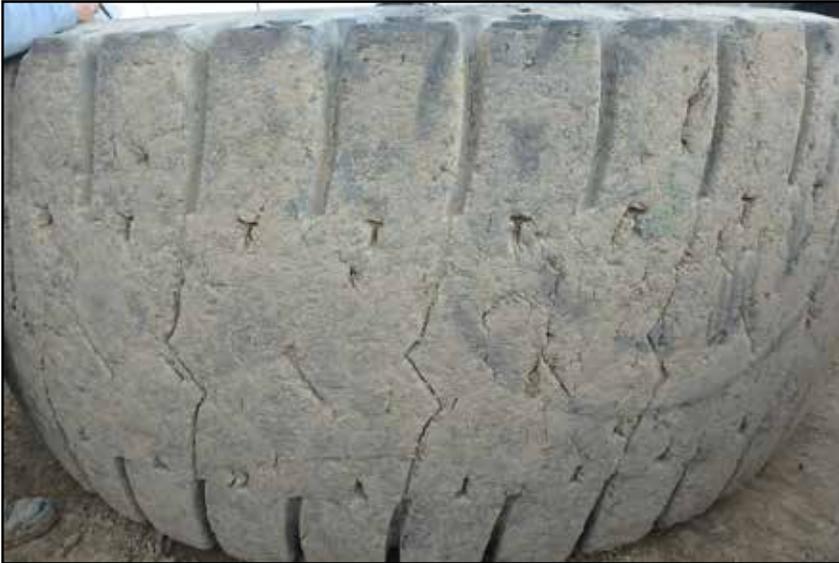
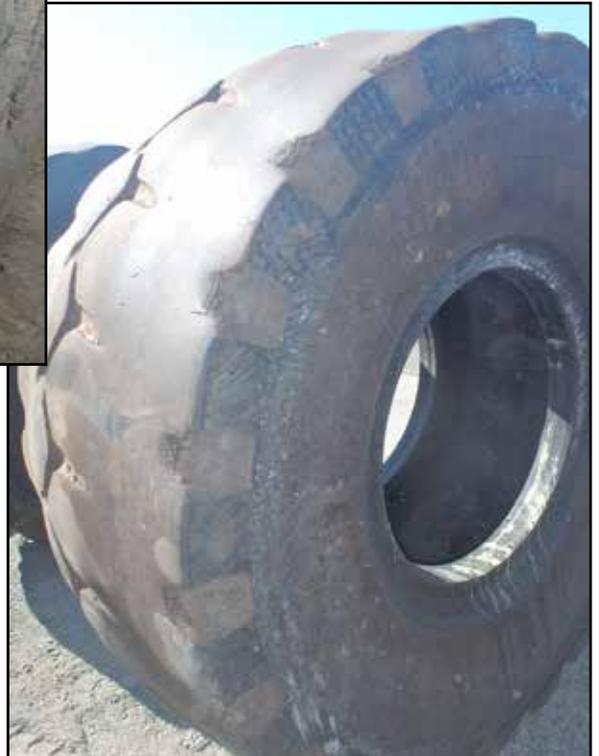
DESCRIPTION	Normal wear.
--------------------	---------------------

OBSERVATION	Tire normally worn out and withdrawn from service with no sign of abnormal wear.
PROBABLE CAUSES(S)	NA
EVOLUTION	NA
RECOMMENDED ACTION	None.
PREVENTION	Comply with the legislation of your local country if the machine is subject to traffic regulations (e.g. cranes). If the tire is accepted for retreading, and to avoid losing the possibility of retreading it, withdraw the tires from use as soon as the tread pattern disappears.
DO NOT CONFUSE WITH	Page 27

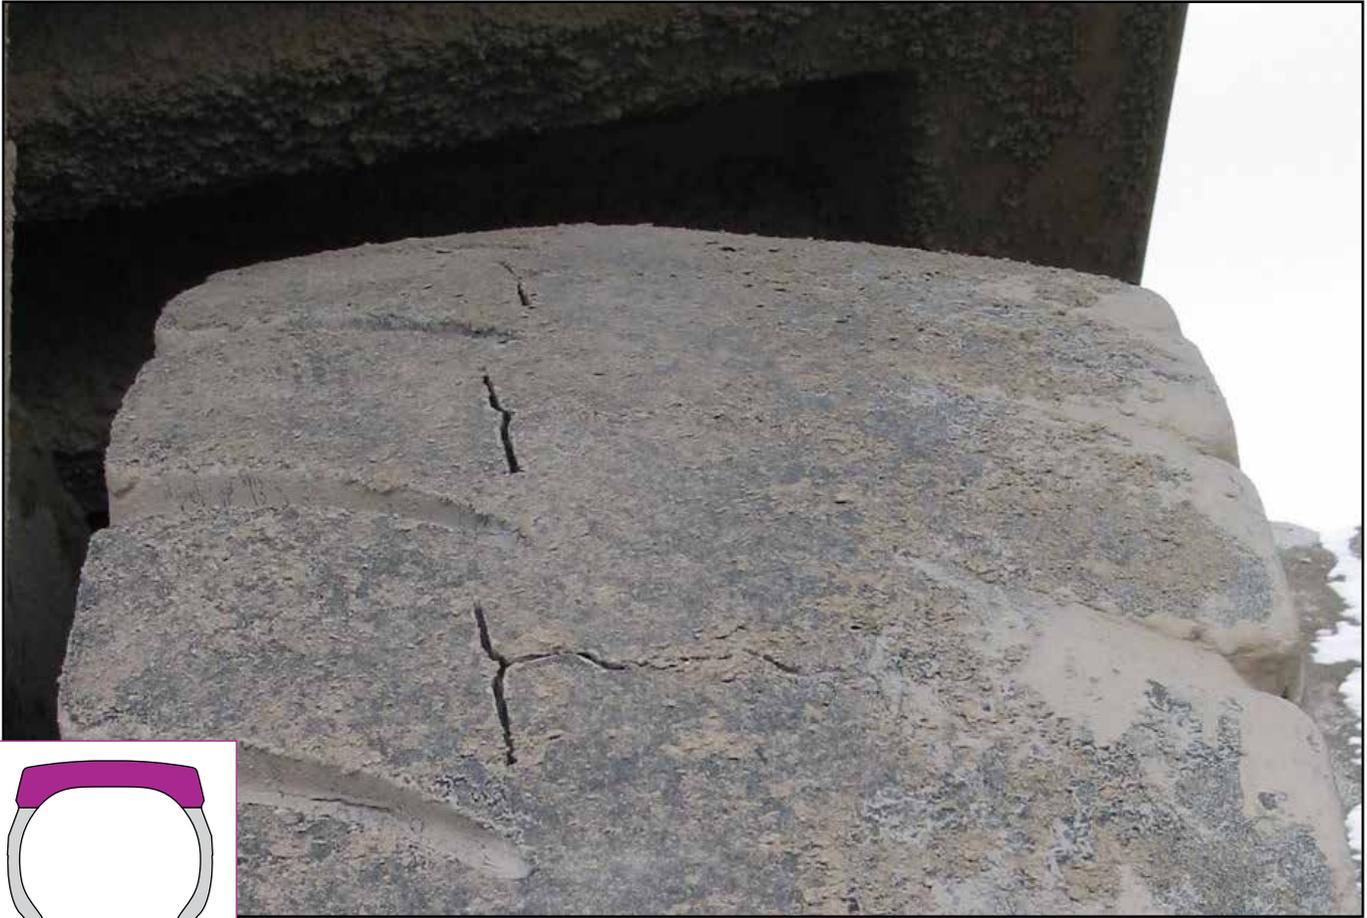
Sloped wear.

OBSERVATION	Wear increasing from one shoulder to the other, but the tread blocks have no trailing edges transverse to the direction of travel.
PROBABLE CAUSES(S)	Because of the nature of the application, the tire, when travelling, is inclined in relation to the vertical (positive or negative camber).
EVOLUTION	Crown plies exposed, loss of life and retreadable casing.
RECOMMENDED ACTION	Switch to a position where the forms of wear are less of a problem and regroove if the tire is branded "Regroovable". To be retreaded if the tread pattern has disappeared and the size is accepted.
PREVENTION	Do not wait until the tire is half-worn before rotating.
DO NOT CONFUSE WITH	Any other wear patterns.

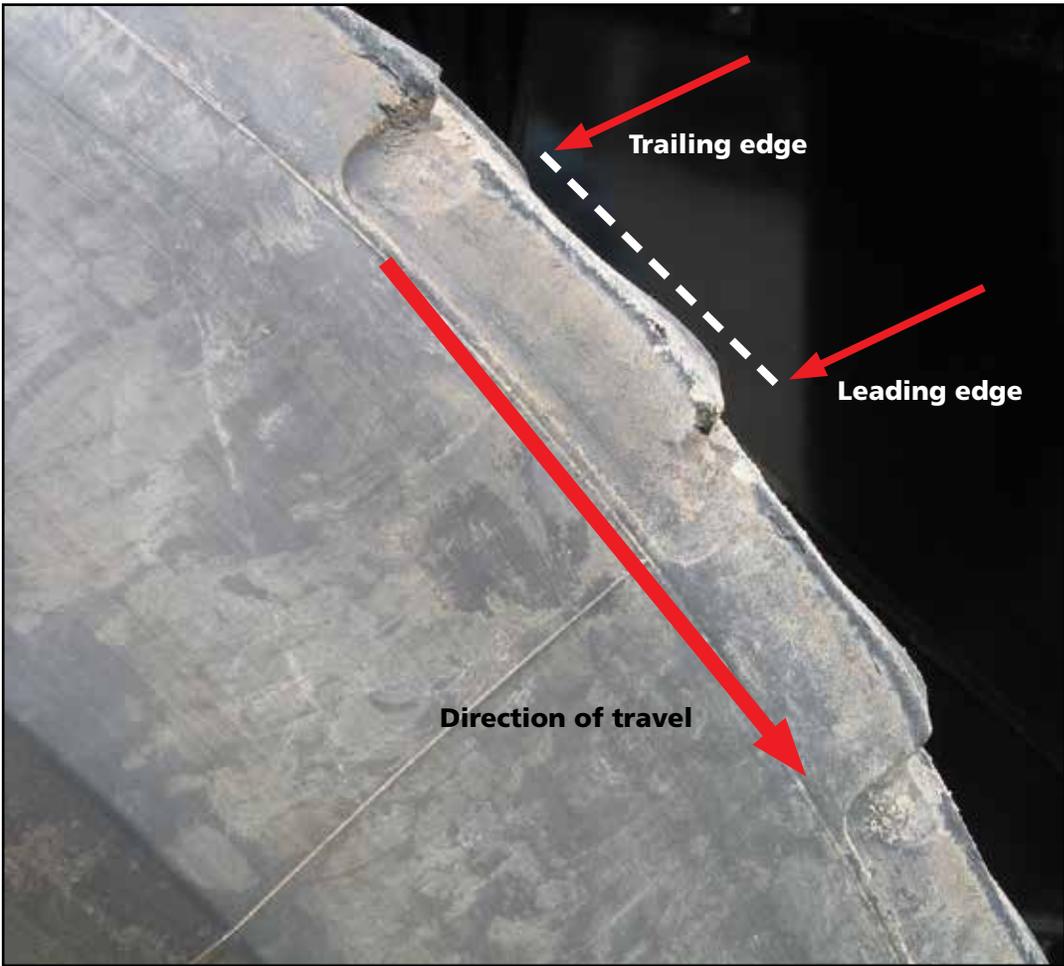
DESCRIPTION	Heel and toe wear.
<div style="border: 1px solid #800080; width: 100px; height: 100px; margin-bottom: 10px; display: flex; align-items: center; justify-content: center;">

OBSERVATION	Heel and toe wear (wear on trailing edges of blocks).
PROBABLE CAUSES(S)	Association of slow wear, hard roads, large slip angle: for example, on trailing axle (trailing edge worn). Or rapid wear, hard road, high braking or incorrect dual matching (new tire with worn): leading edge worn. These two effects are combined when going downhill loaded.
EVOLUTION	Continuous irregular wear, increase in vibrations and operator discomfort.
RECOMMENDED ACTION	Rotate tires as soon as the effect becomes visible.
PREVENTION	In the case of rigid dumpers, if the tread design is directional, switch tread direction on the front axle; switch the tires around before wear is too pronounced. Review the choice of tread pattern and/or the type of rubber.

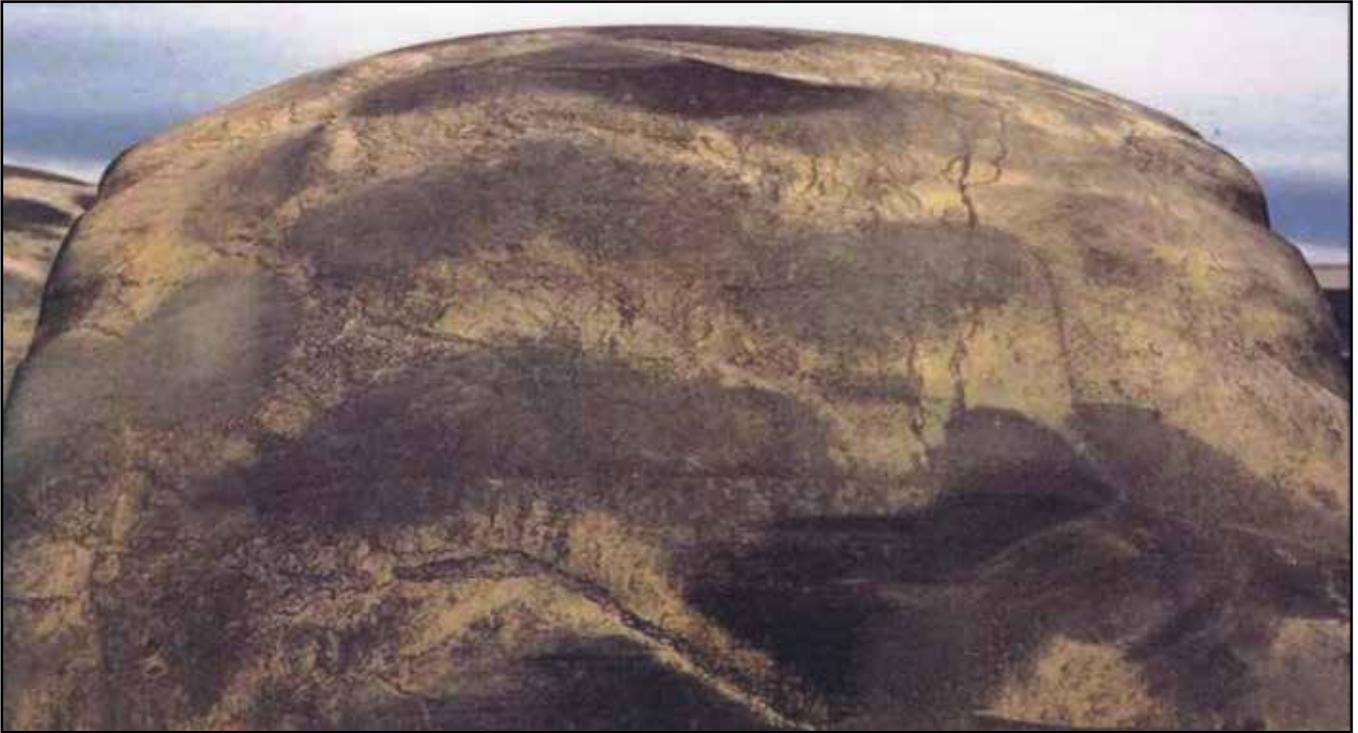
Wear on the shoulders giving rounded profile.

Greater wear on the shoulders.

If possible, weigh the machine by axle to determine optimum pressure. Investigate causes of low pressure.

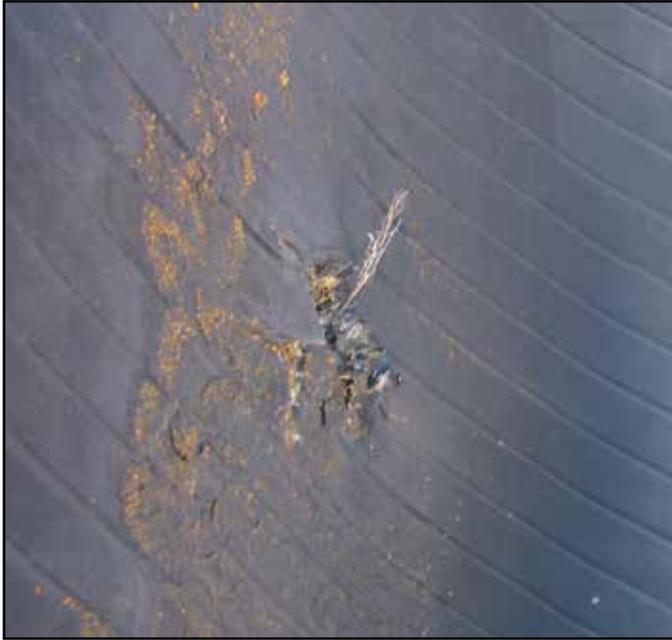
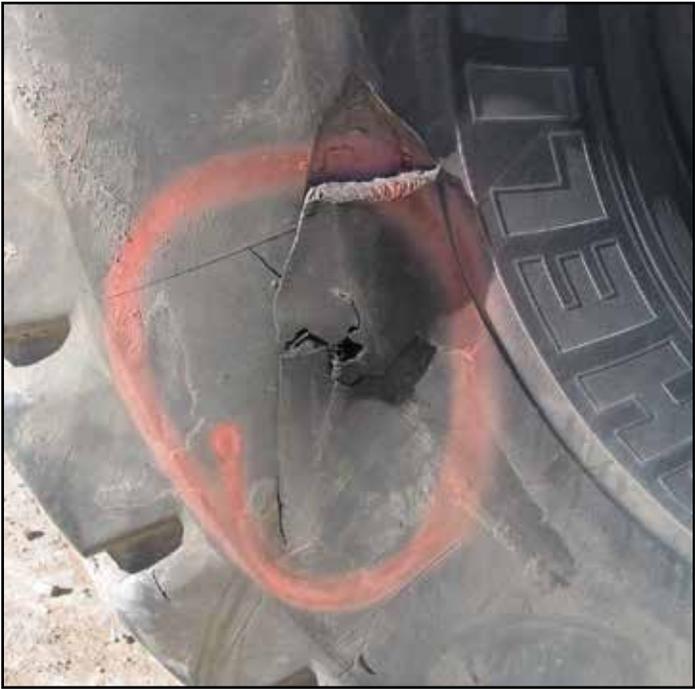
OBSERVATION	Perforation or cut extending through the sidewall.
PROBABLE CAUSES(S)	Accidental cut or perforation, contact with rock ejectors.
EVOLUTION	Runflat with or without rapid air loss.
RECOMMENDED ACTION	If the damage is within the recommended limits, submit for repair (depending on the tire's residual value).
PREVENTION	Review the inflation pressure if perforations are frequent. Improve the working environment. Improve the condition of the haul roads.
DO NOT CONFUSE WITH	Page 65

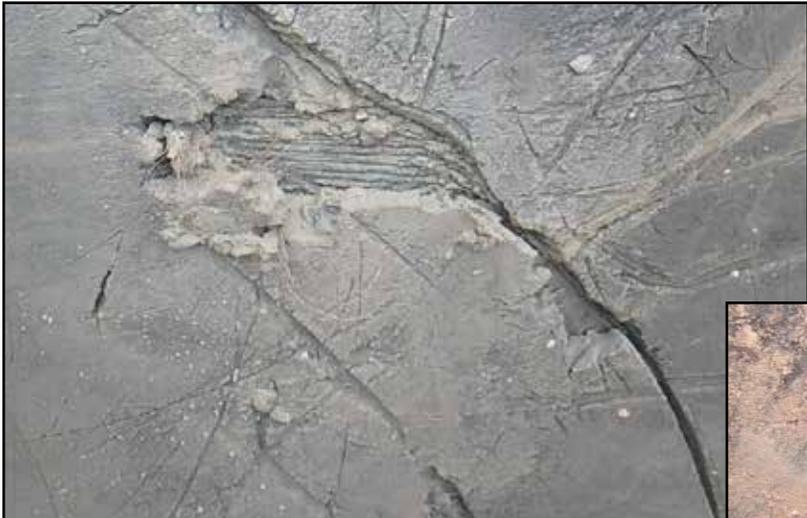
DESCRIPTION	Localized sidewall damage affecting the casing ply but not extending to the interior of the tire.
<div style="display: flex; justify-content: space-between; align-items: flex-start;"> <div style="width: 45%;">

</div>	
OBSERVATION	Localized sidewall damage not extending to the interior but affecting the casing ply or its turn-up.
PROBABLE CAUSES(S)	Accidental sidewall cut, shock or impact.
EVOLUTION	Splitting open radially or rupture.
RECOMMENDED ACTION	Repair, depending on the tire's residual value. Assess the extent of the damage to ensure that it is within the recommended limits.
PREVENTION	Review tire pressure if damage is frequent. Identify areas where damage is likely to occur. Improve the condition of the haul roads and work conditions.

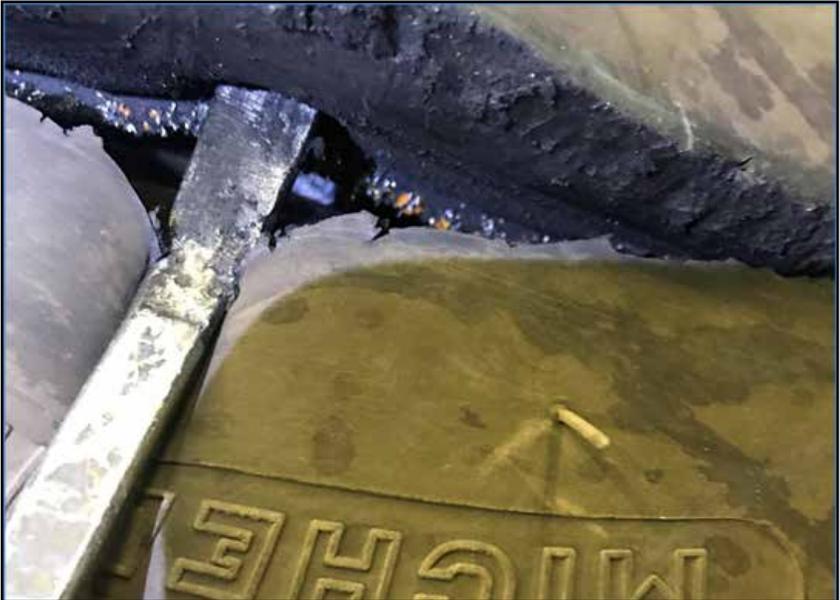
DESCRIPTION	Rupture of the turn-up in the bead area.
--------------------	---

OBSERVATION	Rupture of the casing ply turn-up in the bead-bearing area behind the flange.
PROBABLE CAUSES(S)	Tire's nominal load capacity exceeded. Under-inflation. Improper mounting or incorrect flange height. Often seen on industrial and underground tires.
EVOLUTION	Casing ply rupture, rapid deflation.
RECOMMENDED ACTION	If cords have lost their frette or are broken, scrap.
PREVENTION	If possible, weigh the machine by axle to determine optimum pressures. When fitting, ensure that the tire is correctly centered on the rim and seated per Michelin's bead seating pressure guidance. Verify that the wheel and flange parts are correct.
DO NOT CONFUSE WITH	Pages 37, 53, 64

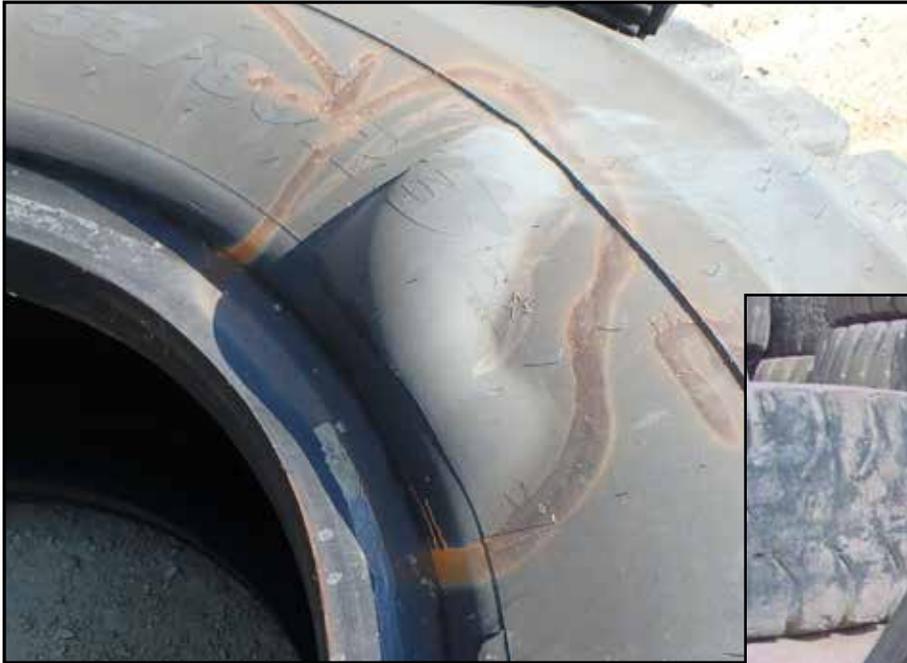
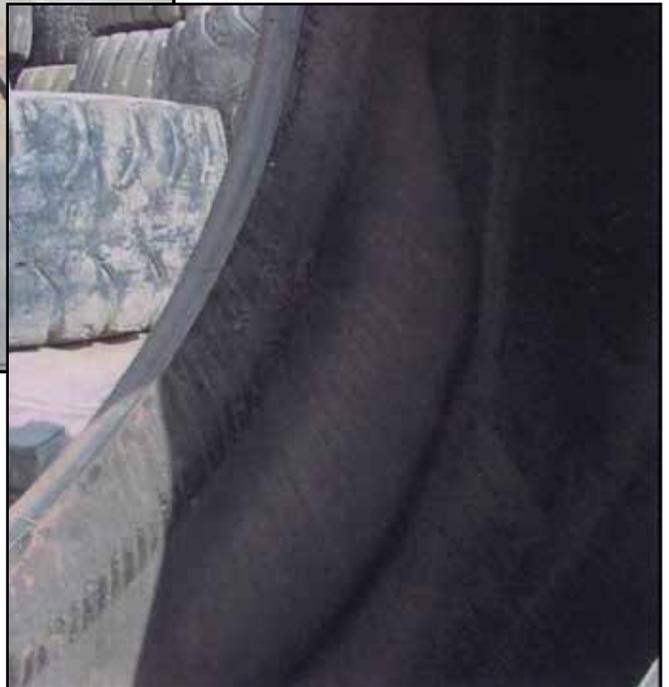
OBSERVATION	Generally circumferential bulges in the lower part of the sidewall, hard to the touch. Visible on the exterior and interior of the tire.
PROBABLE CAUSES(S)	Tire's nominal load capacity exceeded. Under-inflation. Improper mounting.
EVOLUTION	Continued separation of the bead elements leading to a rupture of the casing.
RECOMMENDED ACTION	Scrap.
PREVENTION	If possible, weigh the machine by axle to determine optimum pressures. Review and adapt the advised pressure. Make tire fitters aware of the need to follow the proper fitting/seating procedures.
DO NOT CONFUSE WITH	Pages 37, 38, 39
