EARTHMOVER TIRE CONDITIONS ANALYSIS GUIDE

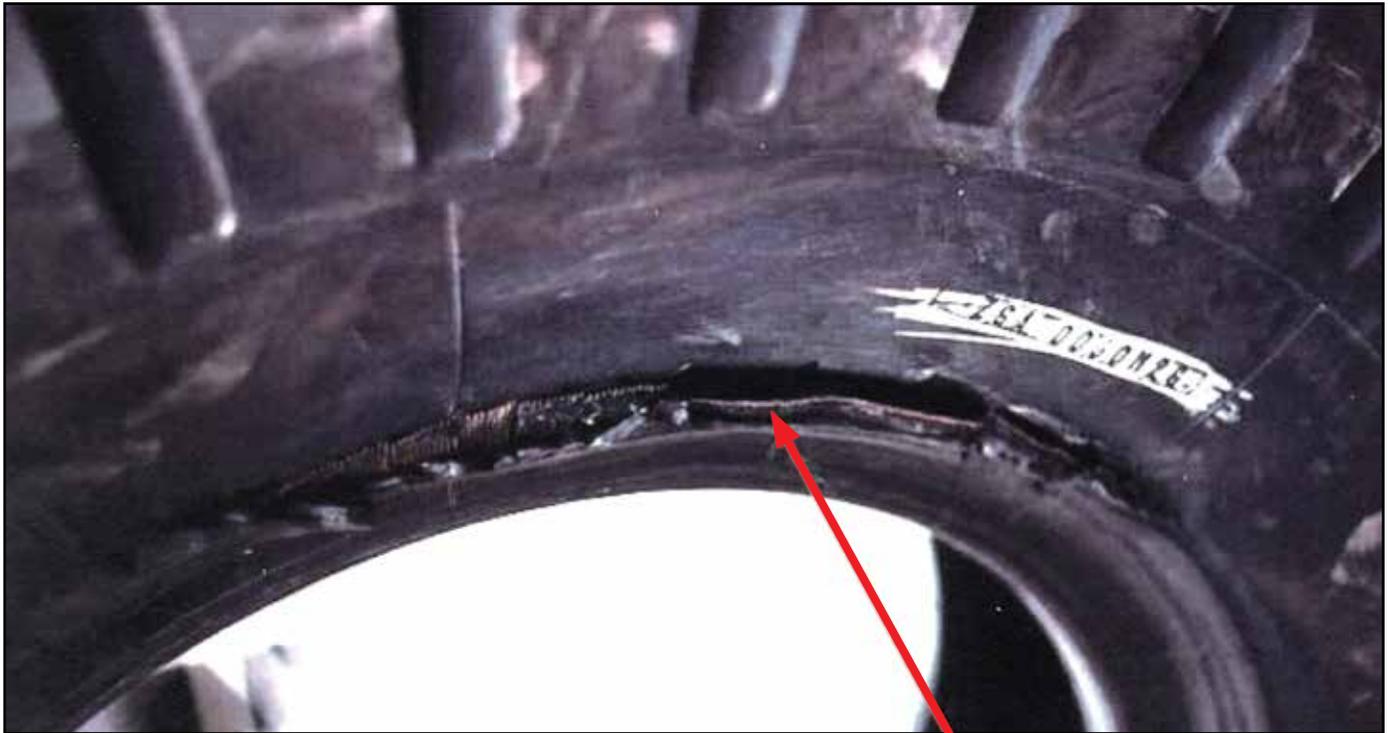
OBSERVATION	Circumferential separation at the top/end of the turn-up in the bead area.
PROBABLE CAUSES(S)	Tire's nominal load capacity exceeded. Under-inflation. Improper mounting.
EVOLUTION	Continued separation of the bead elements leading to a rupture of the casing.
RECOMMENDED ACTION	Scrap.
PREVENTION	If possible, weigh the machine by axle to determine optimum pressures. Review and adapt the advised pressure. Make tire fitter aware of the need to follow the proper fitting/seating procedures.
DO NOT CONFUSE WITH	Pages 38, 64, 76

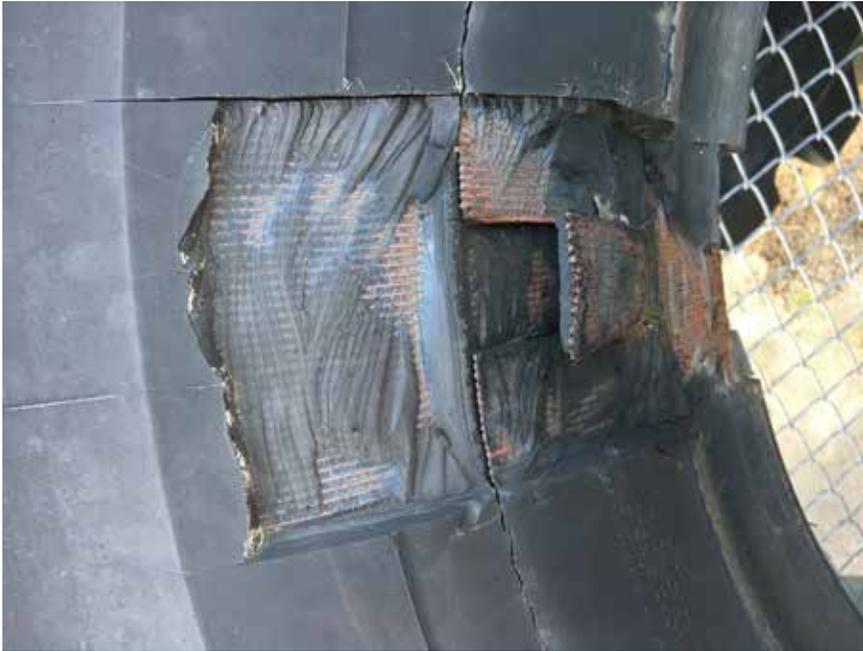
OBSERVATION	Separation at the end of the high casing ply turn-up (mid-height turn-up) or reinforcement on the sidewall
PROBABLE CAUSES(S)	Tire's nominal load capacity exceeded, under-inflation. Improper mounting.
EVOLUTION	Opening will continue to spread; once completely open the tire could rupture.
RECOMMENDED ACTION	To be examined by the Manufacturer to decide if tire should keep running. If not, scrap.
PREVENTION	If possible, weigh the machine by axle to determine optimum pressures. When mounting is done on the machine, make sure tire fitters are aware of correct mounting and seating pressures.
DO NOT CONFUSE WITH	Page 36

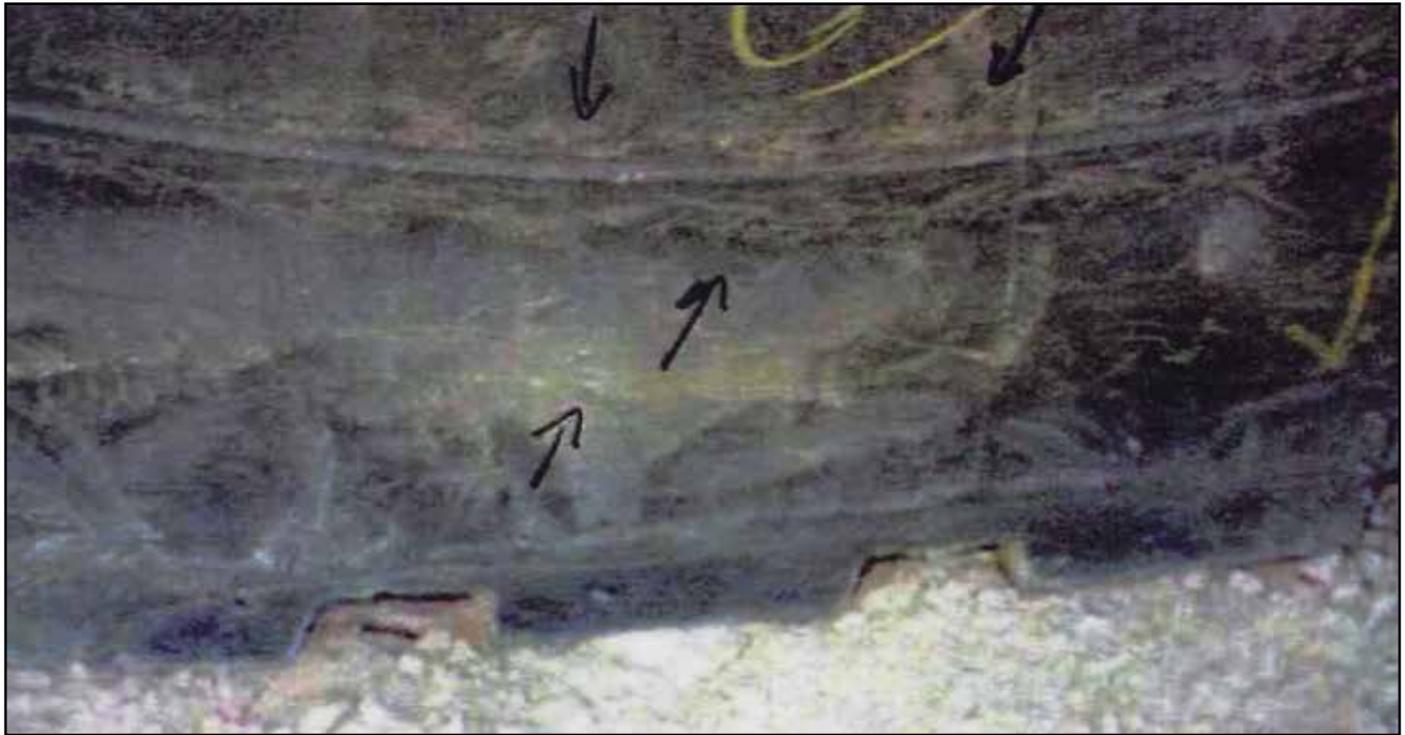
OBSERVATION	Ozone cracking in flexing zone on the tire sidewall.
PROBABLE CAUSES(S)	Normal phenomenon of rubber, linked to storage conditions. Accentuated by a concentration of ozone.
EVOLUTION	Cracks will continue to progress very slowly.
RECOMMENDED ACTION	Leave in service or scrap if the casing ply is damaged.
PREVENTION	Avoid exposing tires, even momentarily, to ozone emissions (i.e. arc welding). Ensure proper storage of new machines and tires.
DO NOT CONFUSE WITH	NA

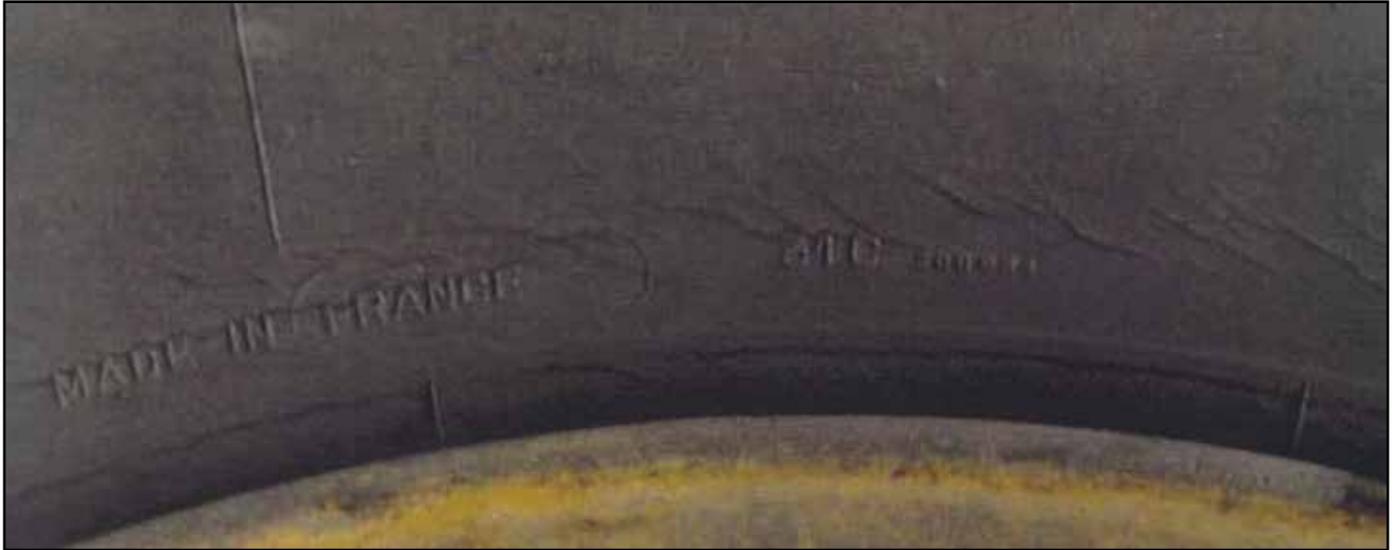
OBSERVATION	Ozone cracking in bead area, on sidewall.
PROBABLE CAUSES(S)	Normal phenomenon of rubber, accentuated by a concentration of ozone.
EVOLUTION	Cracks will continue to progress very slowly.
RECOMMENDED ACTION	Leave running (unless the casing ply turn-up is visible, then scrap).
PREVENTION	Avoid exposing tires, even momentarily, to ozone emissions (arc welding set). Ensure proper storage of new machines and tire equipment.
DO NOT CONFUSE WITH	Pages 36, 37

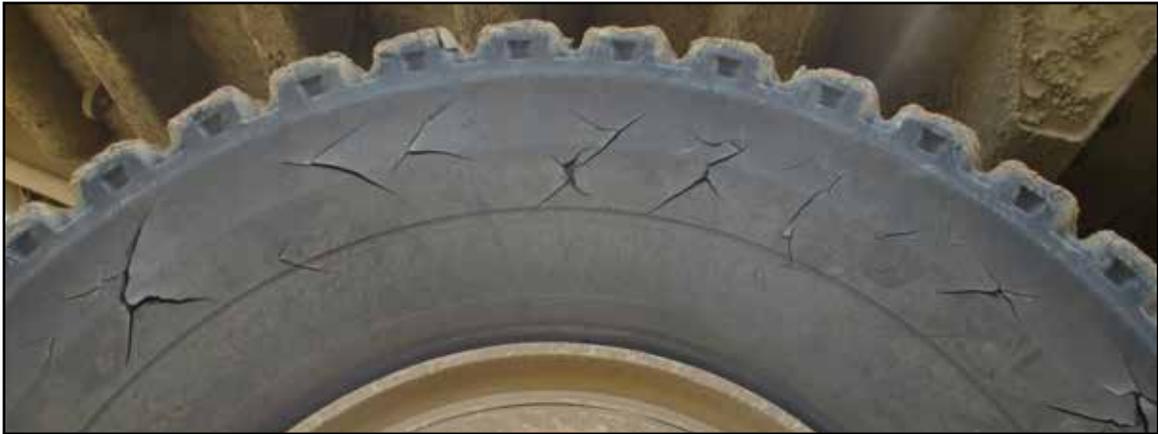
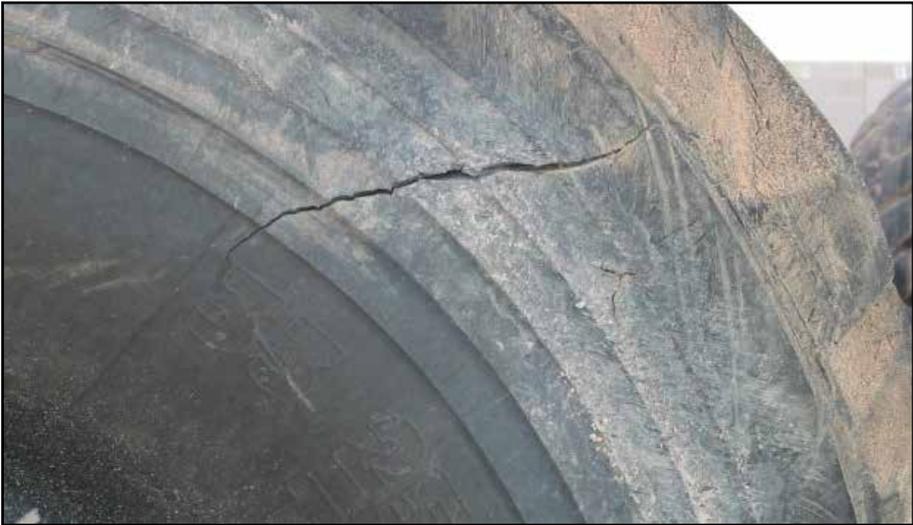
OBSERVATION	Oblique splits on the sidewall.
PROBABLE CAUSES(S)	Development of damage by excessive flexing initiated by cut(s).
EVOLUTION	Air loss following propagation of the split to the interior of the split, without rupture.
RECOMMENDED ACTION	In the case of little wear, make a preventive repair before any ply becomes visible. If wear is advanced and plies are damaged with sidewall deformation, scrap. If wear is advanced, but there is no sidewall deformation and the tire is not accepted for retreading, leave running. If there are a lot of oblique splits, do not advise retreading.
PREVENTION	Keep an eye on cuts on transport machines. Look for places where there is a possibility of impact. Improve condition of haul roads.
DO NOT CONFUSE WITH	Pages 21, 32, 33

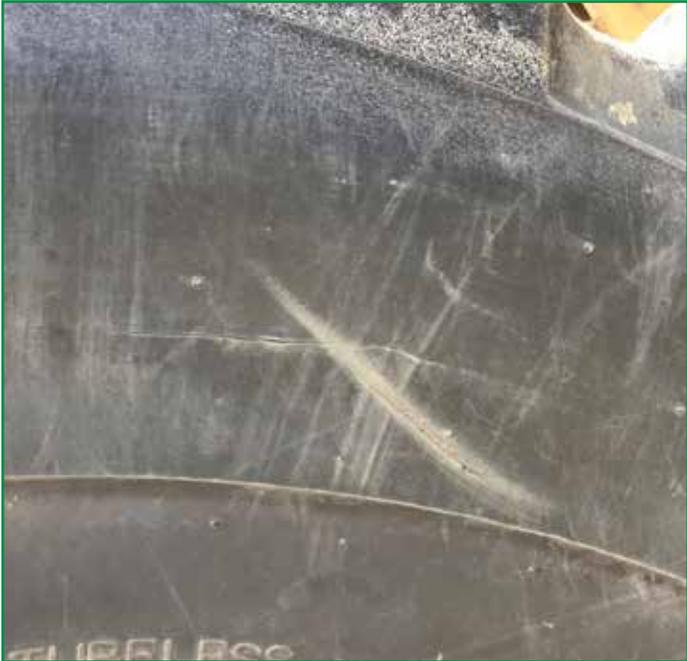
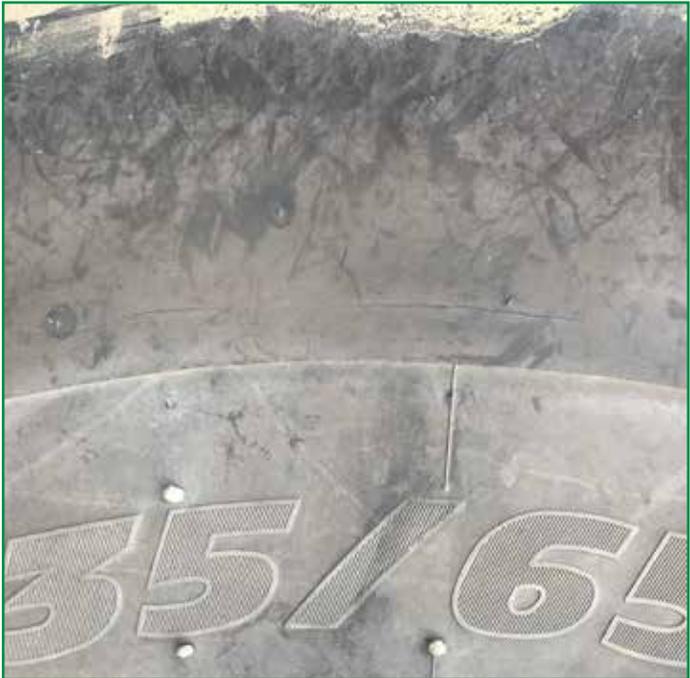
OBSERVATION	Rubber splits in the sidewall/shoulder area without separation between the plies.
PROBABLE CAUSES(S)	Severe scrubbing. Sidewall cut. Localized stress during passage over an obstacle.
EVOLUTION	Tearing out of the tread band rubber in the shoulder. Rupture of the casing ply at the edge of the crown block.
RECOMMENDED ACTION	<p>In the case of little wear and:</p> <ul style="list-style-type: none"> • The split is not deep <2 to 3mm: make a simple buffing • > 2 to 3mm: make preventive repair before any ply becomes visible. <p>If wear is advanced and plies are damaged with sidewall deformation, scrap. If wear is advanced, but there is no sidewall deformation and the tire is not accepted for retreading, leave running. If there are many circumferential splits, do not advise retreading.</p>
PREVENTION	Keep an eye on cuts on transport machines. Look for places where there is a possibility of impact. Improve condition of haul roads.

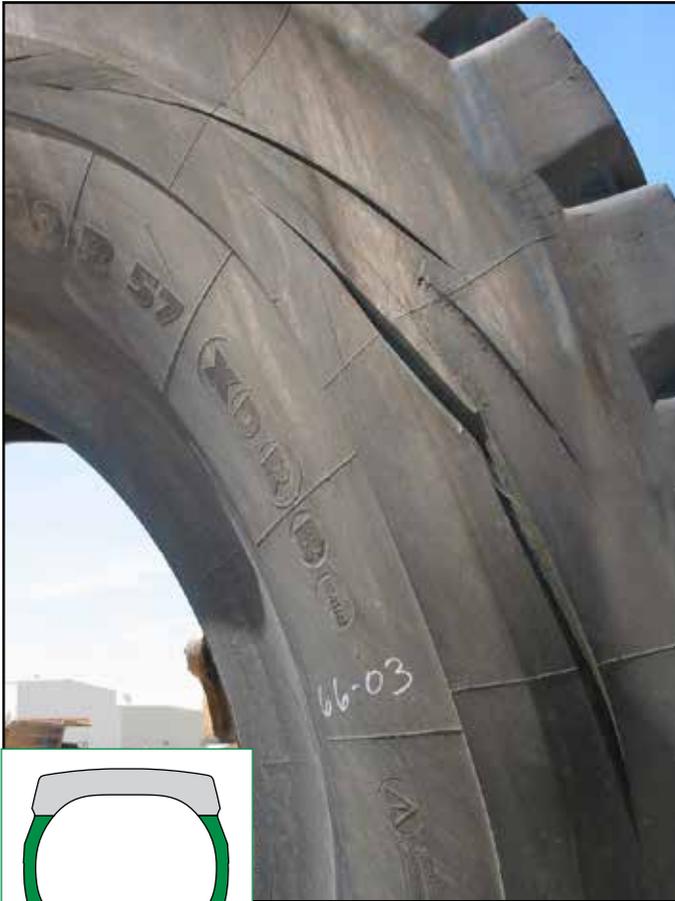
OBSERVATION	Repeated circumferential cuts/scratches to the sidewall.
PROBABLE CAUSES(S)	Sidewall rubbing repeatedly against part of the vehicle or an obstacle.
EVOLUTION	Continued wear leading to possible rupture of the casing ply.
RECOMMENDED ACTION	Comply with the legislation in force in the country if the machine is subject to traffic regulations (e.g. cranes). If wear is advanced and the tire is not accepted for retreading, leave running on site only.
PREVENTION	Look for the offending part. Check the general condition of the rock ejectors, spacers, wings, etc. Examine the site conditions in which the machine is operating.
DO NOT CONFUSE WITH	Page 46

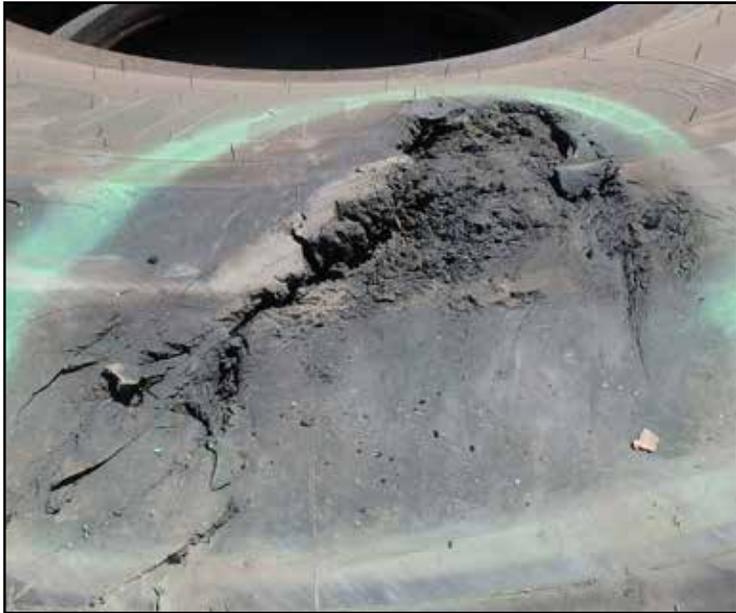
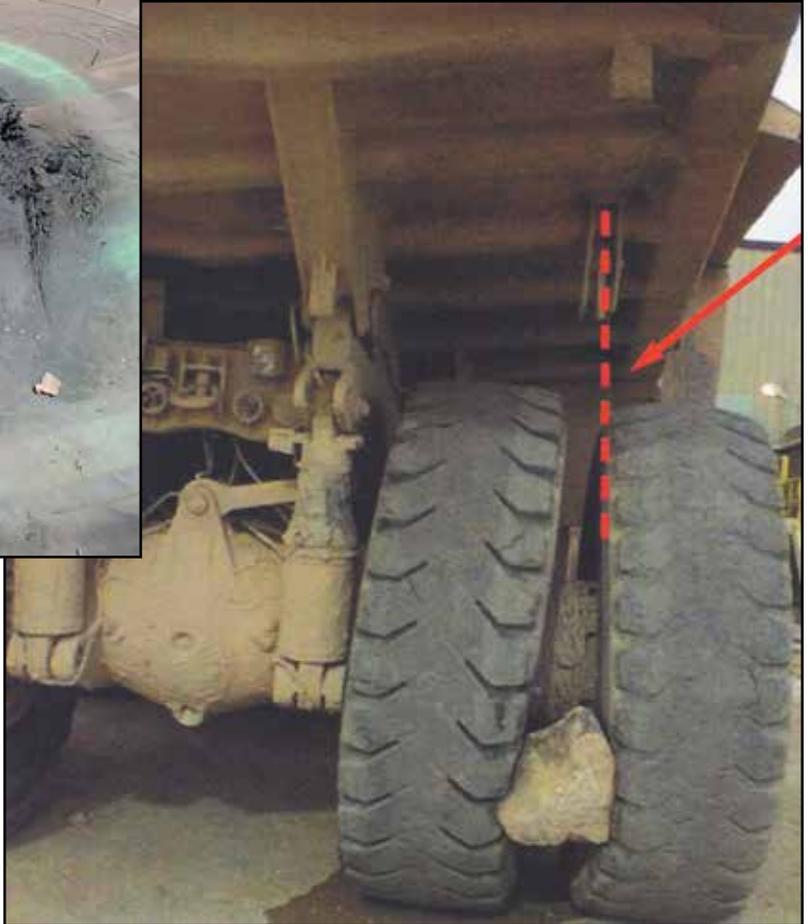
DESCRIPTION	Sidewall damage due to an object trapped between dual tires.
--------------------	---

OBSERVATION	Sidewall damaged by object trapped between duals.
PROBABLE CAUSES(S)	Object trapped between duals.
EVOLUTION	Damage could lead to rapid deflation of one or both tires.
RECOMMENDED ACTION	<p>Step 1: Deflate both tires before removing wheel bolts.</p> <p>Step 2: Remove for internal examination of both tires, depending on the size of the object or impact.</p> <p>Step 3: Measure the damage and repair in accordance with the recommended limits. If wear is advanced and the size can be retreaded, retread. Otherwise, scrap.</p>
PREVENTION	Make sure that rock ejectors are fitted (preventing objects from becoming trapped between duals). Improve condition of haul roads.
DO NOT CONFUSE WITH	Page 62

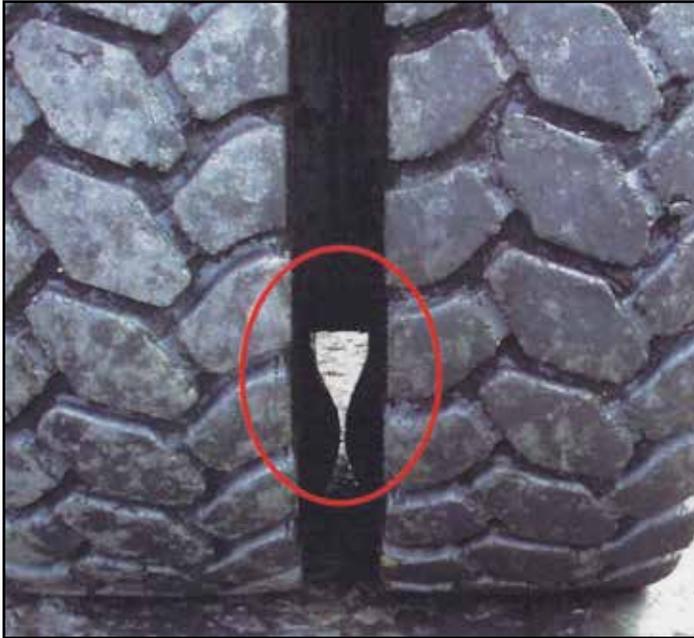
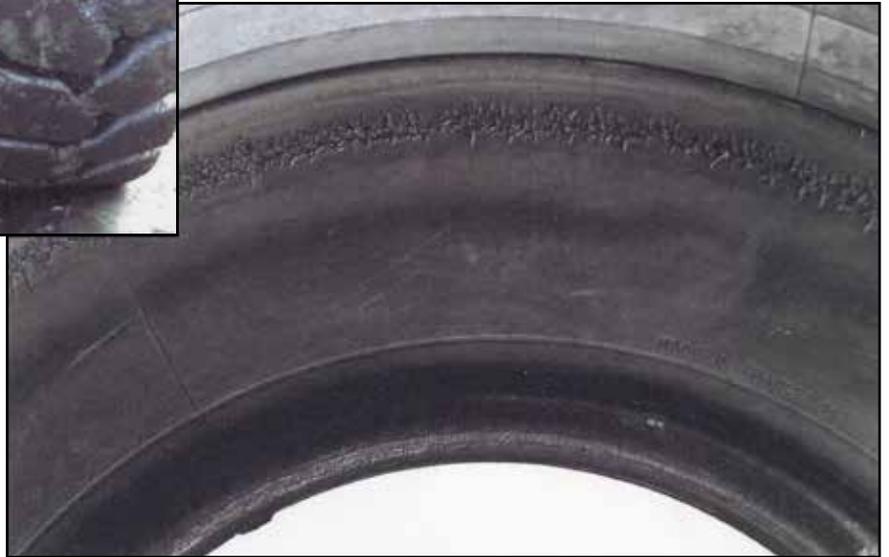
OBSERVATION	Friction between duals because of kissing. Damage to the sidewall by dual tires kissing (with/without casing ply rupture).
PROBABLE CAUSES(S)	Insufficient pressure or tire's nominal load capacity exceeded. Travelling laden up a very steep slope. Incorrect wheel offsets (dual spacing).
EVOLUTION	Damage could lead to rapid deflation of one or both tires.
RECOMMENDED ACTION	Remove and examine the interior of the tires. If the size is accepted for retreading, remove the tire before the first ply becomes visible. If the size is not accepted for retreading, leave running on site until the ply becomes visible. Comply with the legislation in force in the country if the machine is subject to traffic regulations (e.g. cranes).
PREVENTION	Adapt the pressure to the load. Check pressures regularly. Study the conditions of use and reduce gradients if possible. Check for correct dual spacing.
DO NOT CONFUSE WITH	NA

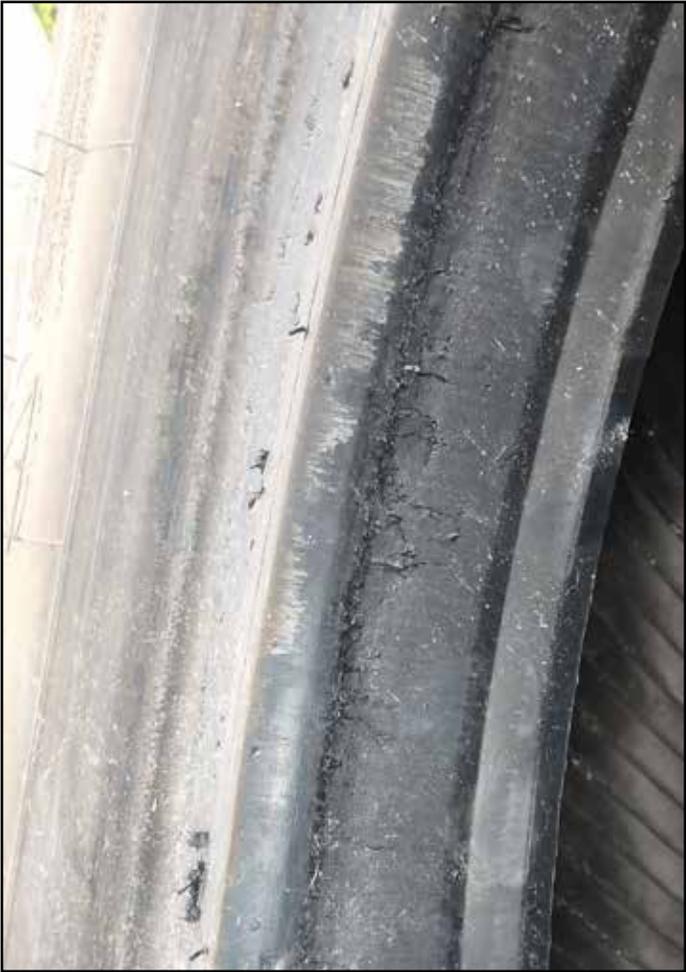
OBSERVATION	Deformation/compression of rubber at the bead heel.
PROBABLE CAUSES(S)	Linked to an excessive gap between flange and rim, not a fitting problem. Very high pressures push the material under that gap.
EVOLUTION	Tire may begin indexing due to the high pressures stretching the bead wire.
RECOMMENDED ACTION	Put back into use. To make it easier to seat the bead when inflating, trim off the excess rubber (use a hemispherical rasp with a hand grinder with a maximum speed of 3000 r.p.m.).
PREVENTION	If possible, weigh the machine by axle to determine optimum pressures for the load.
DO NOT CONFUSE WITH	NA

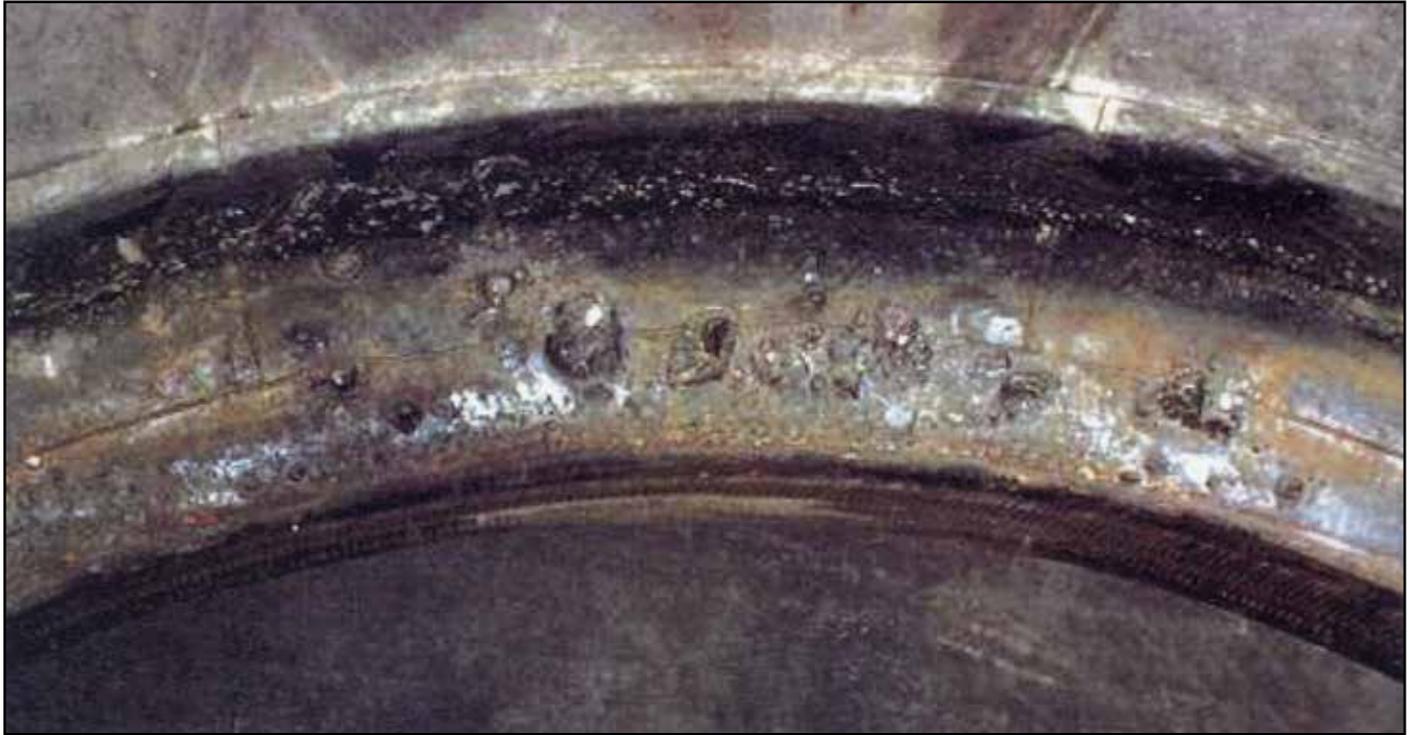
DESCRIPTION	Bead damage due to gravel, rust, etc.
--------------------	--

OBSERVATION	Bead damaged by gravel or rust.
PROBABLE CAUSES(S)	Gravel penetrating between the tire and the flange as a result of pressures being too low in relation to the use and frequent scrub. Accentuated by flanges which are rusty or worn.
EVOLUTION	Damage to casing cables.
RECOMMENDED ACTION	Clean the beads and wheel components.
PREVENTION	Check weights and define the recommended pressure. Clean and paint the wheel and its components. If the components are rusty, replace them.
DO NOT CONFUSE WITH	Page 49

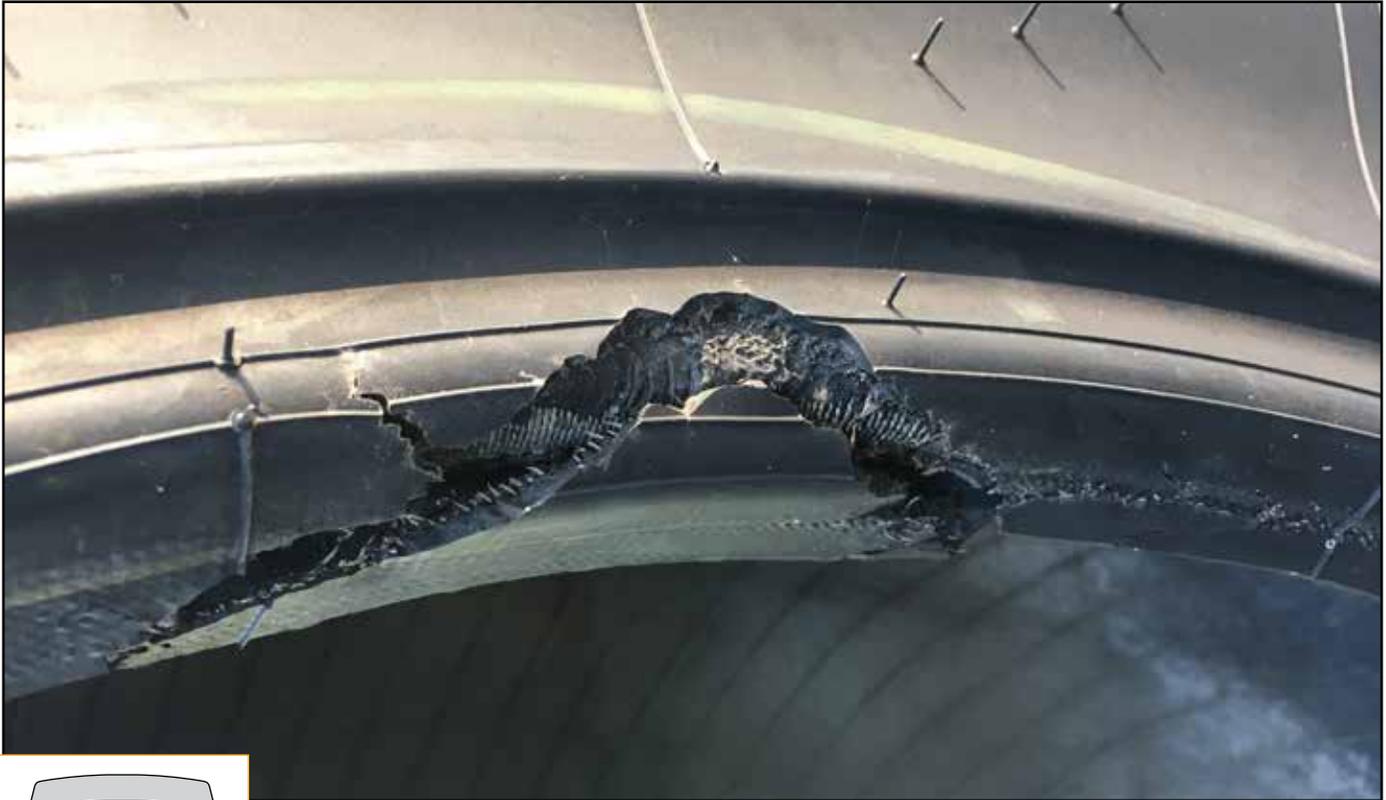
DESCRIPTION	Bead damage caused during mounting or demounting (from a tire lever or mounting machine).
--------------------	--

OBSERVATION	Damage to the rubber or a ply in the bead.
PROBABLE CAUSES(S)	Damage caused by mounting or handling tools. Fitting tools in poor condition or improperly used.
EVOLUTION	Deformation of the bead wire, rupture of the casing, broken bead.
RECOMMENDED ACTION	To be examined by Michelin or repair expert to determine if repairable. If not, scrap.
PREVENTION	Verify the condition of the fitting and handling equipment and the method used.
DO NOT CONFUSE WITH	Pages 48, 51

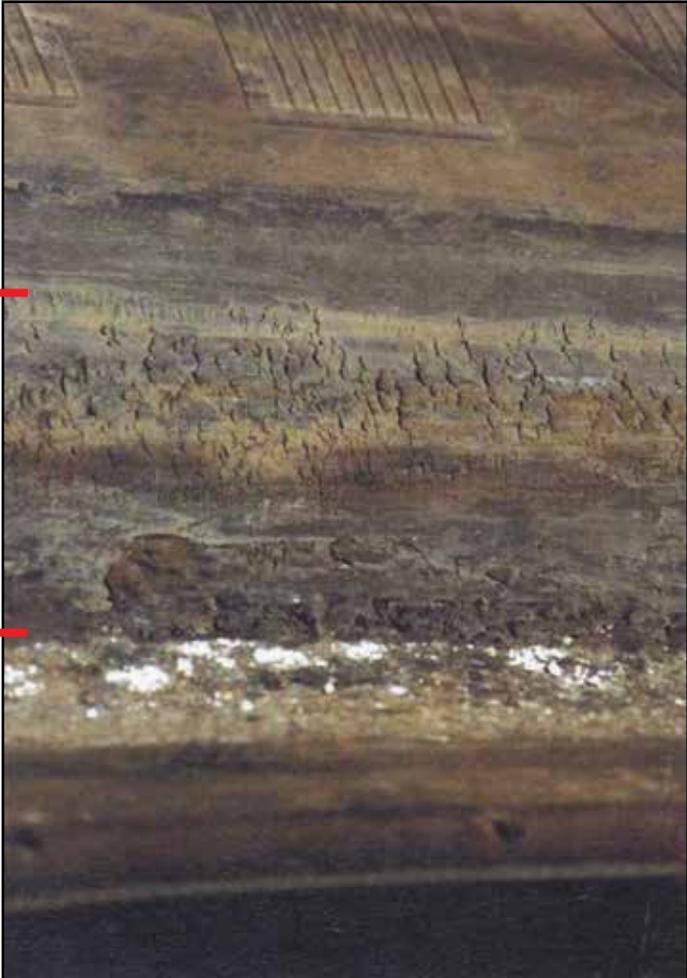
OBSERVATION	Small tears in rubber in the bead support zone.
PROBABLE CAUSES(S)	High torque. Heat build-up in bead zone resulting from intensive braking or faulty braking system.
EVOLUTION	Tears could reach casing ply turn-up, exposing steel cords to oxidation.
RECOMMENDED ACTION	Leave running. Scrap tire if turn-up becomes exposed.
PREVENTION	Monitor development.
DO NOT CONFUSE WITH	Pages 53, 54

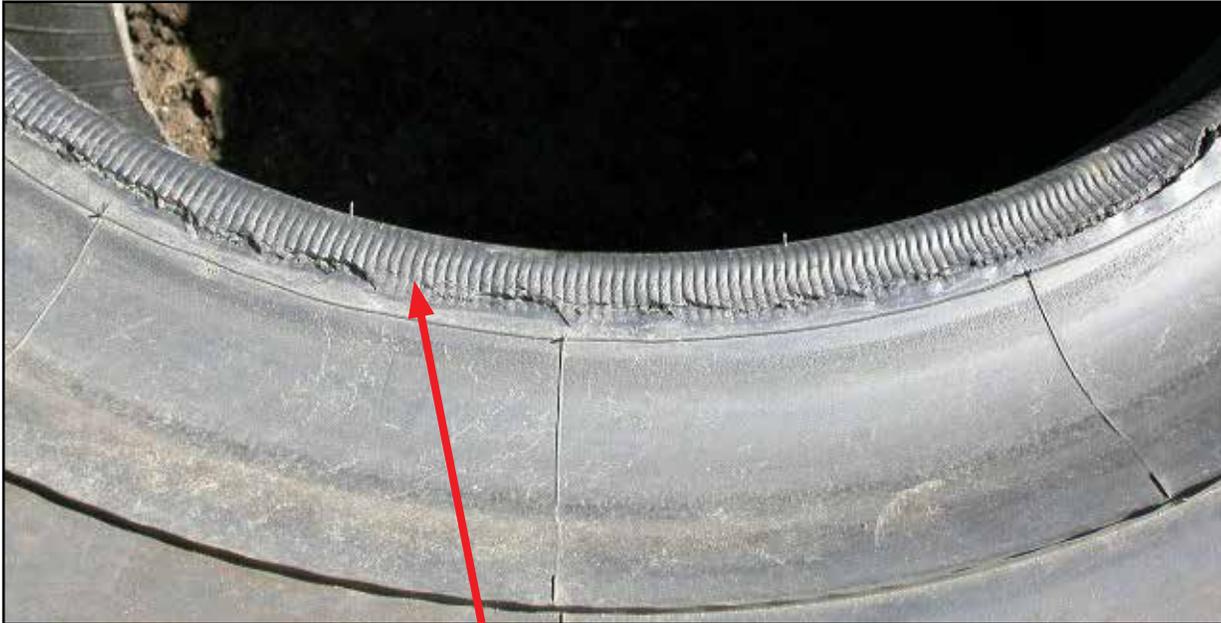
Bead support zone

DESCRIPTION	Damage or deformation of the bead due to poor seating on the rim (mismount).
--------------------	---

OBSERVATION	Knurling marks from rim base of bead seat band on bead heel and/or lower bead support zone and not on the bead sole. On rims without knurling, deformation of the bead.
PROBABLE CAUSES(S)	Insufficient lubrication, seating pressure or incorrect centering of the tire when fitting.
EVOLUTION	Split may eventually develop at top of turn-up. Remove when the split opens 180° or if cables are visible in the bead area.
RECOMMENDED ACTION	Leave running if the plies are not affected and if inflation seating is possible.
PREVENTION	Verify the condition of the fitting and handling equipment and the method used.
DO NOT CONFUSE WITH	Page 49

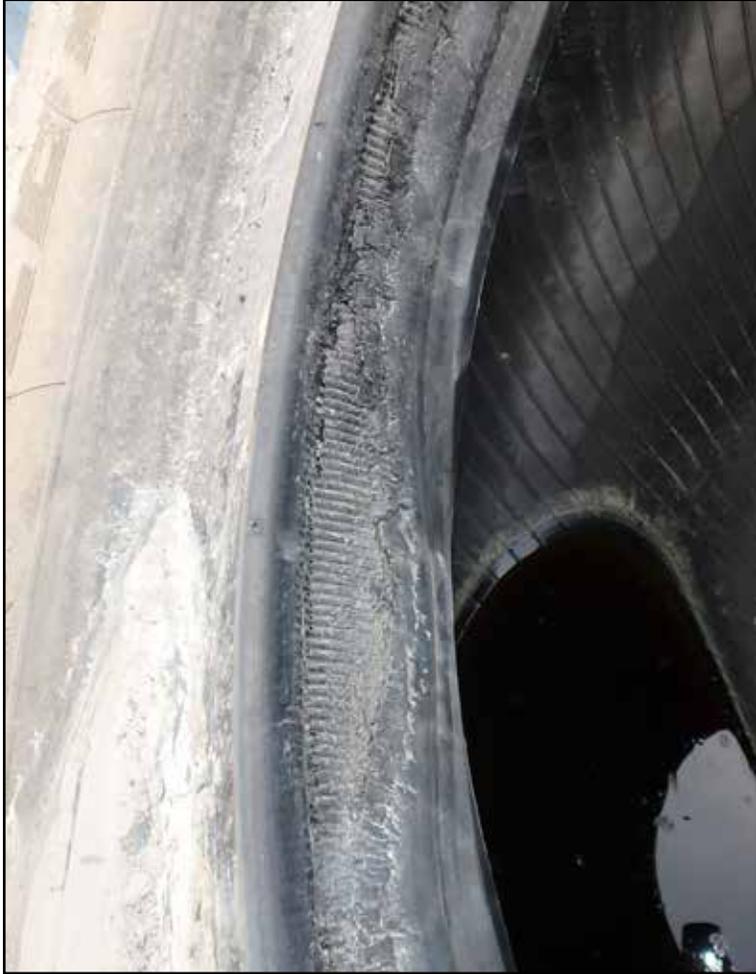
DESCRIPTION	Wear on the bead sole.

OBSERVATION	Wear at the base of the beads.
PROBABLE CAUSES(S)	Nominal load capacity of the tire exceeded, creating a transverse movement of the bead. Wheel dirty or in poor condition. Indexing on rim, furthered by the absence of proper mounting/seating pressure.
EVOLUTION	Casing cords and bead strength will be damaged and weakened.
RECOMMENDED ACTION	Scrap.
PREVENTION	Weigh the machine; adjust the inflation pressures. Before refitting, clean all wheel components. Verify the condition of the fitting and handling equipment and the method used. If locking keys are absent, suggest their use (between rim and taper and/or between rim and loose flanges). Verify rim dimension in conjunction with the rim manufacturer to ensure that it meets the specification.
DO NOT CONFUSE WITH	Page 77

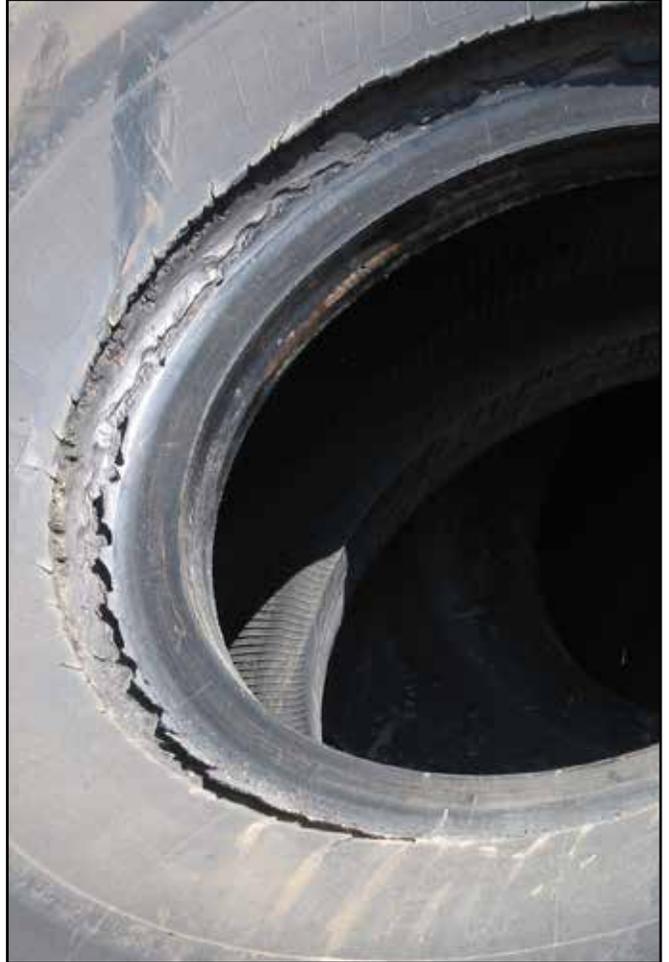
DESCRIPTION	Wear in the bead bearing area.
--------------------	---------------------------------------

OBSERVATION	Circumferential wear of the rubber in the bead support zone.
PROBABLE CAUSES(S)	Tire's nominal load capacity exceeded. Under-inflation. Tire not suitable for application or poor condition of the flange. High torque. Abrasive materials caught between flange and bead (e.g. sand or coal).
EVOLUTION	This wear will reach but not damage the casing ply.
RECOMMENDED ACTION	Leave running, except where plies are visible, then scrap.
PREVENTION	Verify the recommended pressure; increase if possible. Check whether a change of flange is necessary.
DO NOT CONFUSE WITH	Pages 34, 37, 50

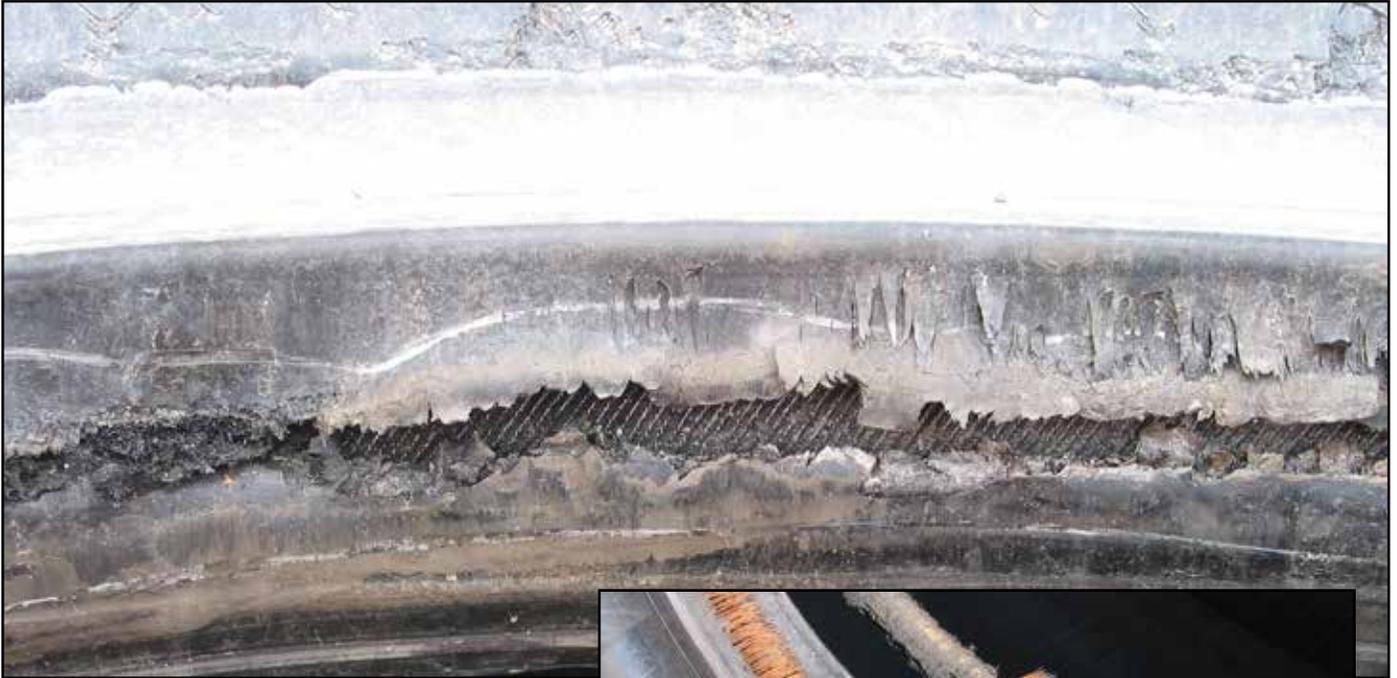
OBSERVATION	Circumferential split at the base of the bead.
PROBABLE CAUSES(S)	High torque and/or tire's nominal load capacity exceeded and/or rotation on rim, aggravated by high rim temperature.
EVOLUTION	Rupture of the casing ply or bead wire.
RECOMMENDED ACTION	Scrap.
PREVENTION	If possible, weigh the machine by axle to determine optimum pressures. Verify the presence of locking keys (between rim and taper and/or between rim and loose flange). Measure the circumference of the rim to ensure that it is within specification.
DO NOT CONFUSE WITH	Pages 49, 52

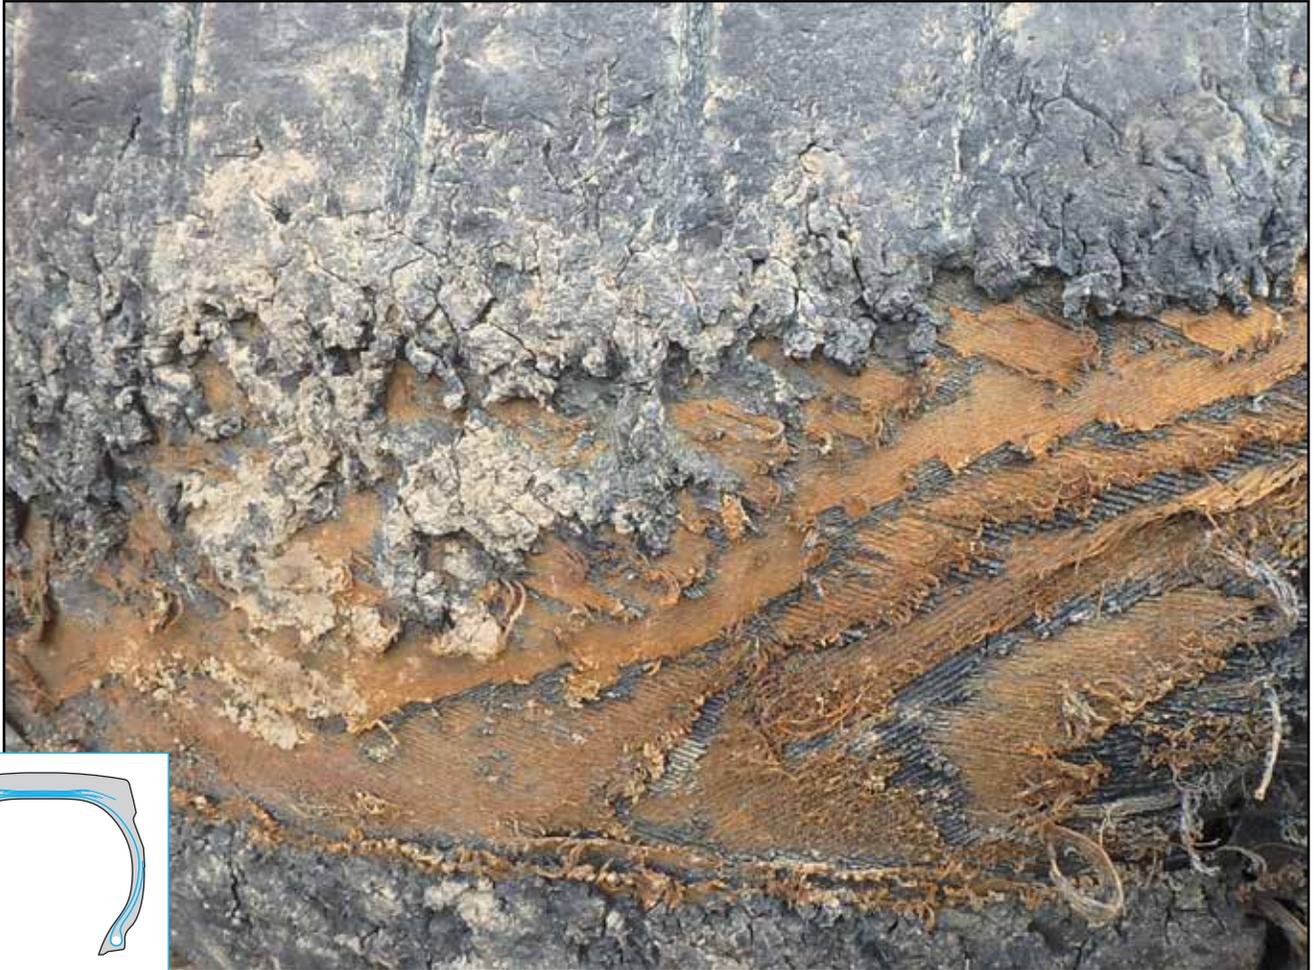
DESCRIPTION	Extensive deterioration of the crown plies by oxidation.
--------------------	---

OBSERVATION	Extensive deterioration of the crown plies by oxidation.
PROBABLE CAUSES(S)	Numerous cuts in the tread rubber or stone trapping in the base of the tread grooves drilling into the tire and allowing moisture to penetrate and oxidation to develop.
EVOLUTION	Casing rupture, leak.
RECOMMENDED ACTION	Scrap.
PREVENTION	Improve condition of haul roads. Avoid excess water exposure when spraying haul roads. Remove stones from tread grooves. Review the choice of tire type.
DO NOT CONFUSE WITH	Pages 13, 18

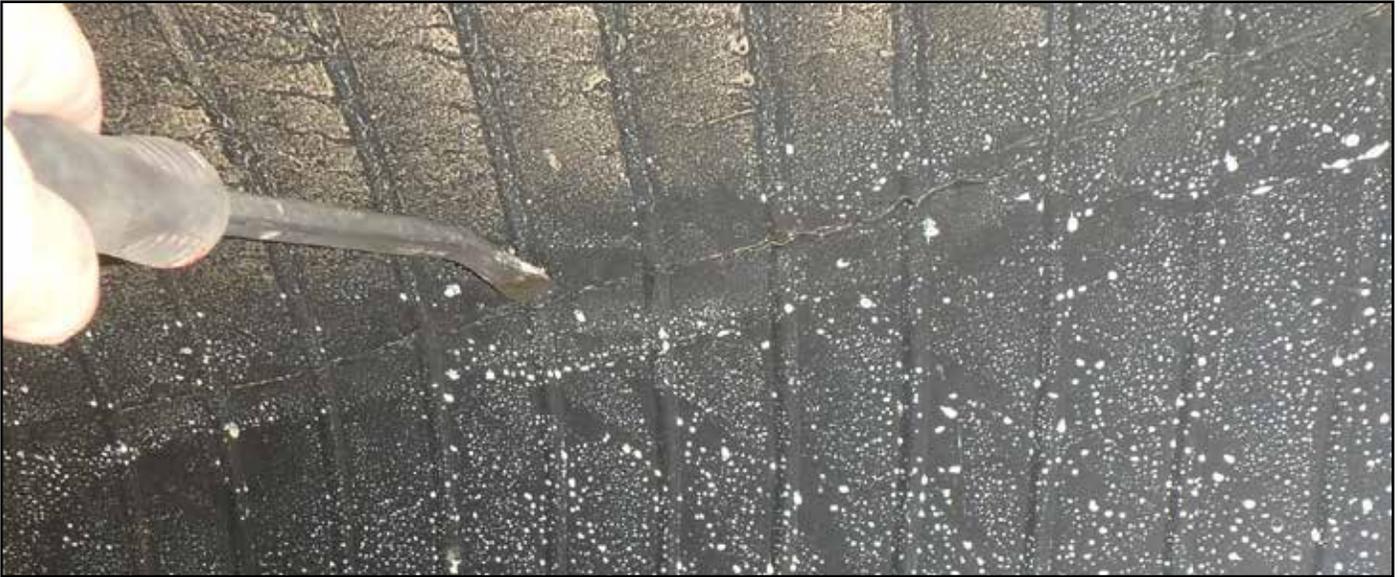
OBSERVATION	Splitting at the end of interior reinforcement products.
PROBABLE CAUSES(S)	Over-deflection, not enough pressure for the load and/or high torque.
EVOLUTION	Runflat.
RECOMMENDED ACTION	Scrap.
PREVENTION	Verify recommended inflation pressure.
DO NOT CONFUSE WITH	Pages 59, 61, 66

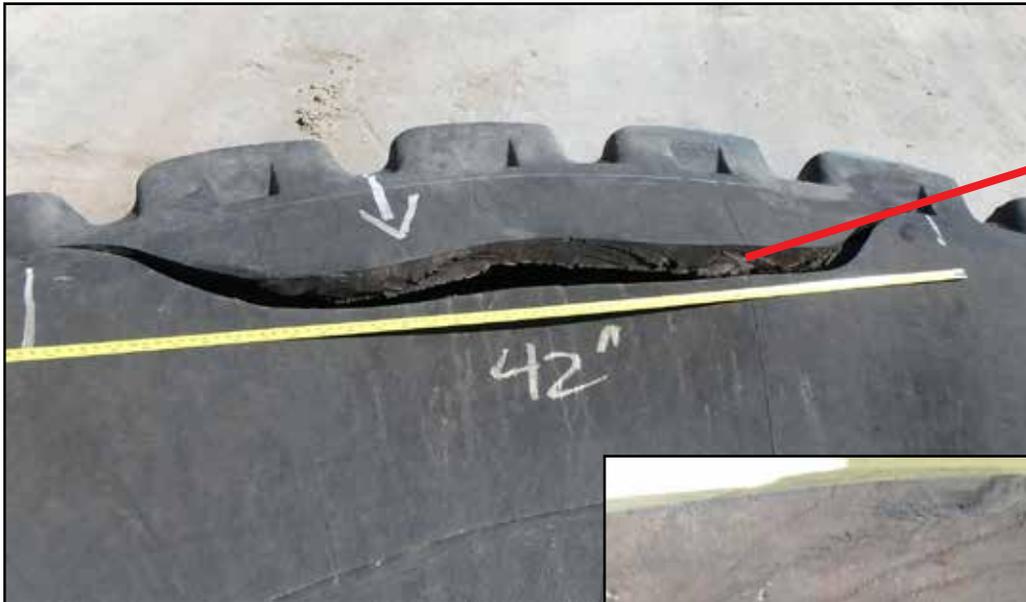
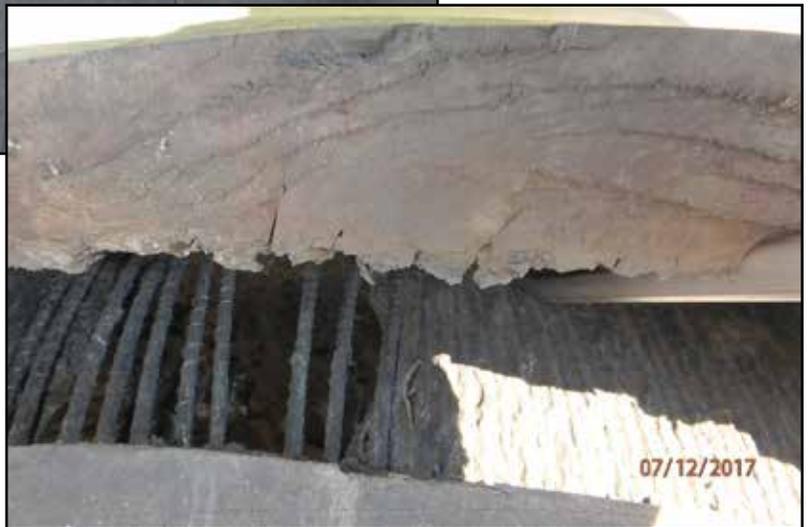
OBSERVATION	Pocket of separation between the casing ply and the crown block.
PROBABLE CAUSES(S)	Shock, high speeds, mis-alignment of front wheels.
EVOLUTION	Rapid deflation.
RECOMMENDED ACTION	Scrap.
PREVENTION	Verify TMPH/TKPH. Review tire pressure if damage is frequent. Improve the condition of the haul roads and work conditions
DO NOT CONFUSE WITH	Pages 14, 17

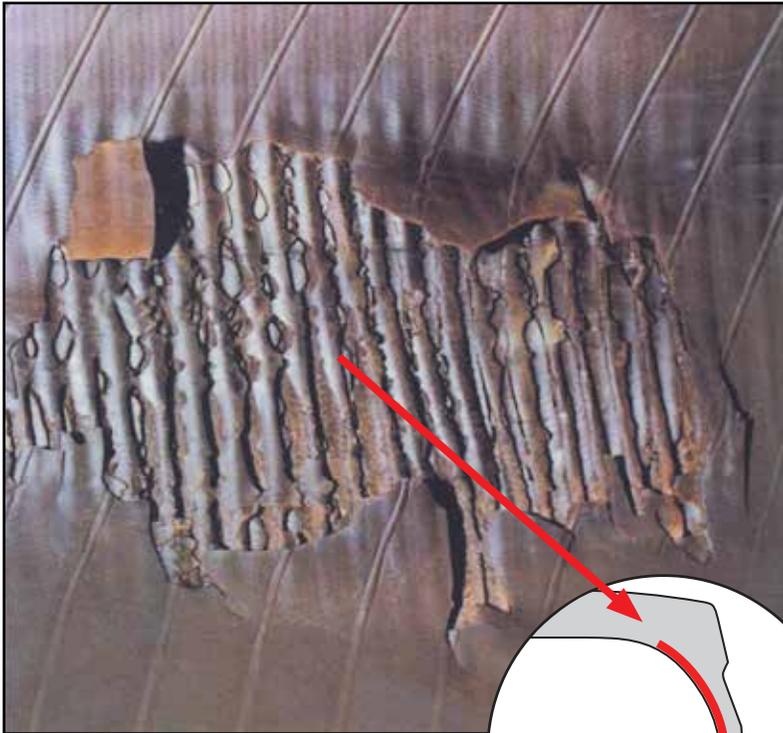
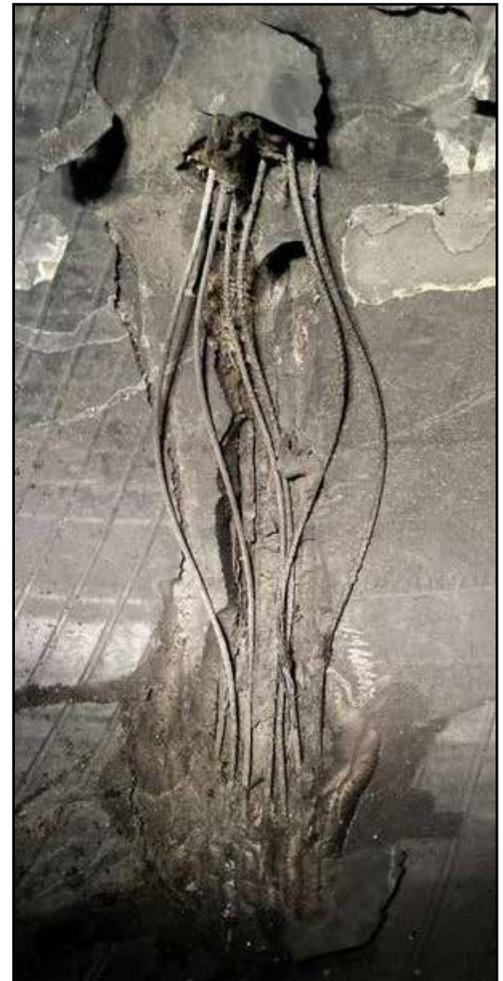
OBSERVATION	Raised or exposed casing cables in the interior shoulder area. Detachment of cables/ rubber.
PROBABLE CAUSES(S)	Overload or underinflation, aggravated by hard cornering. Heat and/or fatigue, result from thermo-oxidation of casing rubber. May be aggravated by split in the inner liner. Repair using patch without Butyl liner.
EVOLUTION	Air infiltration, tire fire (torch effect), external bubble on high sidewall or rapid deflation.
RECOMMENDED ACTION	Scrap.
PREVENTION	Verify TMPH/TKPH, recommend nitrogen inflation. Verify load and pressures.
DO NOT CONFUSE WITH	Page 61
