EARTHMOVER TIRE CONDITIONS ANALYSIS GUIDE

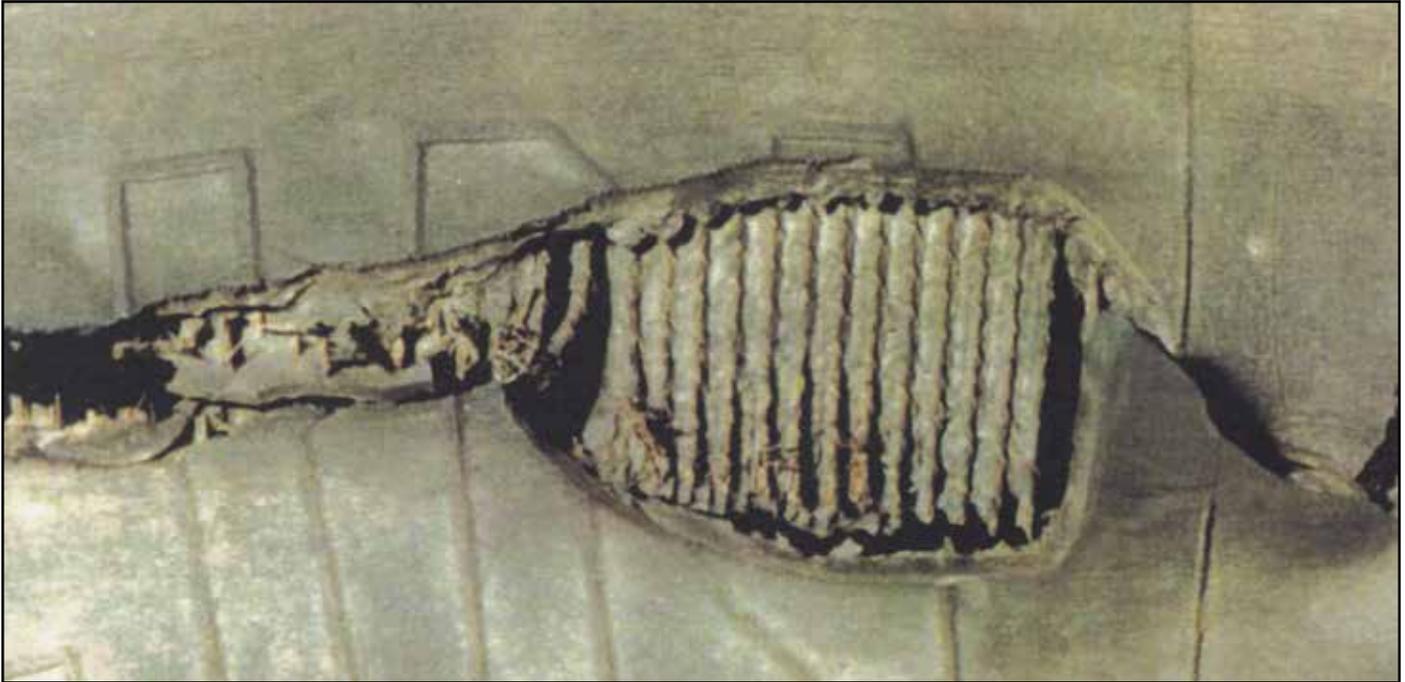
DESCRIPTION	Rupture on a casing ply crease in the sidewall due to shock.
--------------------	---

OBSERVATION	Break in the casing ply at the sidewall resulting from an impact.
PROBABLE CAUSES(S)	Impact
EVOLUTION	Air infiltration; runflat.
RECOMMENDED ACTION	Scrap.
PREVENTION	Examine haul road, look for the causes of repeated impact against protruding objects. Improve working environment.
DO NOT CONFUSE WITH	Page 65

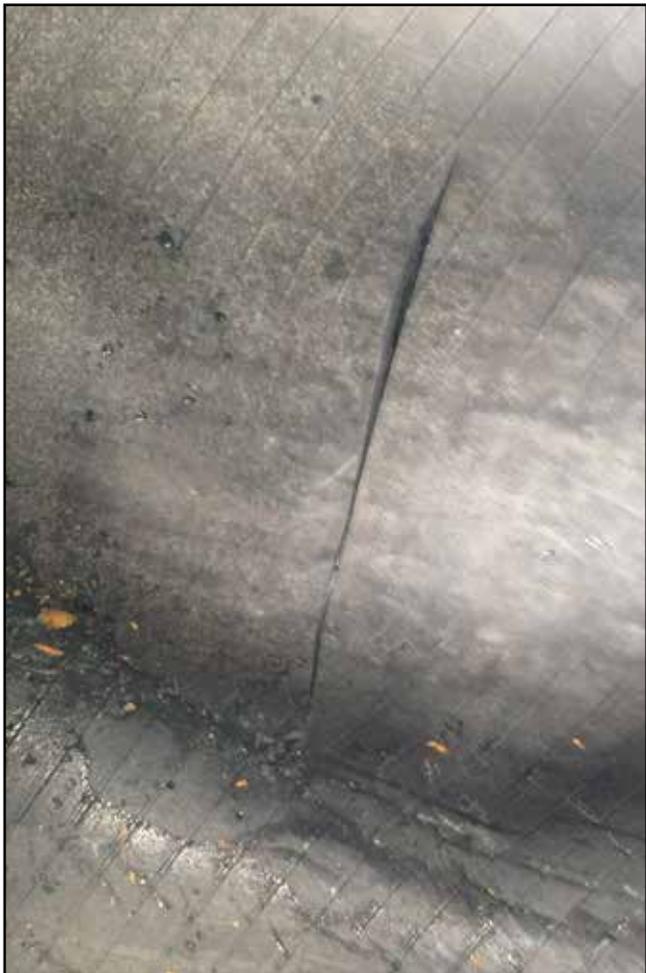
Internal rubber

OBSERVATION	Radial split in calendering rubber of the casing ply resulting from an impact.
PROBABLE CAUSES(S)	Impact or dynamic overload.
EVOLUTION	Air infiltration, sidewall separation or rapid deflation.
RECOMMENDED ACTION	Repair if in accordance with recommendations (see Michelin Earthmover Tires Use and Maintenance Guide), otherwise scrap.
PREVENTION	Look for the places where there is a possibility of impact. Improve condition of haul roads.
DO NOT CONFUSE WITH	Page 59

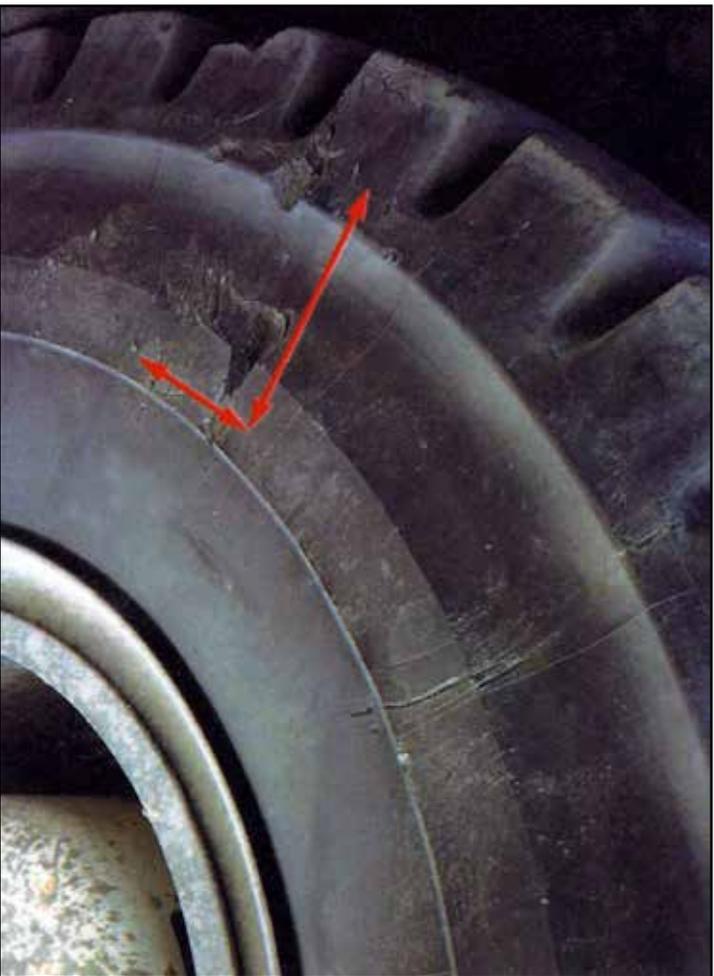
DESCRIPTION	Damage to the sidewall due to a pinch shock.

OBSERVATION	Damage to the sidewall due to a pinch shock.
PROBABLE CAUSES(S)	Impact between two rigid components, accentuated by low pressure.
EVOLUTION	Cut may grow inwards toward the casing. Deformation. Rupture of the casing.
RECOMMENDED ACTION	To be submitted for repair (depending on the tire's residual value) after the damage has been measured and compared with the recommended limits. Scrap if not repairable.
PREVENTION	Look for places where there is a possibility of impact. Improve condition of haul roads.
DO NOT CONFUSE WITH	NA

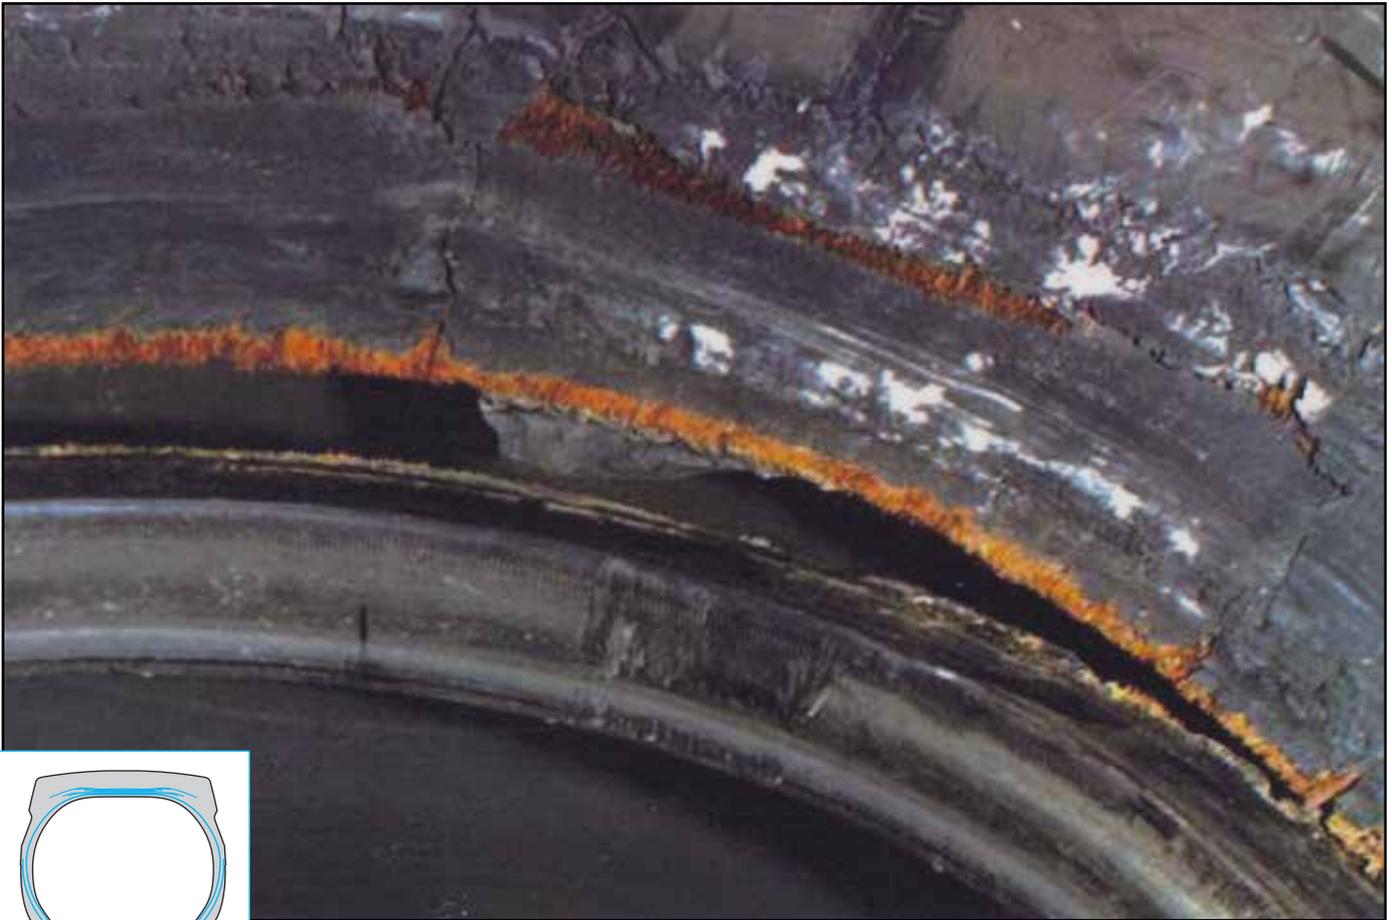
DESCRIPTION	Rupture of the casing ply in the bead area above the bead wire (tringle).
--------------------	--

OBSERVATION	Rupture of the casing ply in the bead zone, above the bead core.
PROBABLE CAUSES(S)	Separation or heat build-up in the bead zone. Tire's nominal load capacity exceeded. Damage to the bead when fitting. Improper mounting on rim.
EVOLUTION	NA
RECOMMENDED ACTION	Scrap.
PREVENTION	Look for indicators, deformation in the bead zone. Have the machine braking system checked. Adapt pressures to the tire load. Verify the ends of the tire levers are in good condition. Make fitters aware: lubricate, center the tire on the rim, inflate per Michelin's bead seating pressure guidance, adjust to the recommended pressure.
DO NOT CONFUSE WITH	NA

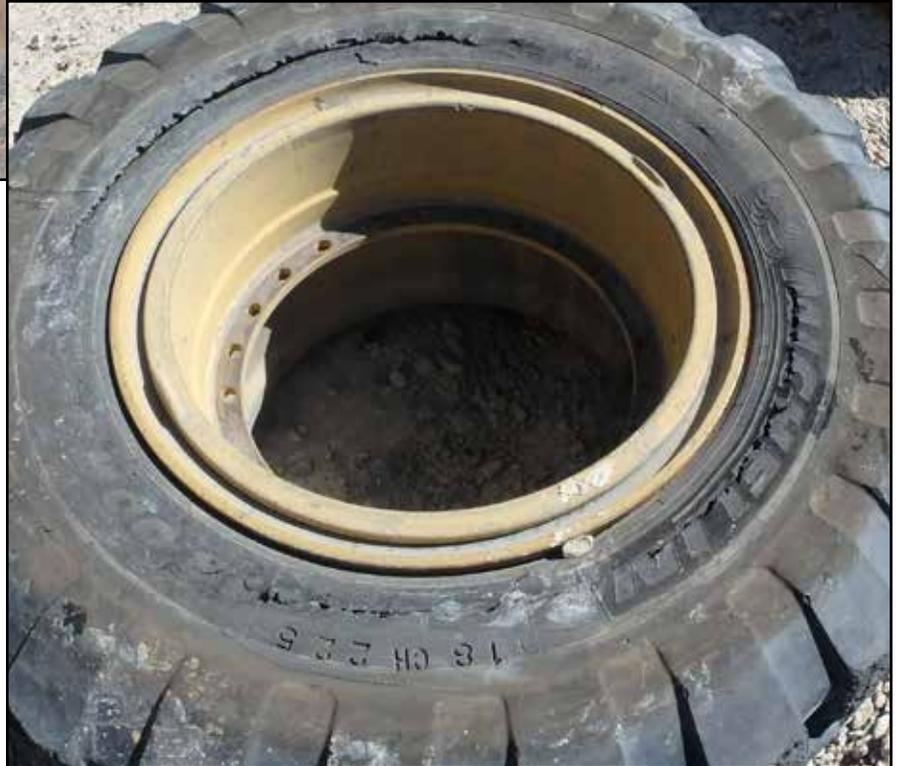
DESCRIPTION	Rupture of the casing ply turn-up in the sidewall.
--------------------	---

OBSERVATION	Rupture of the casing ply turn-up on lower part of the sidewall.
PROBABLE CAUSES(S)	Casing ply fatigue, resulting from the tire's nominal load capacity being exceeded. Low pressure. Fitting not done in accordance with recommendations.
EVOLUTION	Rupture of the casing.
RECOMMENDED ACTION	Scrap.
PREVENTION	Adapt the pressure to the load. Make tire fitters aware: lubricate, center the tire on the rim, inflate per Michelin's bead seating pressure guidance, adjust to the recommended pressure.
DO NOT CONFUSE WITH	Page 54

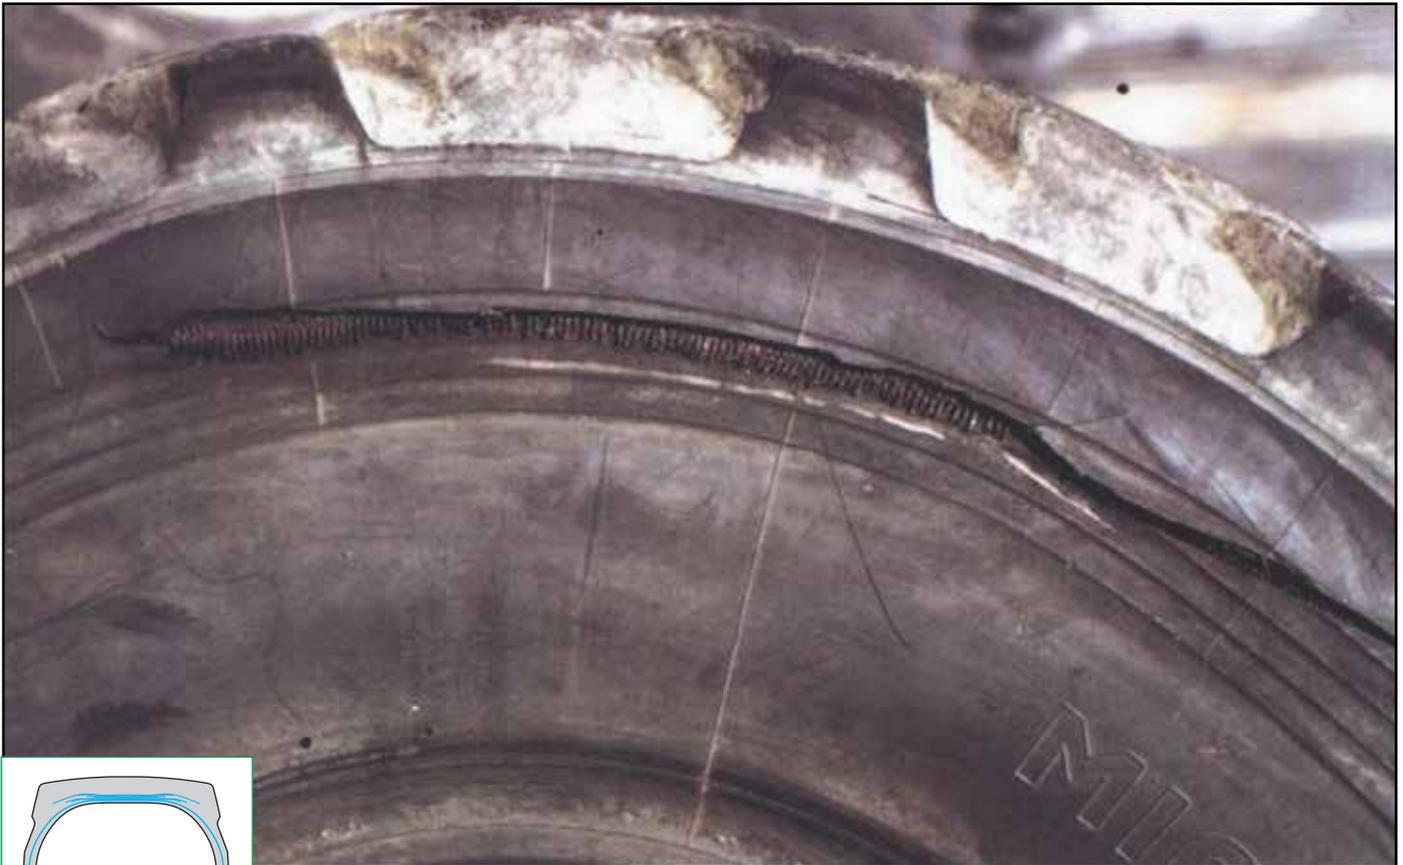
Regular circumferential rupture of the casing ply in the sidewall.

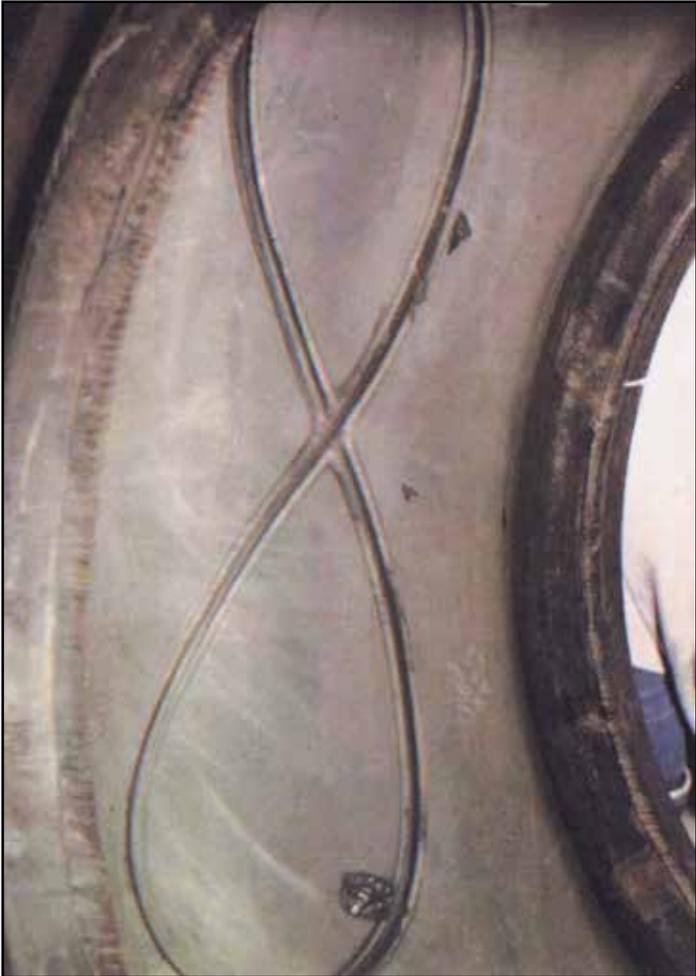
DESCRIPTION	Damage from material or object left in the tire.

OBSERVATION	Damage by object (screwdriver, piece of wood, O-ring, etc.) accidentally left in the tire.
PROBABLE CAUSES(S)	Poor service condition.
EVOLUTION	May cause damage to the inner liner and lead to air infiltration.
RECOMMENDED ACTION	To be repaired if damage is within recommended limits.
PREVENTION	Check the inside of the tire; remove any debris before fitting on the rim.
DO NOT CONFUSE WITH	NA

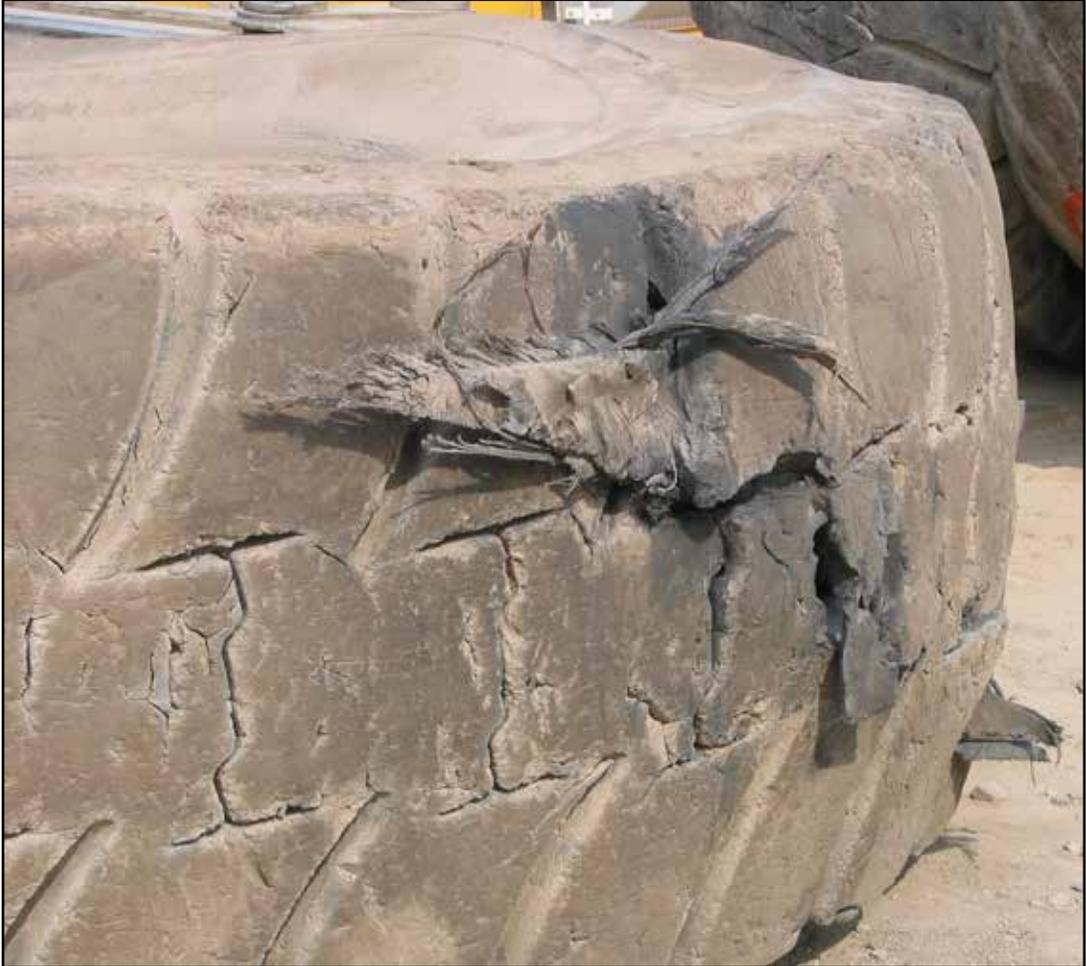
DESCRIPTION	Shock rupture of the crown plies and of the casing ply in the crown area.

OBSERVATION	Shock rupture of the casing and crown plies.
PROBABLE CAUSES(S)	High pressure, high speed and lack of haul road maintenance and operator training.
EVOLUTION	NA
RECOMMENDED ACTION	Scrap.
PREVENTION	Clean and maintain the site roads. Train machine operators to avoid hitting objects; review and adapt pressure if necessary.
DO NOT CONFUSE WITH	NA

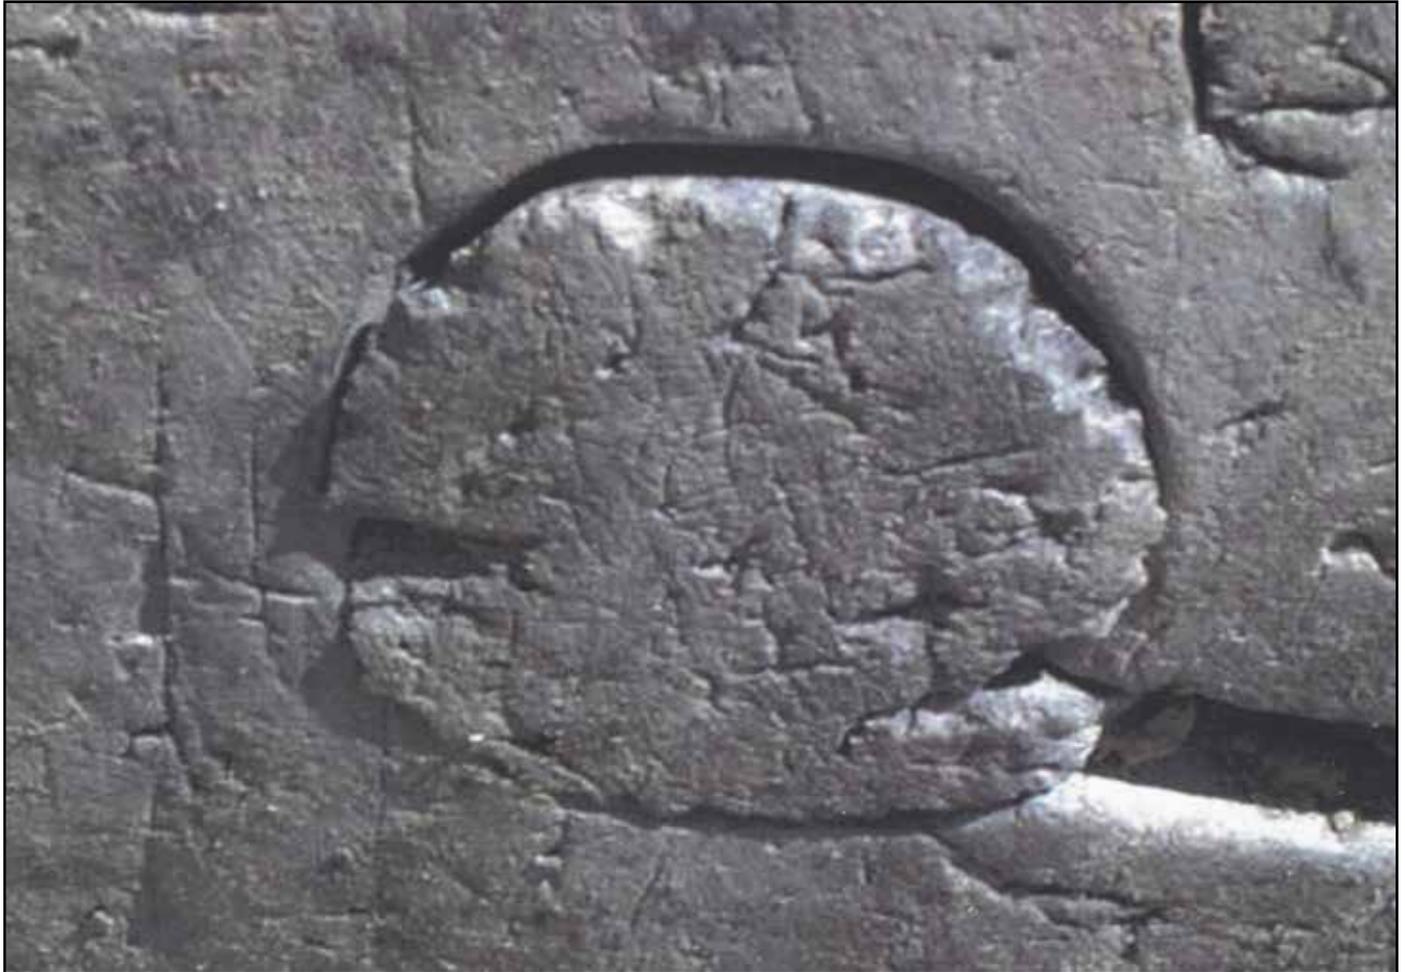
Non-Michelin crown repair in poor condition.

Non-Michelin repair in the crown in poor condition.

Leak.

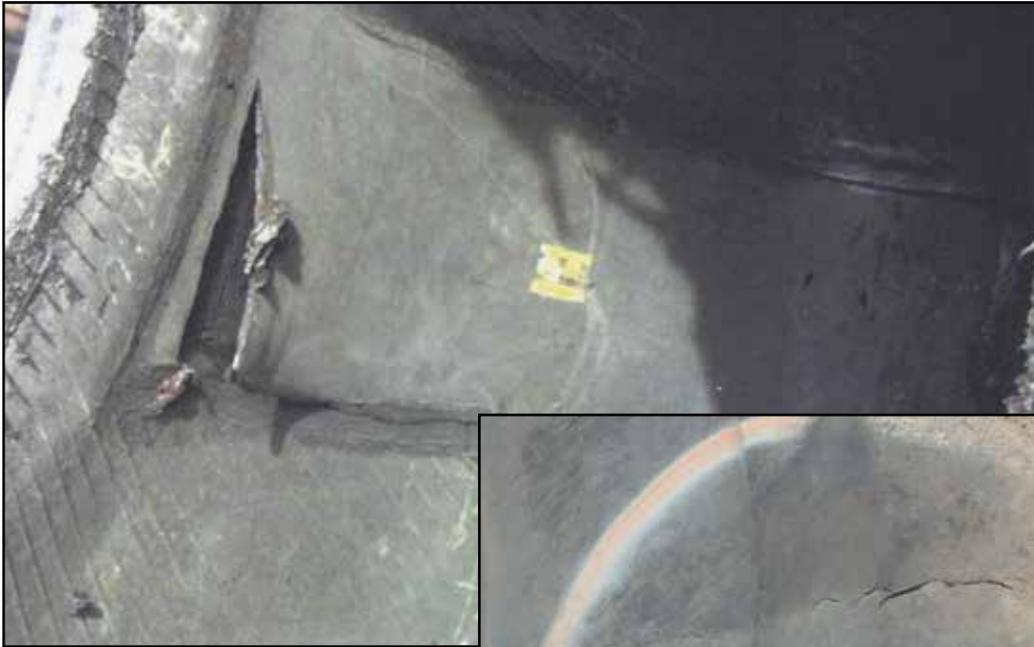
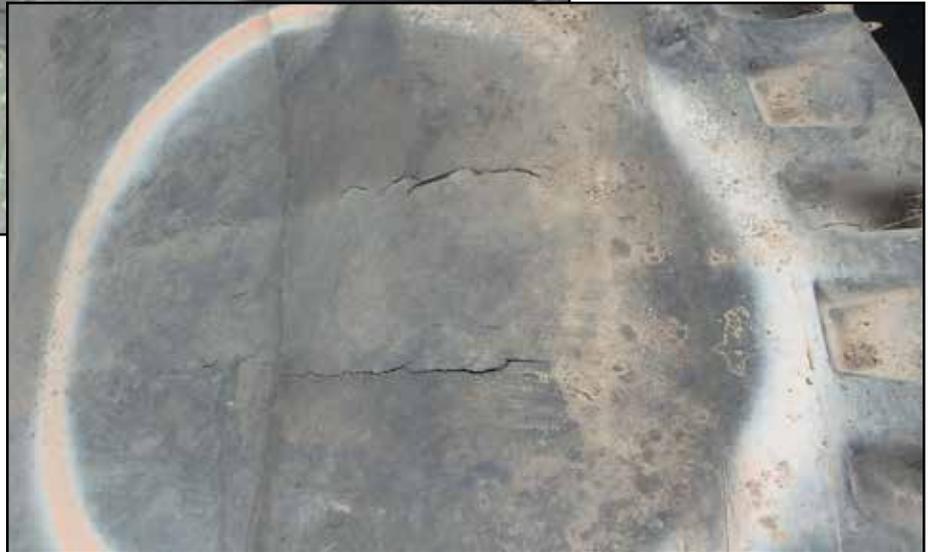
OBSERVATION	Non-Michelin repair in the sidewall in poor condition.
PROBABLE CAUSES(S)	Defective repair or repair out of recommended limits.
EVOLUTION	Leak.
RECOMMENDED ACTION	Scrap.
PREVENTION	Present Michelin recommendation and propose training.
DO NOT CONFUSE WITH	NA

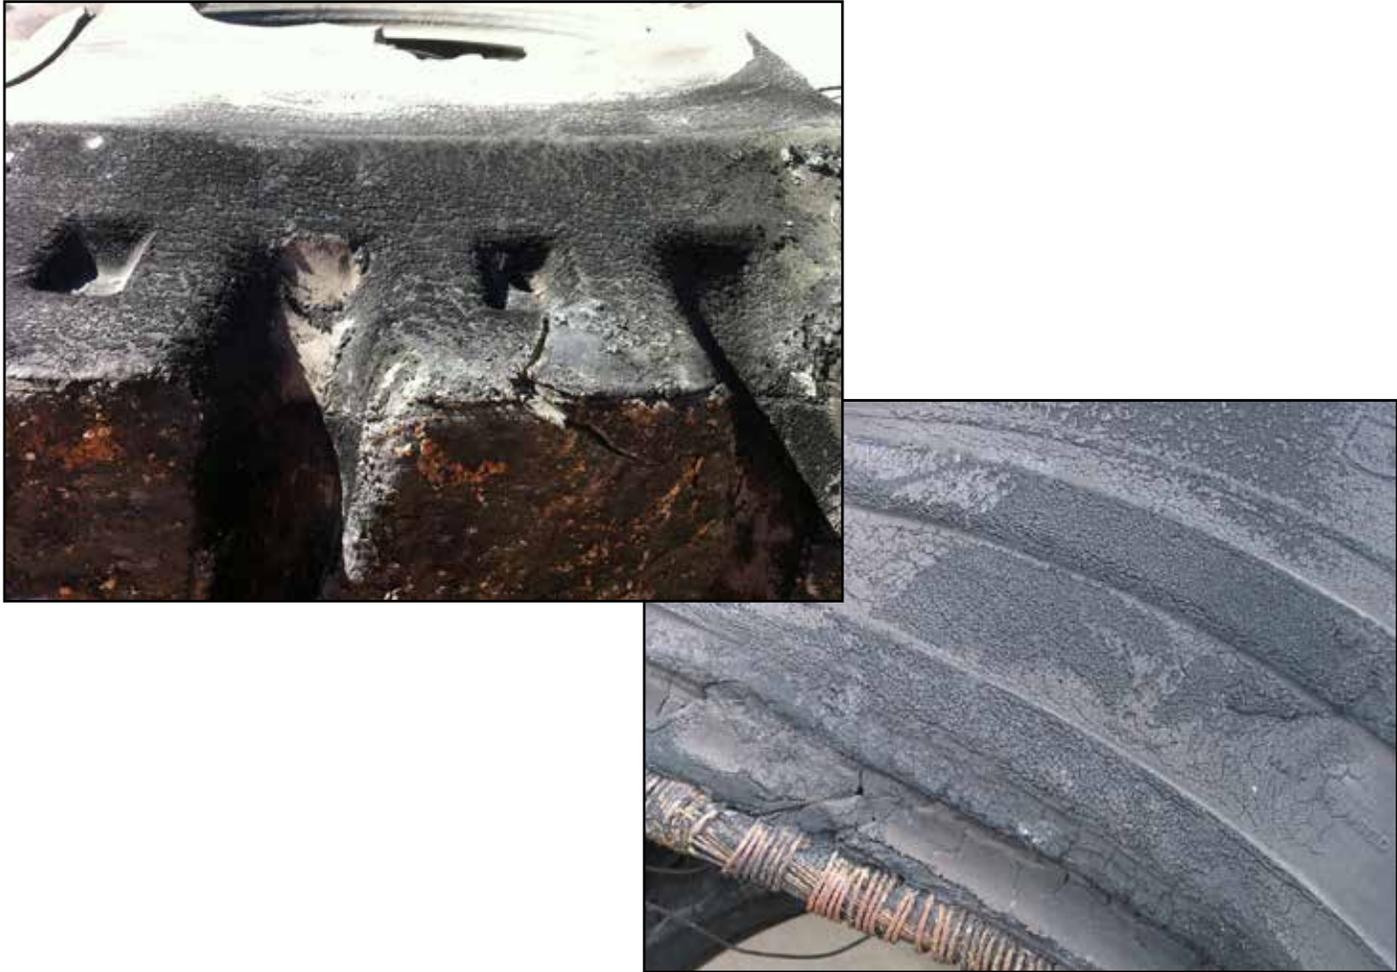
OBSERVATION	Burnt tire.
PROBABLE CAUSES(S)	Fire resulting from an electric arc or other source.
EVOLUTION	Sidewall separation, casing rupture.
RECOMMENDED ACTION	Scrap.
PREVENTION	Keep tires away from all stocks of flammable materials, solvents in particular.
DO NOT CONFUSE WITH	NA

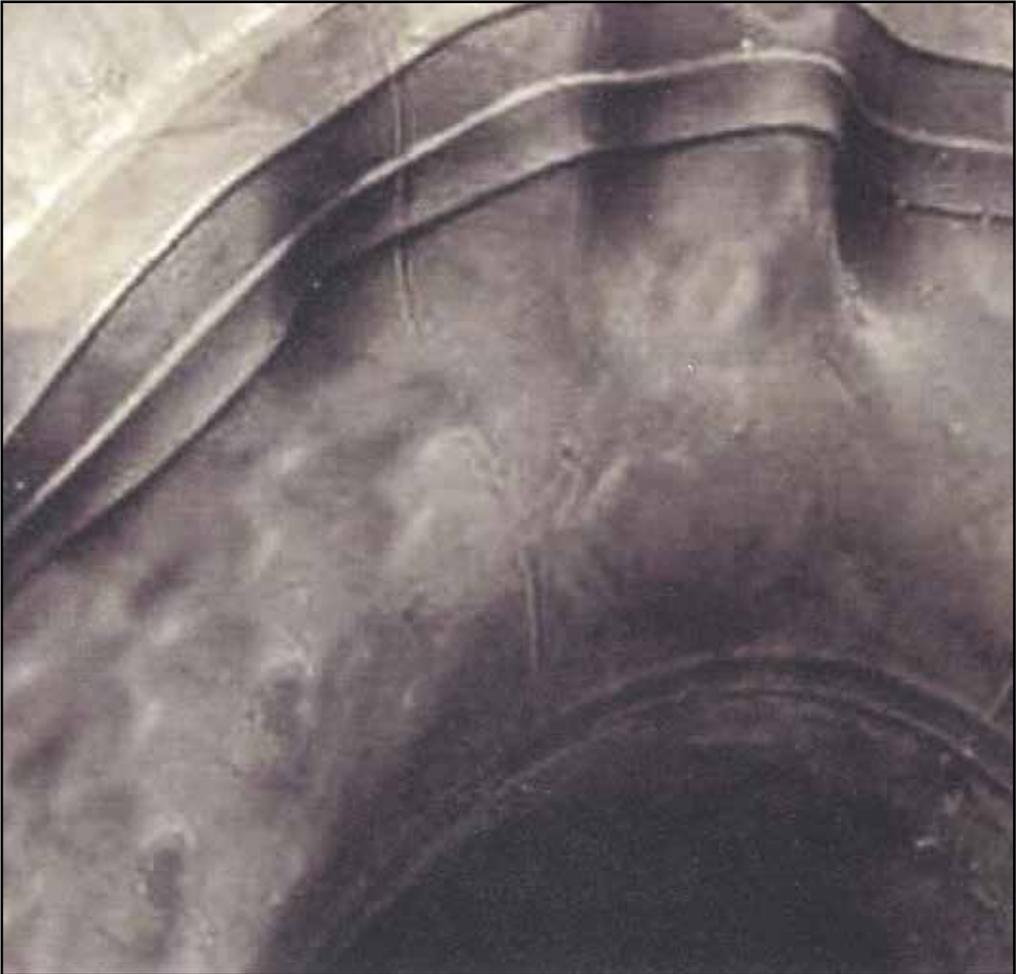
OBSERVATION	Damage by hydrocarbons (oil, grease, diesel fuel, etc.).
PROBABLE CAUSES(S)	Prolonged contact of rubber with a hydrocarbon-based product (diesel oil is worse than ordinary oil). Compactor tires primarily.
EVOLUTION	Sidewall separation, casing rupture.
RECOMMENDED ACTION	Scrap.
PREVENTION	Clean the machine servicing areas. Act quickly to fix any leaks on hydraulic connections or on hubs. If the tire is not deeply soiled, clean it immediately with a pressure washer. For compactors, choose hydrocarbon-free anti-stick products. Keep tires well away from all stocks of hydrocarbons.
DO NOT CONFUSE WITH	Page 58

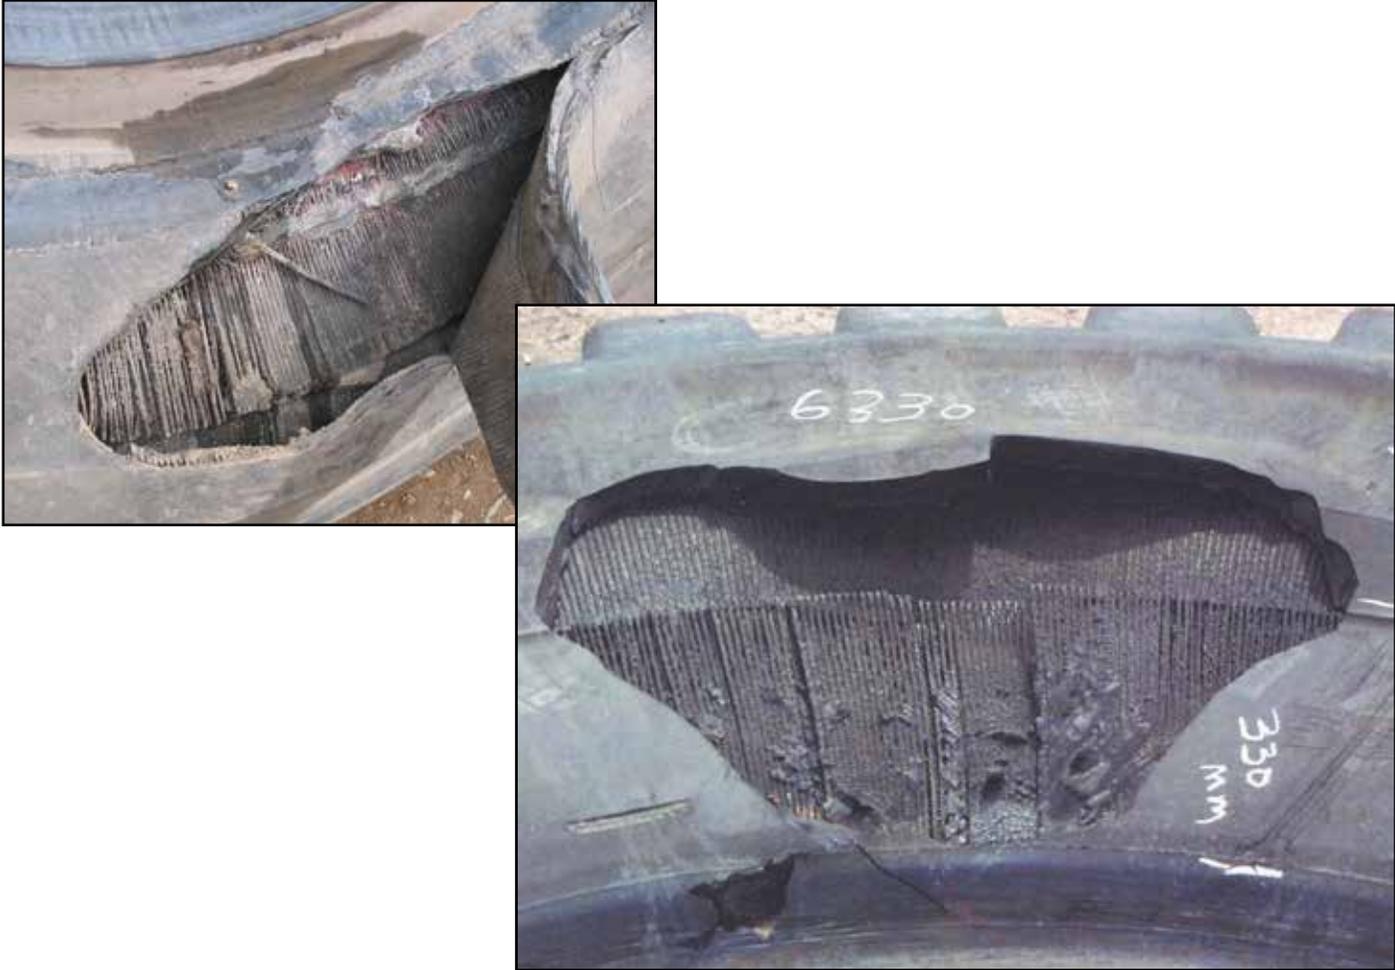
OBSERVATION	Separation in the sidewall as a result of air infiltration without separation between crown plies.
PROBABLE CAUSES(S)	Perforation of inner liner. Damage by tire lever at the bead when fitting the tire on the rim or when handling tires of large sizes. Repair in poor condition. Damage during transport or handling.
EVOLUTION	First stage sidewall bulge, followed by split in the turn-up area.
RECOMMENDED ACTION	Scrap.
PREVENTION	Look for the cause to prevent the condition recurring on other tires. Verify handling and mounting condition.
DO NOT CONFUSE WITH	Page 38

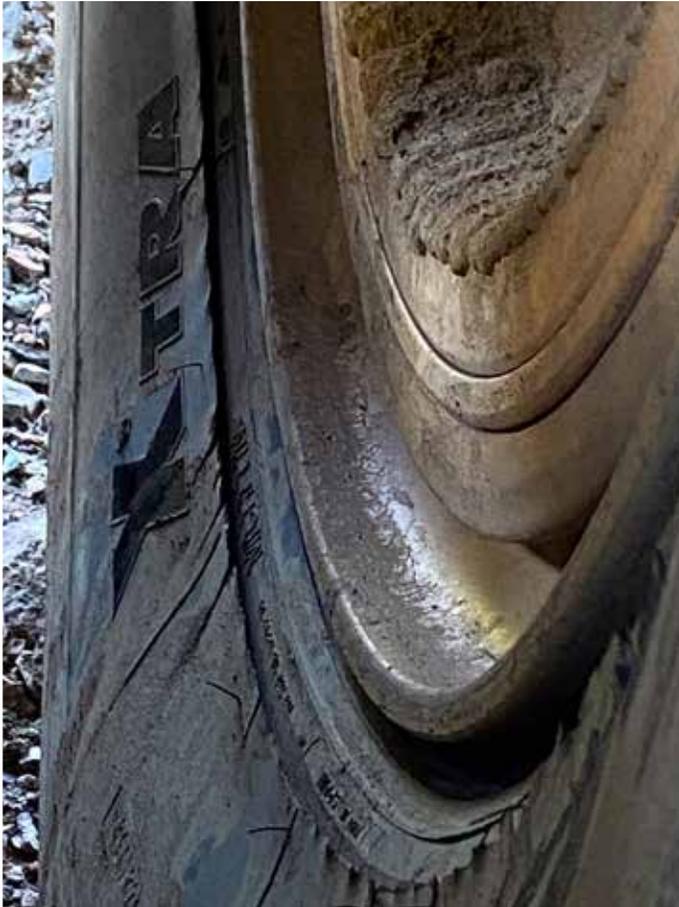
OBSERVATION	Unsticking between sidewall rubber and the bead protector rubber.
PROBABLE CAUSES(S)	Weakness of the bond.
EVOLUTION	The separation will grow circumferentially and down to the point in contact with the rim.
RECOMMENDED ACTION	Leave running.
PREVENTION	None.
DO NOT CONFUSE WITH	Pages 36, 54
