MICHELIN® Energy Guard Bracket Bending Member Damages and Disengagement

MICHELIN ENERGY GUARD SKIRT BRACKET **ASSEMBLY COMPONENTS**

BRACKET BENDING MEMBER DAMAGES AND DISENGAGEMENT

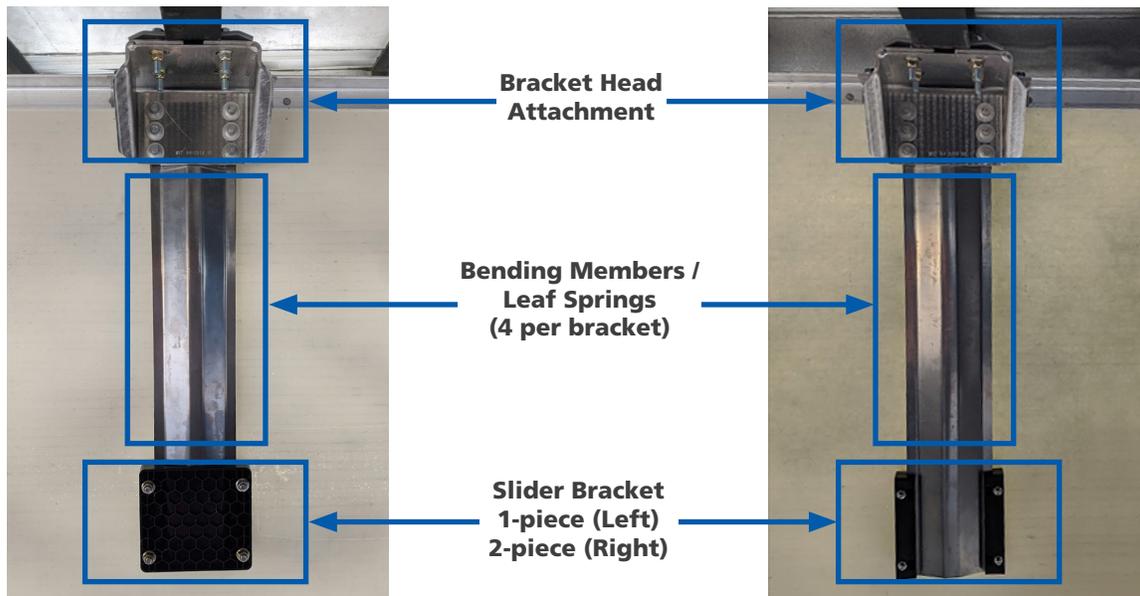
Figure 1. Bracket Assembly Description

On the Energy Guard Skirt system there are brackets (Figure 1) that hold the skirt panel to the trailer. It has been found that under certain usage cases the stainless steel bending members/leaf spring(s) can become disengaged with the lower slider bracket. Disengagement can lead to cracking of the leaf spring material. On rare occasions this has led to the loss of the bending member/leaf spring(s). Improper installation of the slider bracket can exacerbate the issue.

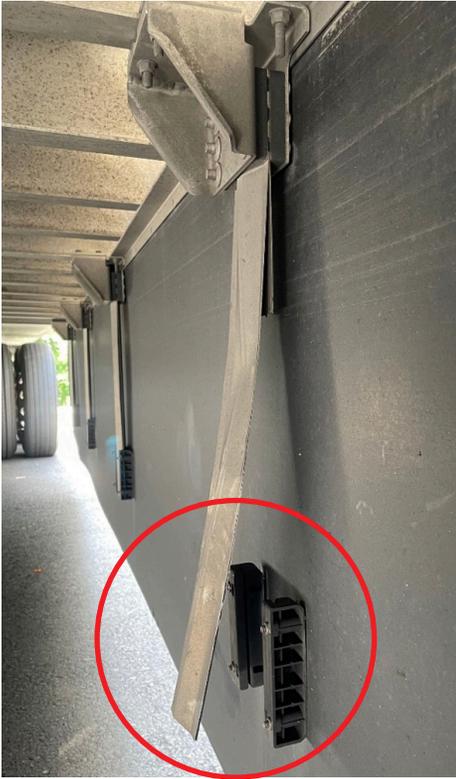
Figure 2. Examples of Leaf Spring Disengagement and Damage.

Leaf springs disengaged with damage

If damages are observed, it is recommended to remove the bracket assembly from service and replace it with new bracket assembly and new hardware (See warranty process below). The installation procedure for a new bracket assembly can be found in the Energy Guard Owner's Manual.

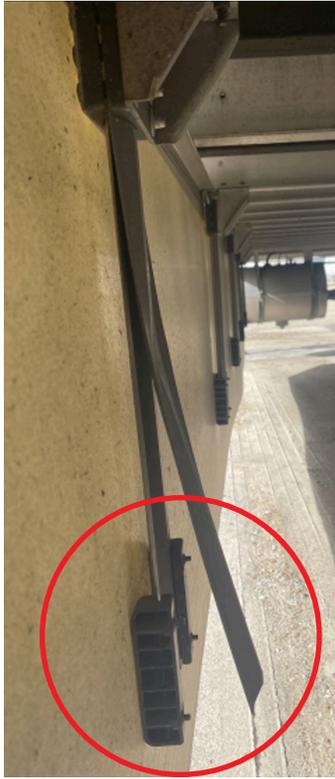
Leaf springs disengaged but undamaged

If leaf springs are found disengaged, and without damage to the system (Figure 2), they can be returned into the slider bracket, by following the guidelines in the owner's manual. If the slider bracket was improperly installed (Figure 3), it should be reinstalled in the correct configuration, per the owner's manual.

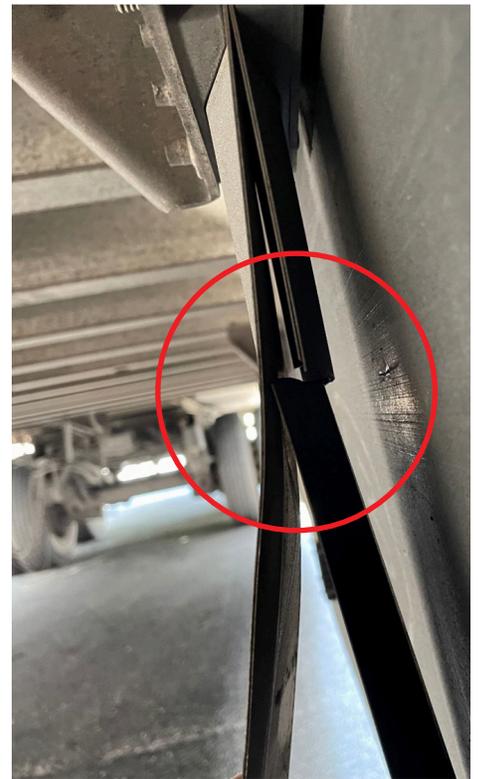
Damaged/broken leaf springs

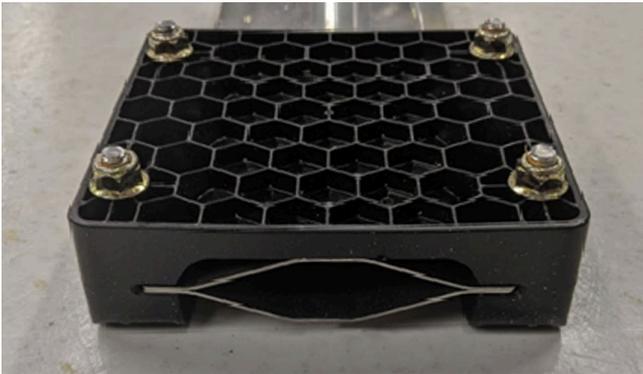
Figure 3. Proper Installation of the Slider Brackets

Properly installed 1-piece sliders

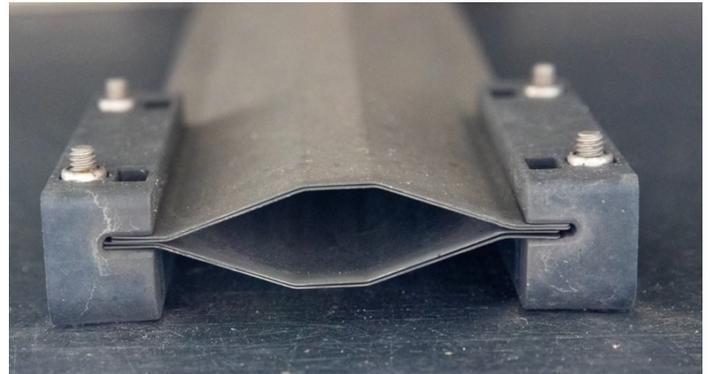
Properly installed 2-piece sliders

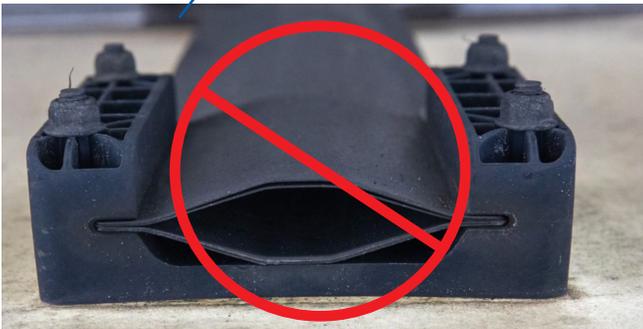
Figure 3. Slider Bracket was Improperly Installed.

Incorrectly installed 1-piece slider
