EARTHMOVER TIRE CONDITIONS ANALYSIS GUIDE

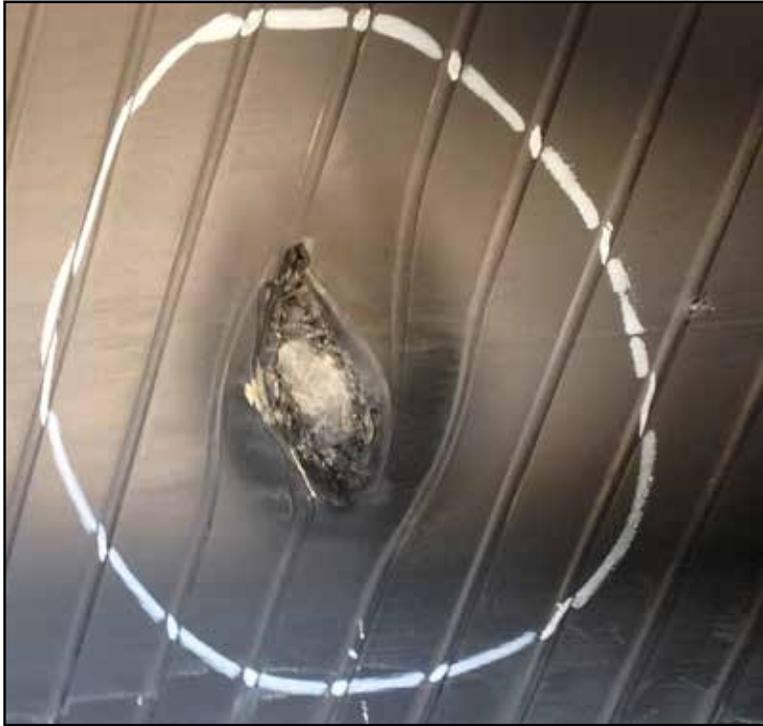
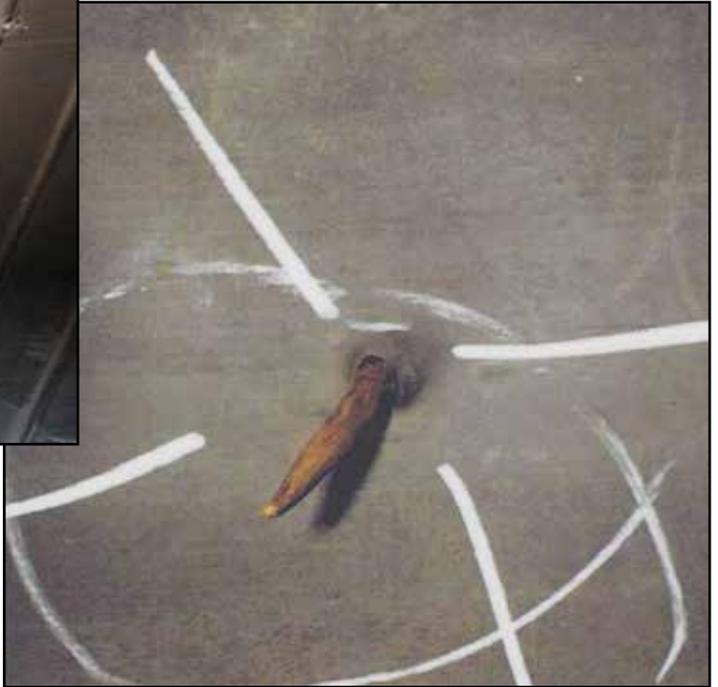
DESCRIPTION	Crown perforation penetrating to the interior.
--------------------	---

View from the inside of the tire

Nail

Rock

OBSERVATION	Perforation passing through the crown and all reinforcing/belt layers.
PROBABLE CAUSES(S)	Accidental damage by a sharp object.
EVOLUTION	Underinflation, air infiltration, runflat, rupture of the casing due to underinflated use.
RECOMMENDED ACTION	Repair if the damage is within recommended limits.
PREVENTION	Maintain site roads; keep clean and in good condition using graders or bulldozers. If similar tire damages persist, check to ensure proper operating pressures. Review choice of tire (increase lug-to-void ratio), tougher compound or deeper tread depth.
DO NOT CONFUSE WITH	Pages 68

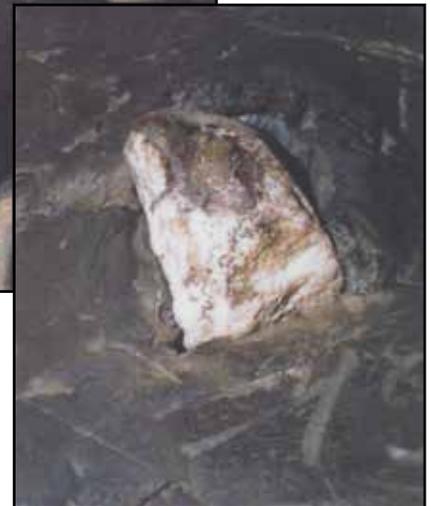
DESCRIPTION	Localized damage to the crown, but not penetrating.
--------------------	--

OBSERVATION	Crown damage not perforating through to interior, possibly affecting the belts.
PROBABLE CAUSES(S)	Accidental damage by a sharp object. High pressure aggravates the situation.
EVOLUTION	Rust, air infiltration, ultimately perforating to interior.
RECOMMENDED ACTION	Repair if the damage is within recommended limits.
PREVENTION	Keep site roads clean and in good condition; maintain using graders or bulldozers. If similar tire damages persist, check for proper (possibly lower) operating pressures, review choice of tire and rubber compound.
DO NOT CONFUSE WITH	Pages 11, 13

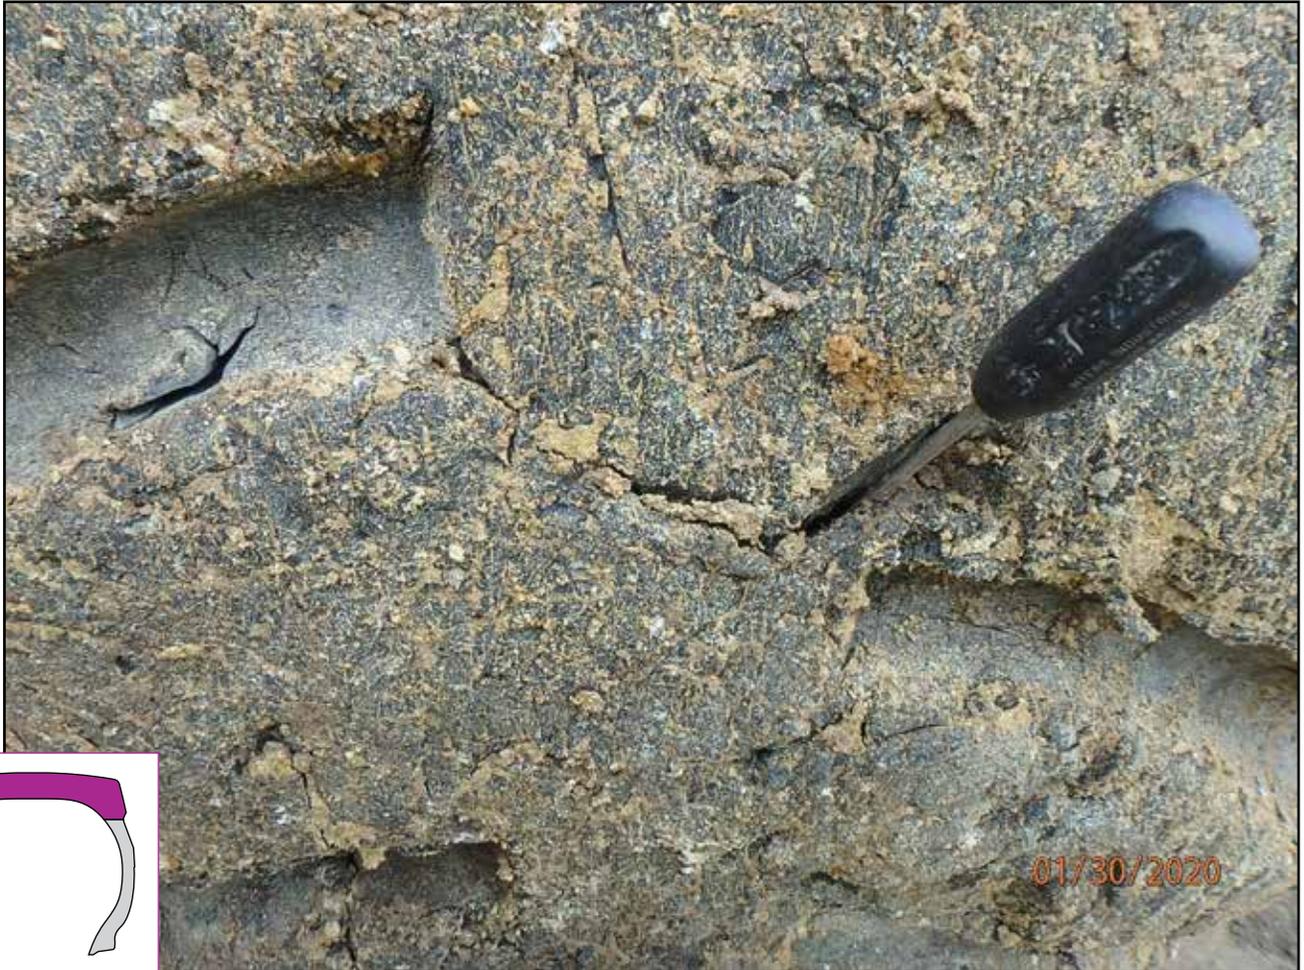
Numerous cuts around the entire tread.

Widespread cuts on the tread.

Working on aggressive sharp stone surfaces. Damage accentuated by over-inflation or continual running on wet surfaces.

Rust, loss of traction, separation in the crown.

Submit the tire for retreading if the plies are not damaged in several places. If it is not accepted for retreading and there is no need for traction, leave it running until the first ply becomes visible.

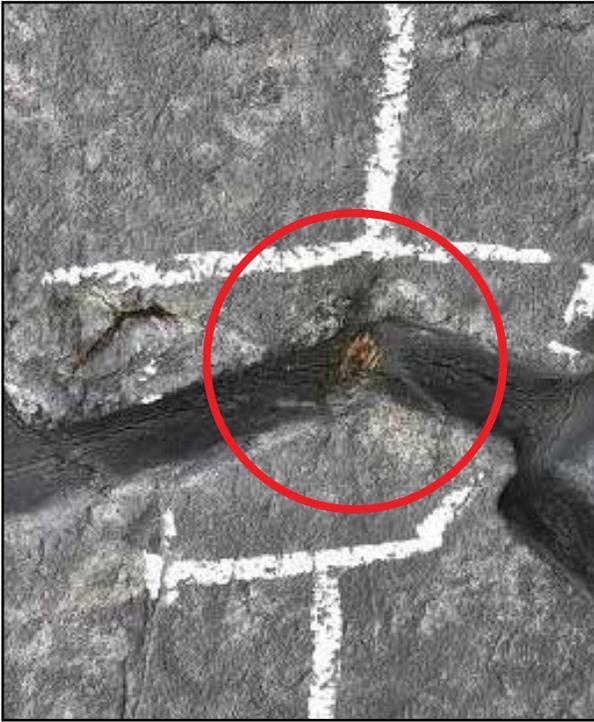
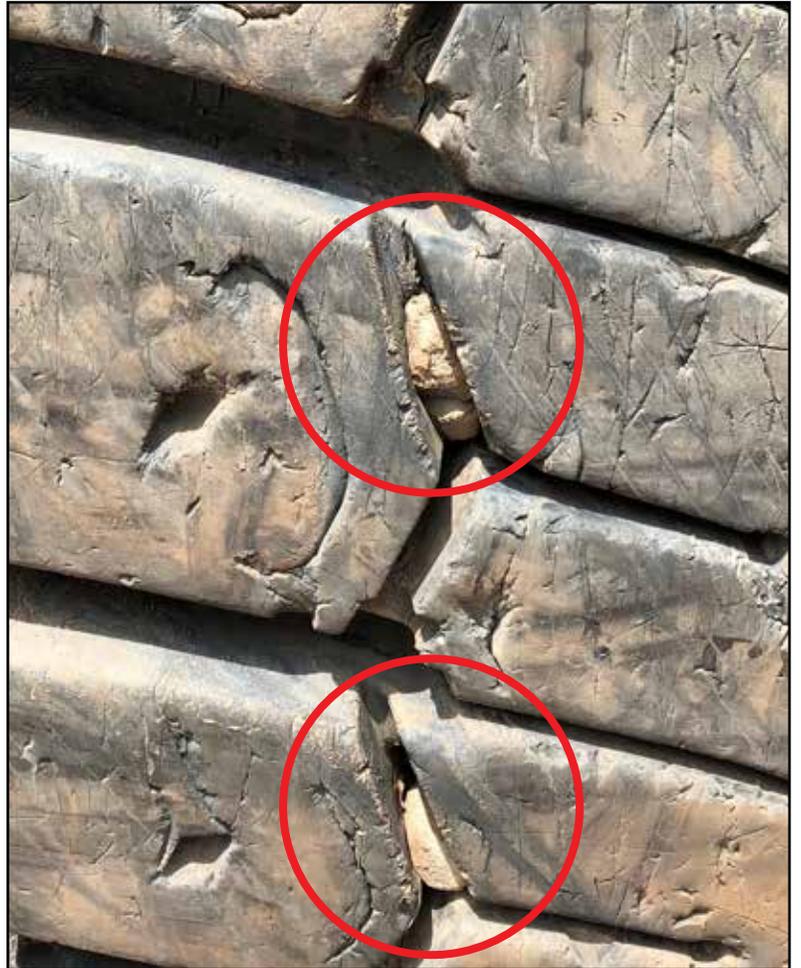
Stone retention.

Stones trapped in the tread pattern or impact of stones at the bottom of the tread grooves.

Penetrations/rock drilling to the belt causing rust, separation and splitting of crown plies.

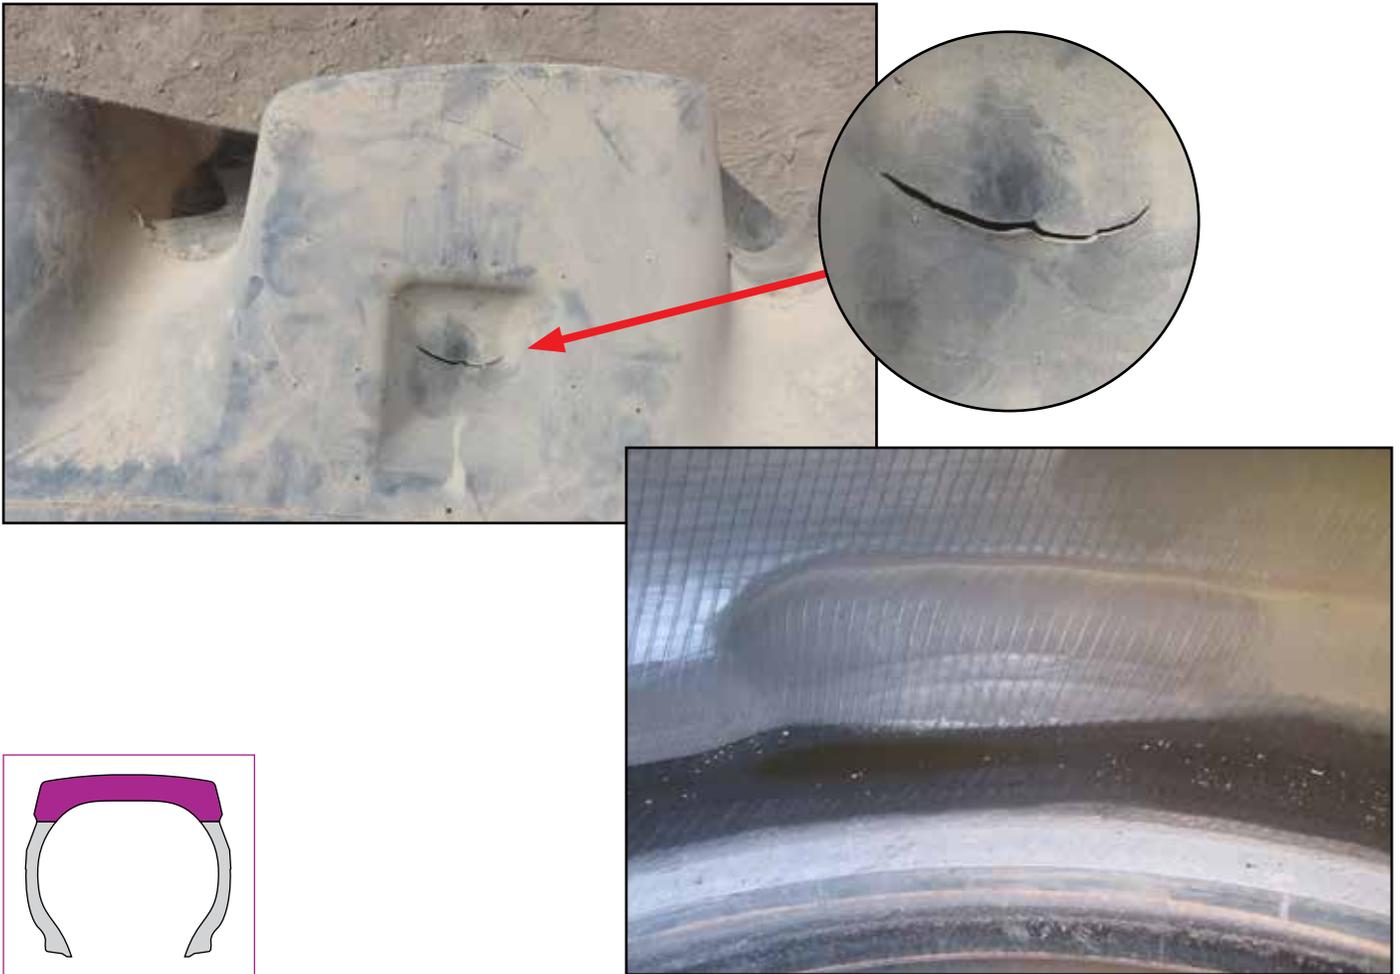
Separation in the rubber under the edge of the crown plies.

The separation starts at the edge of the first crown ply and can be localized or extensive. The rubber can have a sticky or blistered aspect.

Tearing between the casing ply and the sidewall. Rupture of the casing ply under the crown block or the flexion zone. Infiltration. Runflat.

Respect the guidelines concerning load and pressure. Study the conditions of use, layout and maintenance of roads. Check whether machines reach high speeds on fast roads. Make sure the TMPH/TKPH of the tire is greater than that of the site.

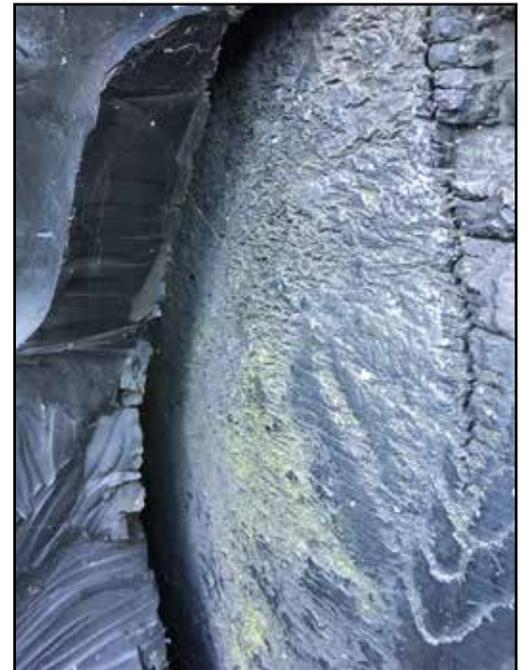
DESCRIPTION	Deterioration of the rubber product(s) between the tread and the crown plies.
--------------------	--

Tread deformation

Rubber generally sticky under the tread

OBSERVATION	Localized deformation or wear of the tread or splits in rubber at the bottom of the tread grooves. Rubber generally sticky between crown ply and tread.
PROBABLE CAUSES(S)	Build-up of heat resulting from under-inflation or overload (tire's nominal load exceeded), associated with numerous, lengthy cycles. High speed travel over surfaces made up of large stones (hammering). Damage amplified by incorrect setting of toe or camber on machine.
EVOLUTION	Partial tread rubber detachment and splitting.
RECOMMENDED ACTION	Scrap.
PREVENTION	Study the conditions of use, layout and maintenance of roads; check whether machines do reach high speeds on fast roads; make sure that the tire usage is within the site TMPH/TKPH. Be aware of indicators: localized wear, splits in rubber at the bottom of the tread grooves.
DO NOT CONFUSE WITH	Page 14

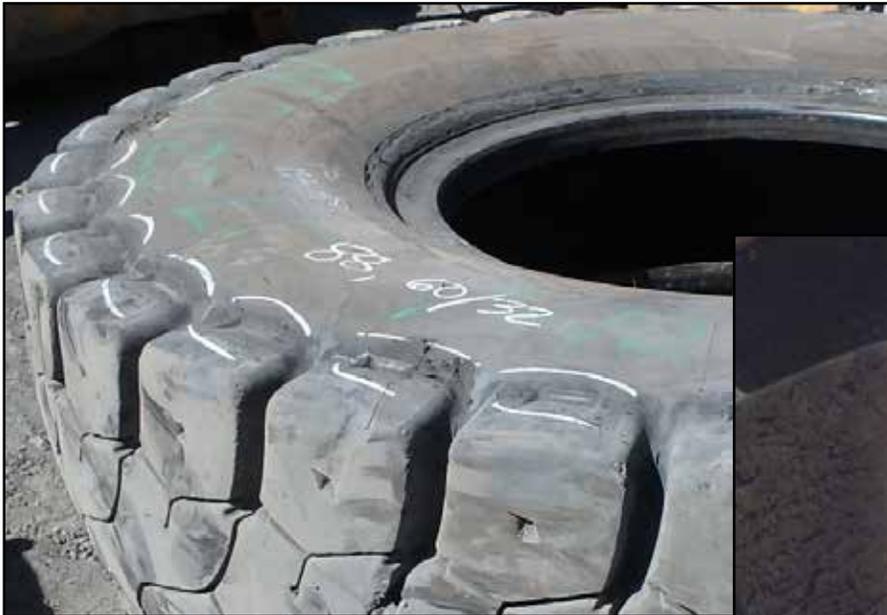
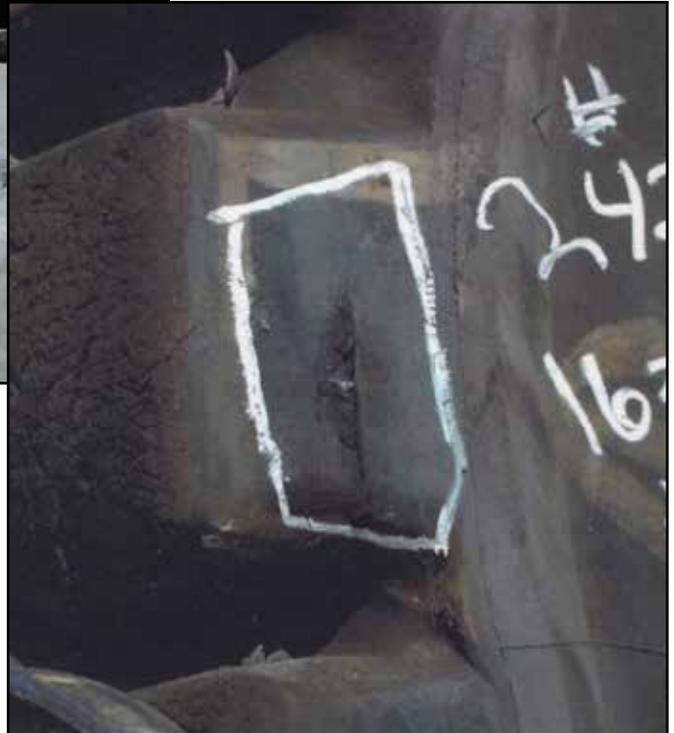
Split in the rubber products at the edge of the crown plies.

Open splits in the shoulder area.

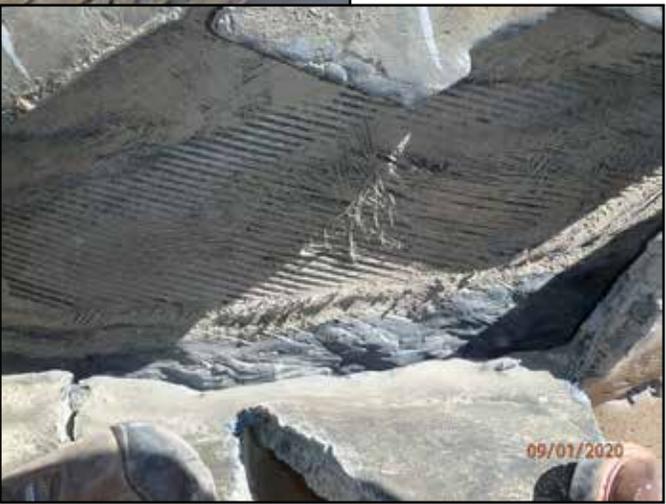
DESCRIPTION	Generalized separation between the tread band and the crown plies.
--------------------	---

OBSERVATION	Generalized separation between the tread band and crown plies without trace of heat.
PROBABLE CAUSES(S)	Repeated aggressions to the tread band. Stone retention. Tread damage.
EVOLUTION	Continued detachment of tread rubber from the crown plies.
RECOMMENDED ACTION	Scrap.
PREVENTION	If possible, weigh the machine and adjust tire pressures accordingly. Check whether there is any hammering. Check haul road maintenance. Consider indicators such as localized deformation or wear on the tread.
DO NOT CONFUSE WITH	Pages 13, 79

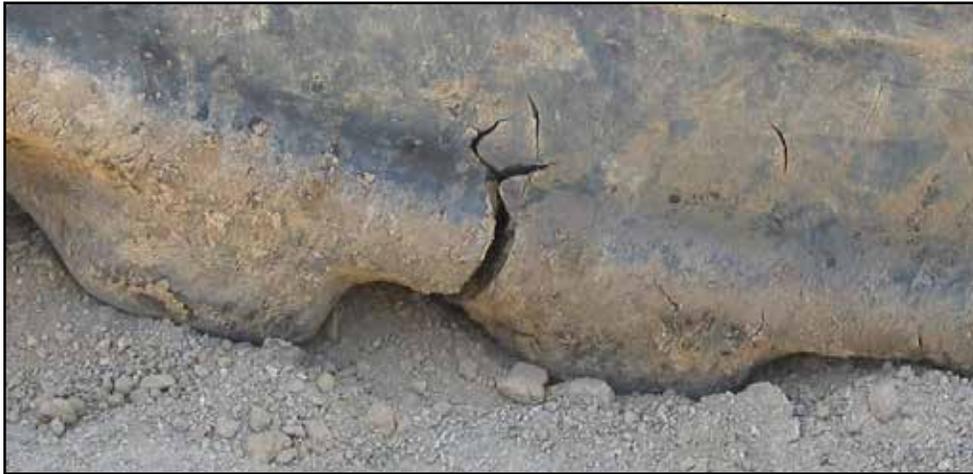
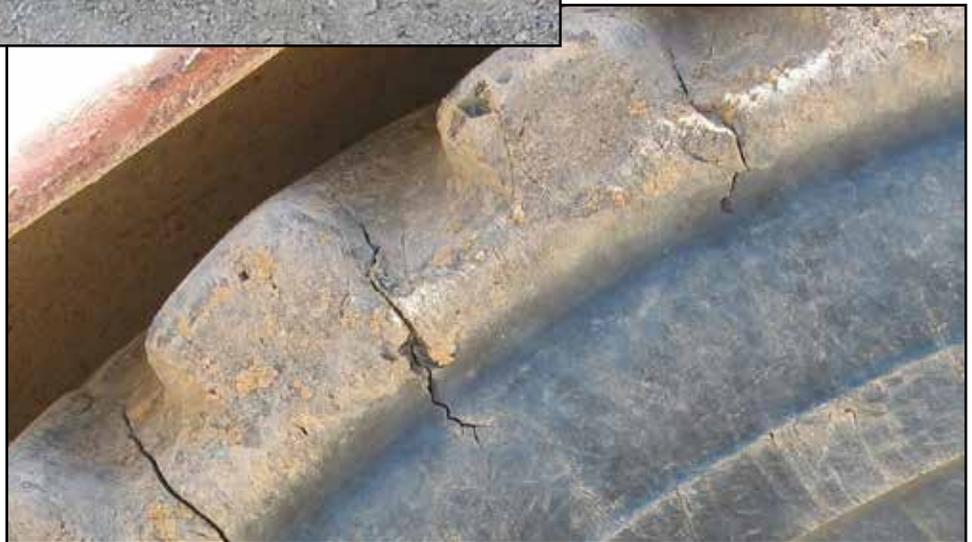
Splits at the bottom or the edge of the tread blocks in the shoulder area.

Splits in rubber at the bottom or edge of tread grooves in the shoulder.

Deterioration of crown plies.

If wear is advanced and the tire cannot be retreaded, keep running until splits reach the protective ply. Retread, if it is accepted, before the splits have reached the plies at several points; otherwise scrap. On a transport machine, if wear is minimal and ply structure is visible, have the tire repaired if possible.

Inspect cuts regularly on transport machines. If wear is slight, make a spot repair before the plies become visible. Otherwise, leave running and monitor.

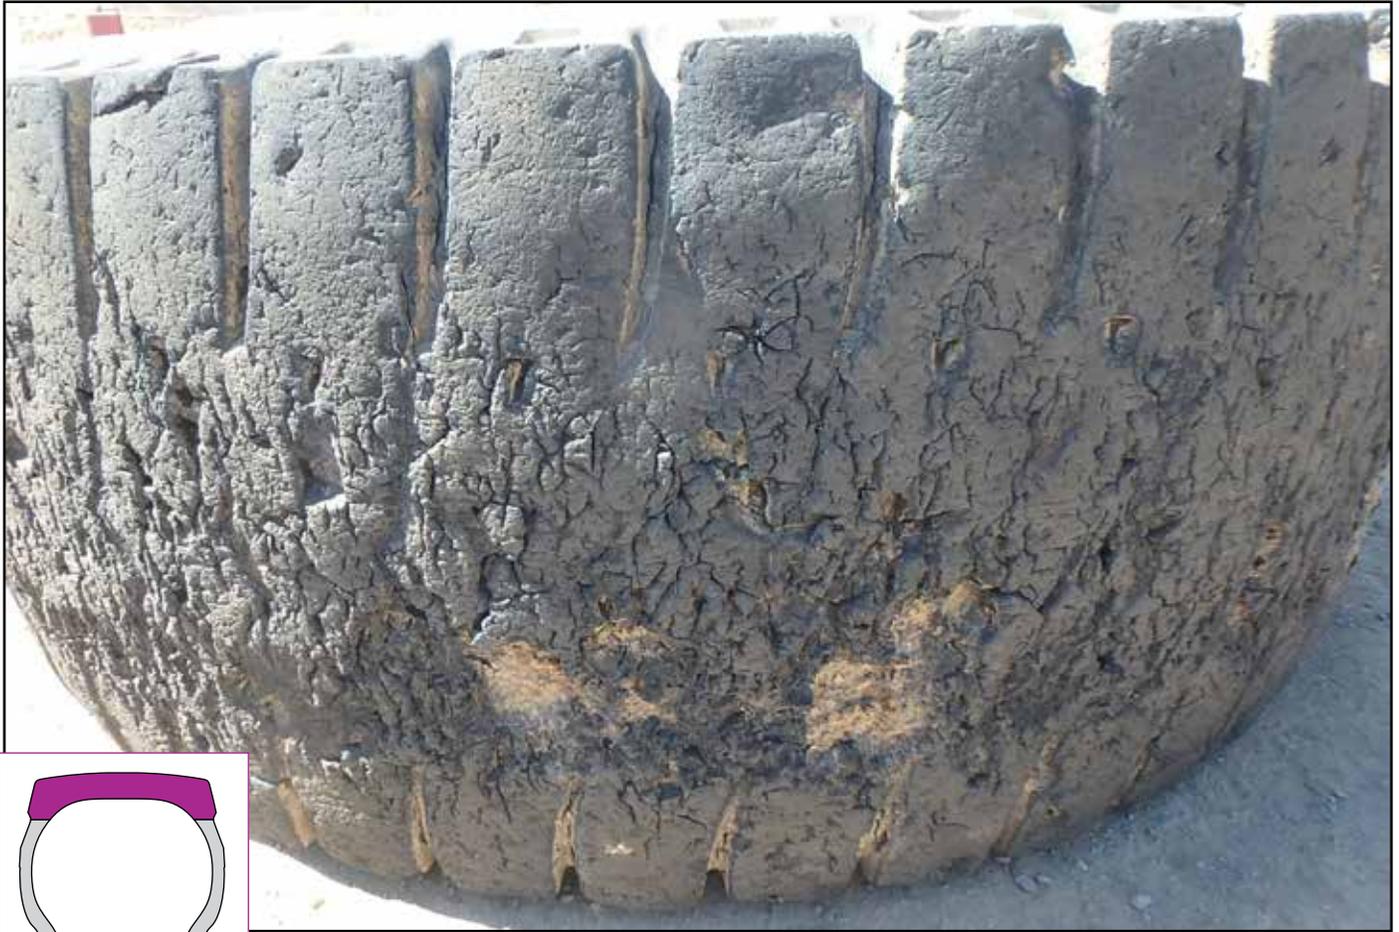
Tread elements tearing out (chunking) due to repeated aggressions.

Tread elements torn (chunking).

Deterioration of crown plies reaching the casing, rapid wear, lack of traction.

If wear is advanced and the tire cannot be retreaded, leave running until the protective ply appears. If the tire is accepted for retreading, send it in before the tears reach the plies at several points.

Look for the causes of spinning (going uphill empty, loose or soft surface, high torque). Clean and maintain the site roads using graders or bulldozers. Review the balance between load and pressure and reduce pressure if possible. Review the choice of tread pattern and/or (harder) type of rubber compound.

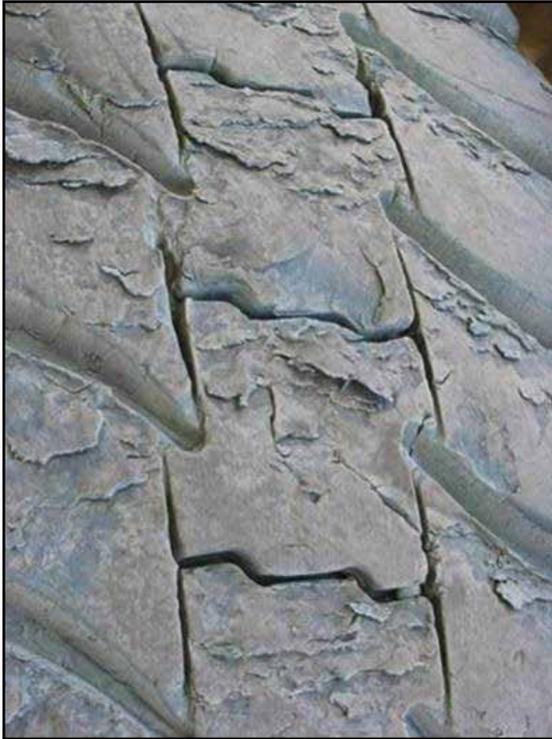
DESCRIPTION	Scaling, or flaking away, of the tread rubber.
--------------------	---

OBSERVATION	Multiple tears in the rubber on the tread, giving a scaly, flaky appearance.
PROBABLE CAUSES(S)	Type of rubber not suited to the surface and conditions of use. More frequent when running on hard tracks covered with very small particles (pebbles, glass, etc.). Accentuated by over-inflation, or by repeatedly changing the direction of travel, and/or by running at high torque, associated with a high average speed.
EVOLUTION	Tearing, deterioration of crown plies and rapid wear.
RECOMMENDED ACTION	If wear is advanced and the tire cannot be retreaded, leave running until the protective ply appears. If the tire is accepted for retreading, send it in before the tears reach the plies at several points.
PREVENTION	Review the balance between load and pressure. Observe the type and diversity of surfaces covered by the machines and redefine the choice of (a harder) rubber compound.
DO NOT CONFUSE WITH	Page 24

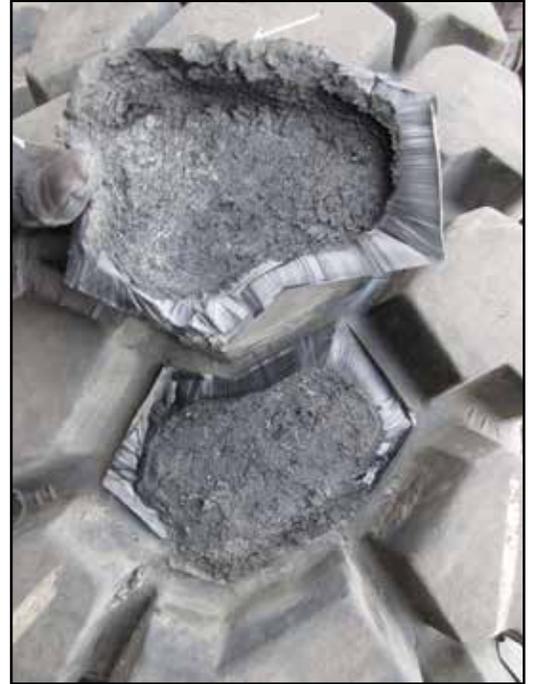
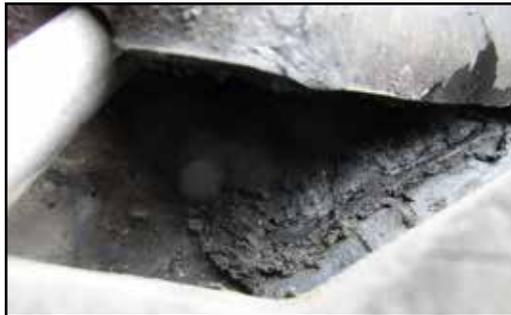
Cavities in the tread band generally in the center.

Cavities in the tread band generally in the center. Aspect of the rubber can be blistered, soft, sticky, with or without tearing out. The damage can be localized or appear in several areas.

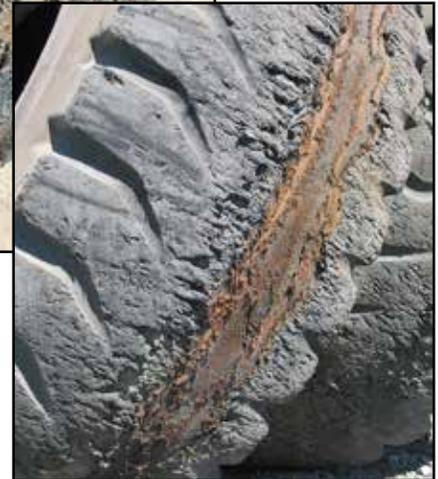
DESCRIPTION	Excessive wear reaching the crown plies.
--------------------	---

OBSERVATION	Excessive wear reaching the crown plies.
PROBABLE CAUSES(S)	NA
EVOLUTION	Wear of protector and working plies.
RECOMMENDED ACTION	Remove from service and scrap according to end user's removal policy.
PREVENTION	Comply with the legislation in force if the machine is subject to traffic regulations (e.g. cranes). If the tire is accepted for retreading, withdraw it from use as soon as the tread pattern disappears.
DO NOT CONFUSE WITH	Page 28

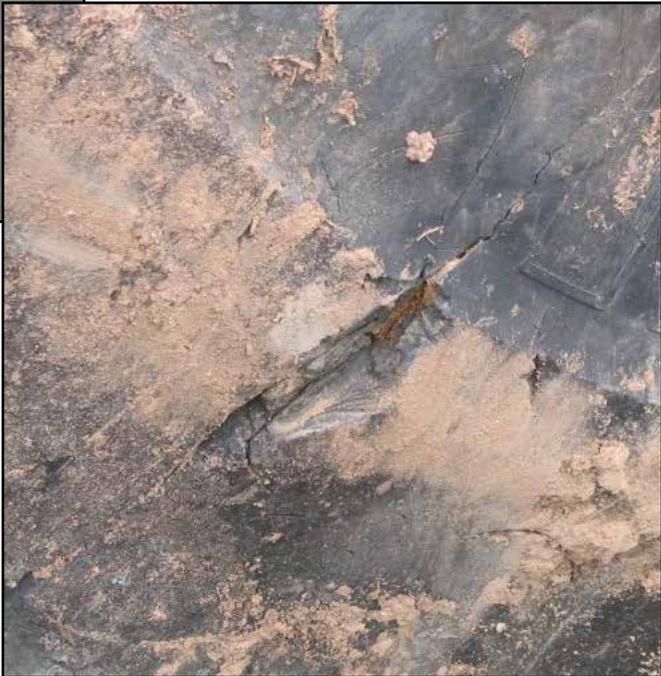
DESCRIPTION	Localized sidewall damage affecting the casing ply but not extending to the interior of the tire.
<div style="display: flex; justify-content: space-between; align-items: flex-start;"> <div style="width: 45%;">

</div>	
OBSERVATION	Localized sidewall damage not extending to the interior but affecting the casing ply or its turn-up.
PROBABLE CAUSES(S)	Accidental sidewall cut, shock or impact.
EVOLUTION	Splitting open radially or rupture.
RECOMMENDED ACTION	Repair, depending on the tire's residual value. Assess the extent of the damage to ensure that it is within the recommended limits.
PREVENTION	Review tire pressure if damage is frequent. Identify areas where damage is likely to occur. Improve the condition of the haul roads and work conditions.

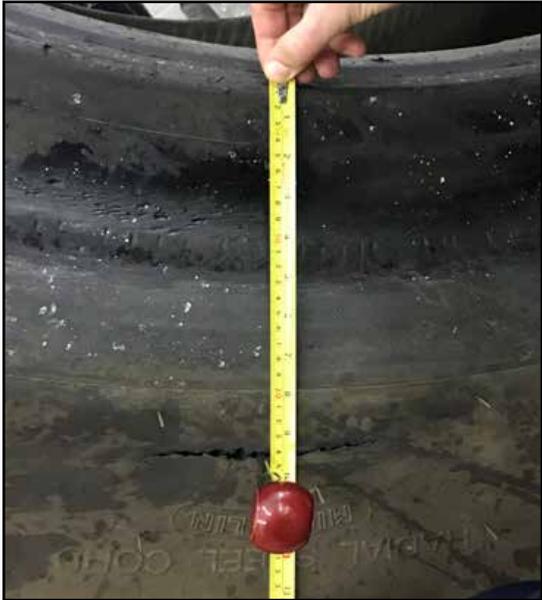
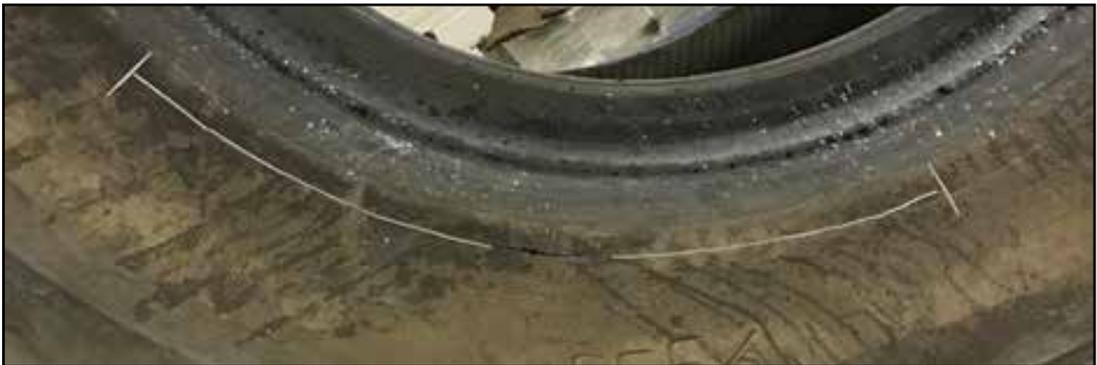
DESCRIPTION	Rupture of the turn-up in the bead area.
--------------------	---

OBSERVATION	Rupture of the casing ply turn-up in the bead-bearing area behind the flange.
PROBABLE CAUSES(S)	Tire's nominal load capacity exceeded. Under-inflation. Improper mounting or incorrect flange height. Often seen on industrial and underground tires.
EVOLUTION	Casing ply rupture, rapid deflation.
RECOMMENDED ACTION	If cords have lost their frette or are broken, scrap.
PREVENTION	If possible, weigh the machine by axle to determine optimum pressures. When fitting, ensure that the tire is correctly centered on the rim and seated per Michelin's bead seating pressure guidance. Verify that the wheel and flange parts are correct.
DO NOT CONFUSE WITH	Pages 37, 53, 64

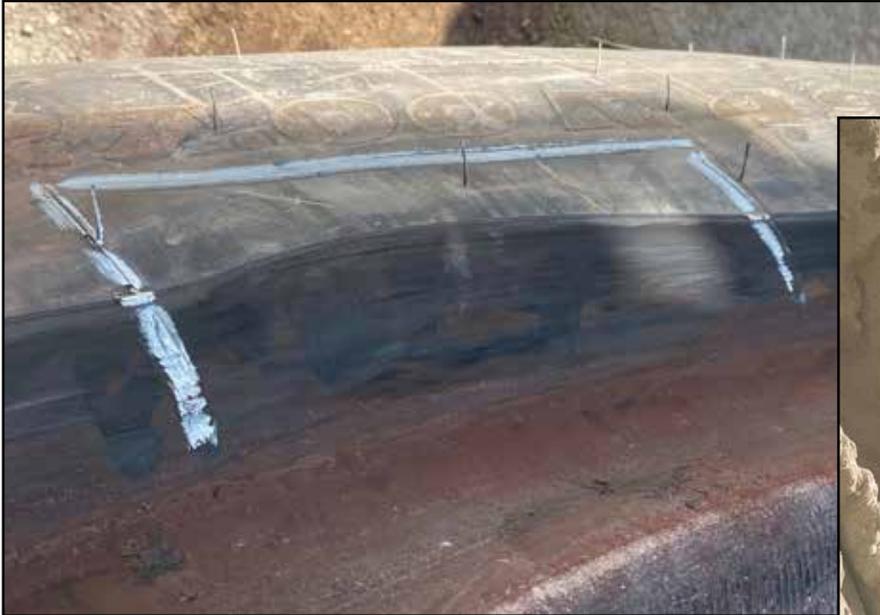
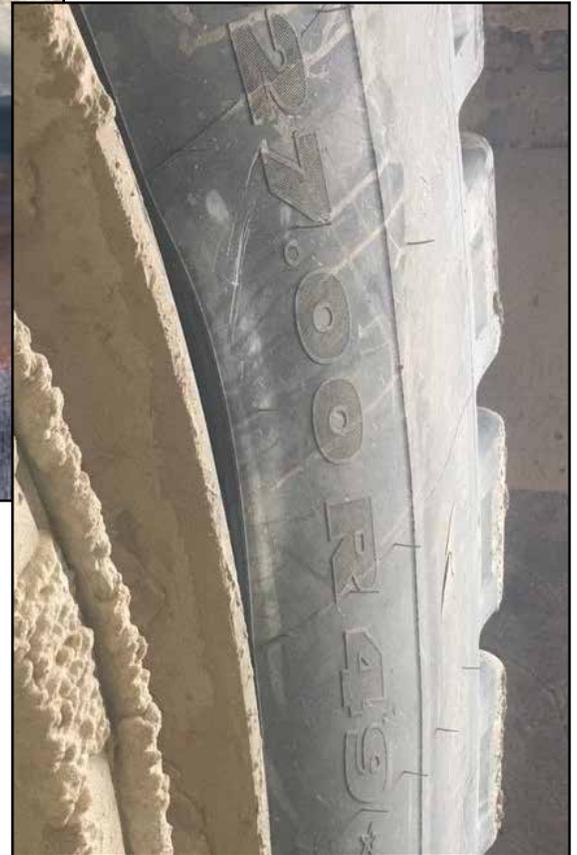
Lumps from the reinforcements in the bead area.

Numerous semi-spherical lumps and/or splits in the guide rib area. Hard bulges in bead area reinforcement zone. Separation at the edge of the bead protector ply.

Over-deflection due to the tire's nominal load capacity being exceeded. Under-inflation. Improper mounting. Incorrect flange or rim width. Heat.

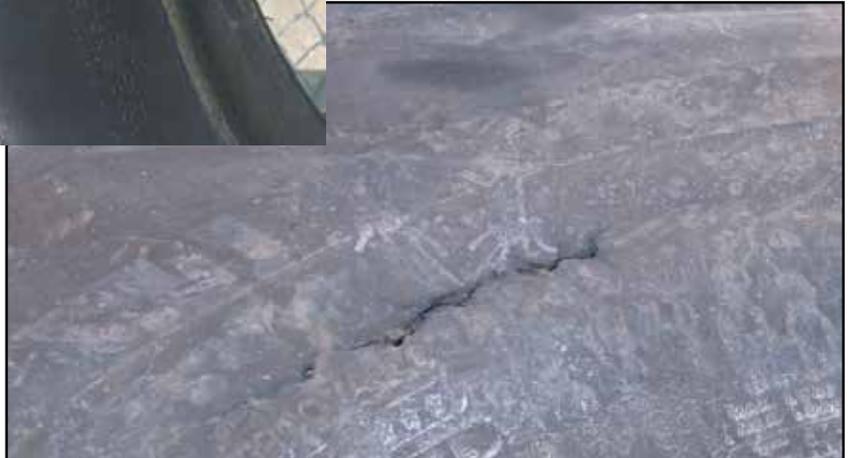
DESCRIPTION	Separation at the end of the inner reinforcing plies or casing ply turn-up in the sidewall (mid-height turn-up).
--------------------	---

OBSERVATION	Separation at the end of the high casing ply turn-up (mid-height turn-up) or reinforcement on the sidewall
PROBABLE CAUSES(S)	Tire's nominal load capacity exceeded, under-inflation. Improper mounting.
EVOLUTION	Opening will continue to spread; once completely open the tire could rupture.
RECOMMENDED ACTION	To be examined by the Manufacturer to decide if tire should keep running. If not, scrap.
PREVENTION	If possible, weigh the machine by axle to determine optimum pressures. When mounting is done on the machine, make sure tire fitters are aware of correct mounting and seating pressures.
DO NOT CONFUSE WITH	Page 36

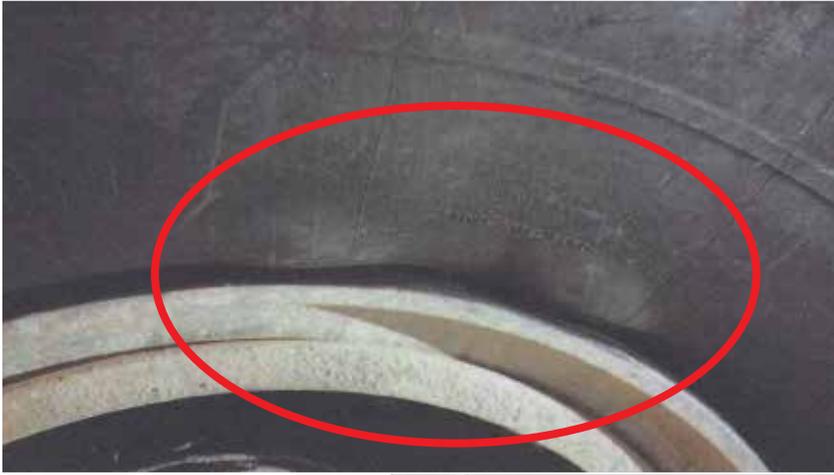
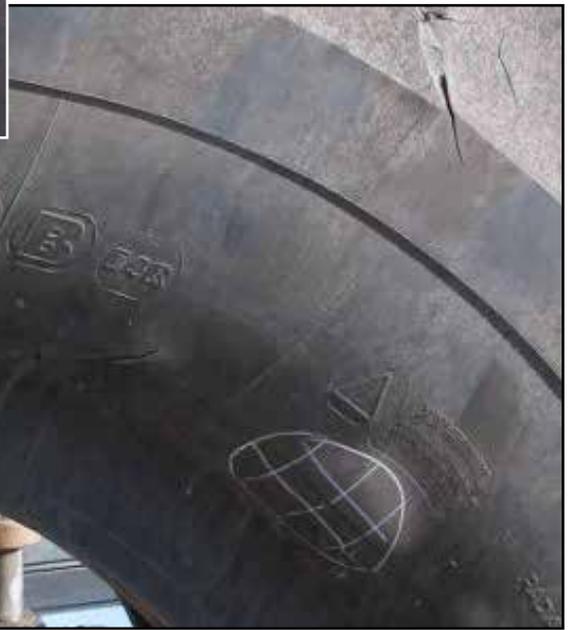
DESCRIPTION	Separation between the packing rubber (BJ) and the bead zone reinforcements.
--------------------	---

OBSERVATION	Separation between the packing rubber (BJ) and the bead zone reinforcements.
PROBABLE CAUSES(S)	Excessive stress in the bead zone. Tire's nominal load exceeded. Underinflation. Flanges in poor condition.
EVOLUTION	Bulges will continue to grow; once open 360 degrees, the tire could rupture.
RECOMMENDED ACTION	Leave in service (after inspection) and if necessary, replace worn or distorted wheel components. Vent by Michelin-qualified personnel per Michelin procedures. Increase pressure to decrease deflection.
PREVENTION	Check service conditions. If possible, weigh the machine by axle to determine optimum pressures.
DO NOT CONFUSE WITH	Pages 35, 37

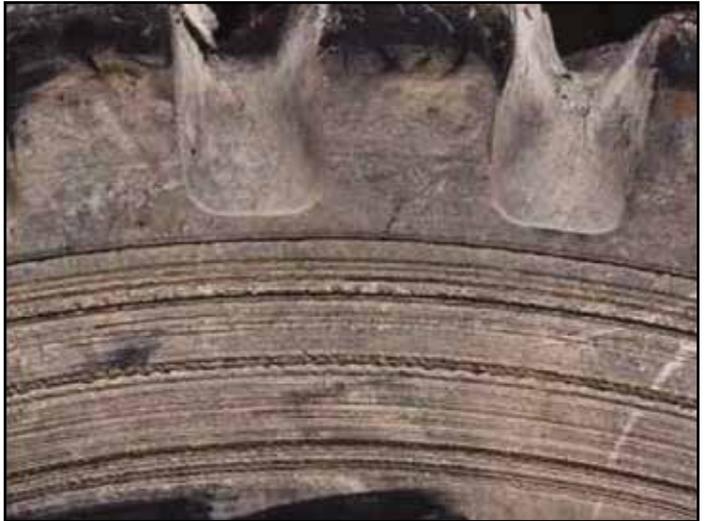
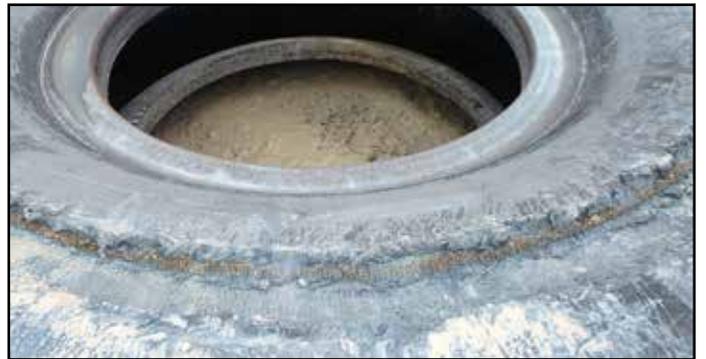
DESCRIPTION	Repeated circumferential cuts/scratches to the sidewall.
--------------------	---

OBSERVATION	Repeated circumferential cuts/scratches to the sidewall.
PROBABLE CAUSES(S)	Sidewall rubbing repeatedly against part of the vehicle or an obstacle.
EVOLUTION	Continued wear leading to possible rupture of the casing ply.
RECOMMENDED ACTION	Comply with the legislation in force in the country if the machine is subject to traffic regulations (e.g. cranes). If wear is advanced and the tire is not accepted for retreading, leave running on site only.
PREVENTION	Look for the offending part. Check the general condition of the rock ejectors, spacers, wings, etc. Examine the site conditions in which the machine is operating.
DO NOT CONFUSE WITH	Page 46

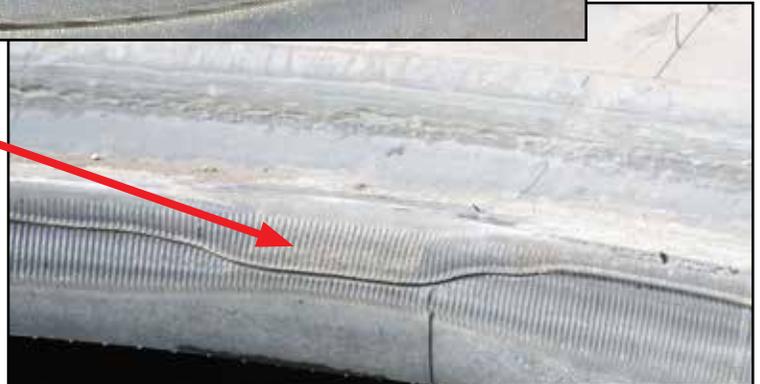
Bead support zone

DESCRIPTION	Damage or deformation of the bead due to poor seating on the rim (mismount).
--------------------	---

OBSERVATION	Knurling marks from rim base of bead seat band on bead heel and/or lower bead support zone and not on the bead sole. On rims without knurling, deformation of the bead.
PROBABLE CAUSES(S)	Insufficient lubrication, seating pressure or incorrect centering of the tire when fitting.
EVOLUTION	Split may eventually develop at top of turn-up. Remove when the split opens 180° or if cables are visible in the bead area.
RECOMMENDED ACTION	Leave running if the plies are not affected and if inflation seating is possible.
PREVENTION	Verify the condition of the fitting and handling equipment and the method used.
DO NOT CONFUSE WITH	Page 49

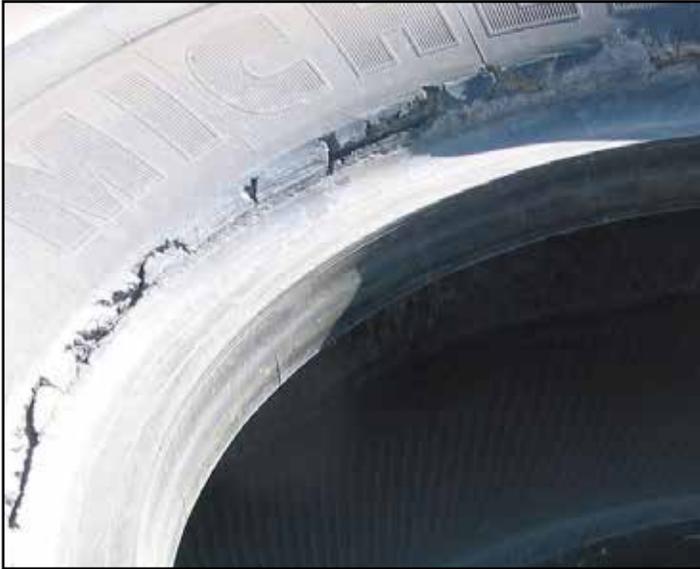
DESCRIPTION	Wear in the bead bearing area.
--------------------	---------------------------------------

OBSERVATION	Circumferential wear of the rubber in the bead support zone.
PROBABLE CAUSES(S)	Tire's nominal load capacity exceeded. Under-inflation. Tire not suitable for application or poor condition of the flange. High torque. Abrasive materials caught between flange and bead (e.g. sand or coal).
EVOLUTION	This wear will reach but not damage the casing ply.
RECOMMENDED ACTION	Leave running, except where plies are visible, then scrap.
PREVENTION	Verify the recommended pressure; increase if possible. Check whether a change of flange is necessary.
DO NOT CONFUSE WITH	Pages 34, 37, 50

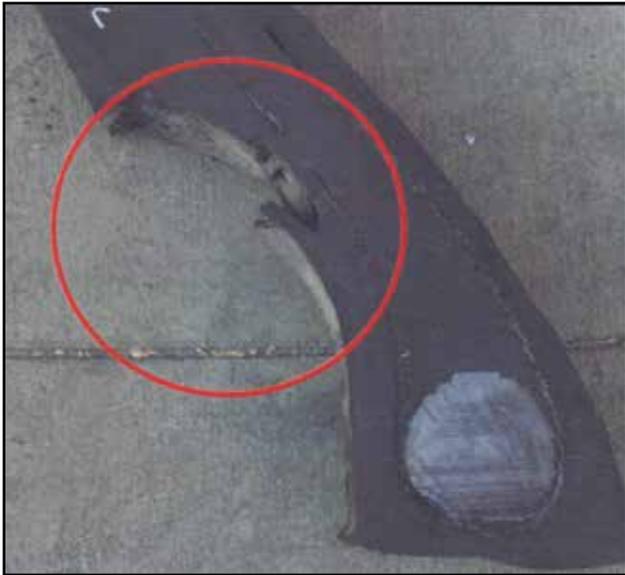
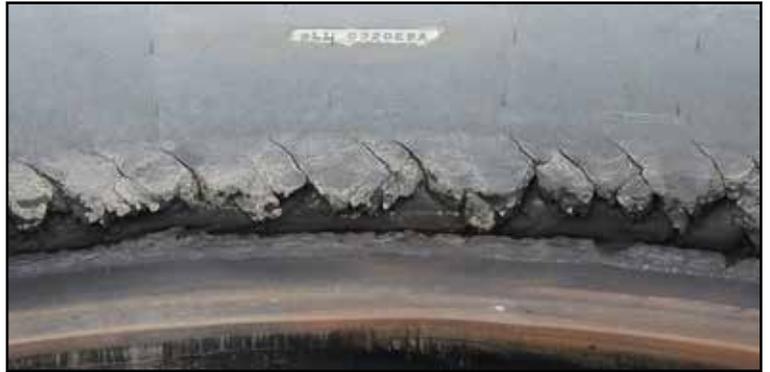
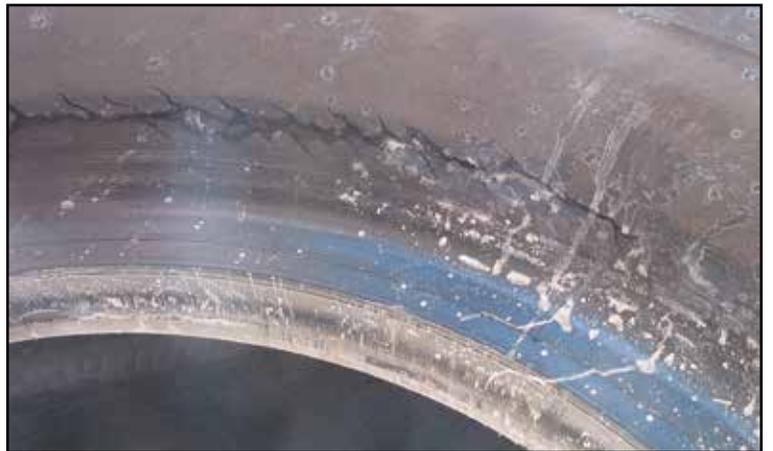
DESCRIPTION	Oblique cracks/splits located in the bearing area.
--------------------	---

OBSERVATION	Oblique splits in the bead support zone.
PROBABLE CAUSES(S)	Over-deflection, tire's nominal load capacity exceeded, under-inflation. High torque.
EVOLUTION	Splits may grow into the turn-up or bead reinforcing ply.
RECOMMENDED ACTION	Leave running, except where plies are visible, then scrap.
PREVENTION	If possible, weigh the machine by axle to determine optimum pressures. Do not exceed the economic nominal tire load.
DO NOT CONFUSE WITH	Pages 37, 50, 64, 78

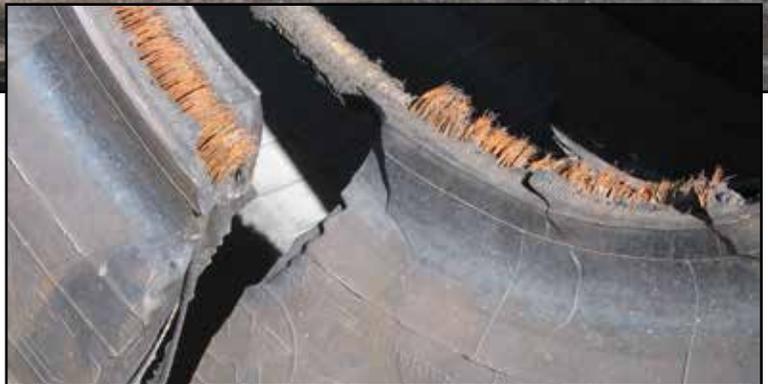
DESCRIPTION	Longitudinal split on the bead sole.
--------------------	---

OBSERVATION	Circumferential split at the base of the bead.
PROBABLE CAUSES(S)	High torque and/or tire's nominal load capacity exceeded and/or rotation on rim, aggravated by high rim temperature.
EVOLUTION	Rupture of the casing ply or bead wire.
RECOMMENDED ACTION	Scrap.
PREVENTION	If possible, weigh the machine by axle to determine optimum pressures. Verify the presence of locking keys (between rim and taper and/or between rim and loose flange). Measure the circumference of the rim to ensure that it is within specification.
DO NOT CONFUSE WITH	Pages 49, 52

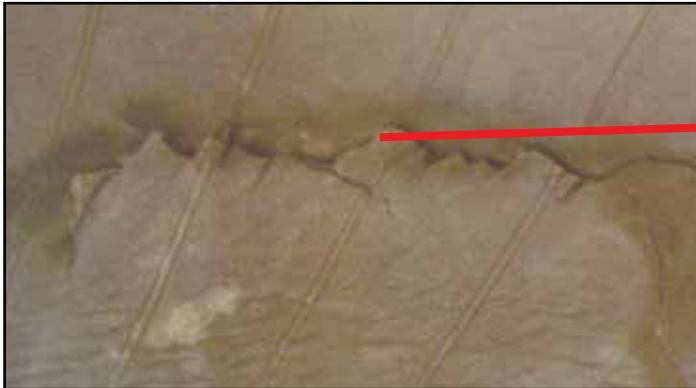
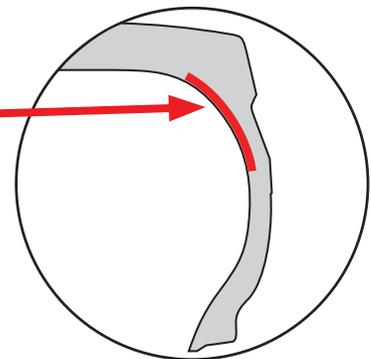
DESCRIPTION	Separation of the internal sidewall reinforcing ply.
--------------------	---

OBSERVATION	Splitting at the end of interior reinforcement products.
PROBABLE CAUSES(S)	Over-deflection, not enough pressure for the load and/or high torque.
EVOLUTION	Runflat.
RECOMMENDED ACTION	Scrap.
PREVENTION	Verify recommended inflation pressure.
DO NOT CONFUSE WITH	Pages 59, 61, 66

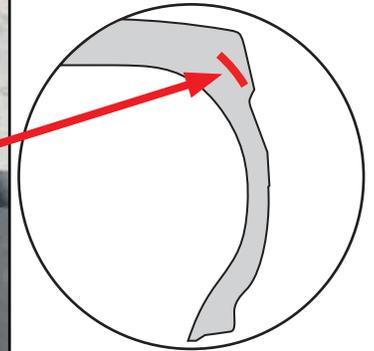
DESCRIPTION	Pocket of separation between the casing ply and the crown block.
--------------------	---

OBSERVATION	Pocket of separation between the casing ply and the crown block.
PROBABLE CAUSES(S)	Shock, high speeds, mis-alignment of front wheels.
EVOLUTION	Rapid deflation.
RECOMMENDED ACTION	Scrap.
PREVENTION	Verify TMPH/TKPH. Review tire pressure if damage is frequent. Improve the condition of the haul roads and work conditions
DO NOT CONFUSE WITH	Pages 14, 17

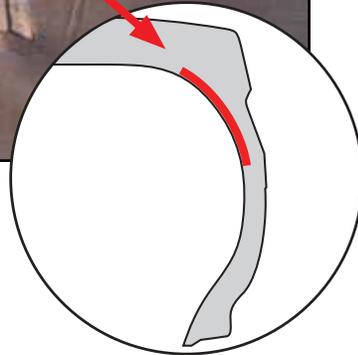
DESCRIPTION	Raised, exposed, or detached casing cables in the interior shoulder area.
--------------------	--

OBSERVATION	Raised or exposed casing cables in the interior shoulder area. Detachment of cables/ rubber.
PROBABLE CAUSES(S)	Overload or underinflation, aggravated by hard cornering. Heat and/or fatigue, result from thermo-oxidation of casing rubber. May be aggravated by split in the inner liner. Repair using patch without Butyl liner.
EVOLUTION	Air infiltration, tire fire (torch effect), external bubble on high sidewall or rapid deflation.
RECOMMENDED ACTION	Scrap.
PREVENTION	Verify TMPH/TKPH, recommend nitrogen inflation. Verify load and pressures.
DO NOT CONFUSE WITH	Page 61

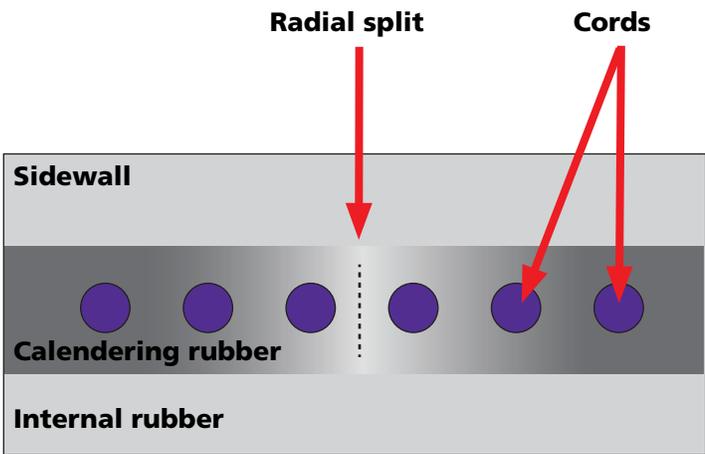
Internal rubber

DESCRIPTION	Radial split in calendering rubber of casing ply resulting from an impact.
--------------------	--

OBSERVATION	Radial split in calendering rubber of the casing ply resulting from an impact.
PROBABLE CAUSES(S)	Impact or dynamic overload.
EVOLUTION	Air infiltration, sidewall separation or rapid deflation.
RECOMMENDED ACTION	Repair if in accordance with recommendations (see Michelin Earthmover Tires Use and Maintenance Guide), otherwise scrap.
PREVENTION	Look for the places where there is a possibility of impact. Improve condition of haul roads.
DO NOT CONFUSE WITH	Page 59

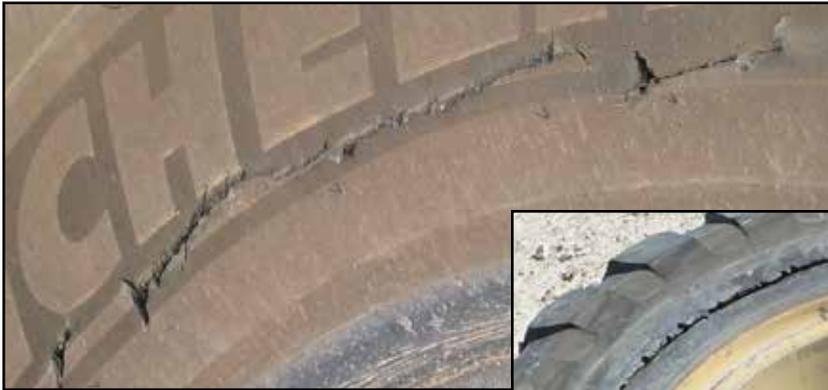
DESCRIPTION	Rupture of the casing ply turn-up in the sidewall.
--------------------	---

OBSERVATION	Rupture of the casing ply turn-up on lower part of the sidewall.
PROBABLE CAUSES(S)	Casing ply fatigue, resulting from the tire's nominal load capacity being exceeded. Low pressure. Fitting not done in accordance with recommendations.
EVOLUTION	Rupture of the casing.
RECOMMENDED ACTION	Scrap.
PREVENTION	Adapt the pressure to the load. Make tire fitters aware: lubricate, center the tire on the rim, inflate per Michelin's bead seating pressure guidance, adjust to the recommended pressure.
DO NOT CONFUSE WITH	Page 54
