EARTHMOVER TIRE CONDITIONS ANALYSIS GUIDE

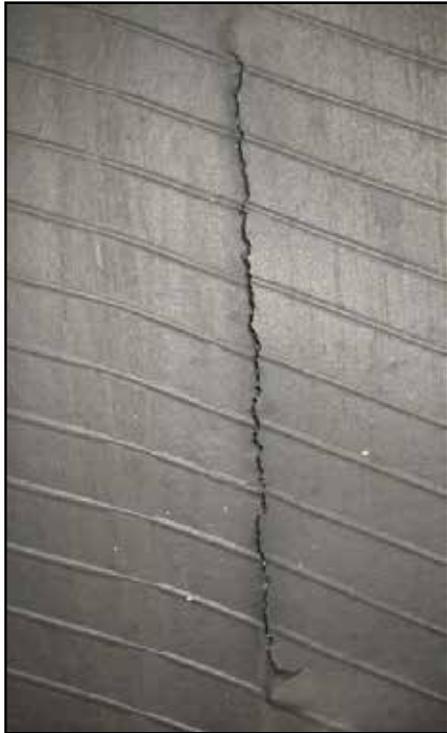
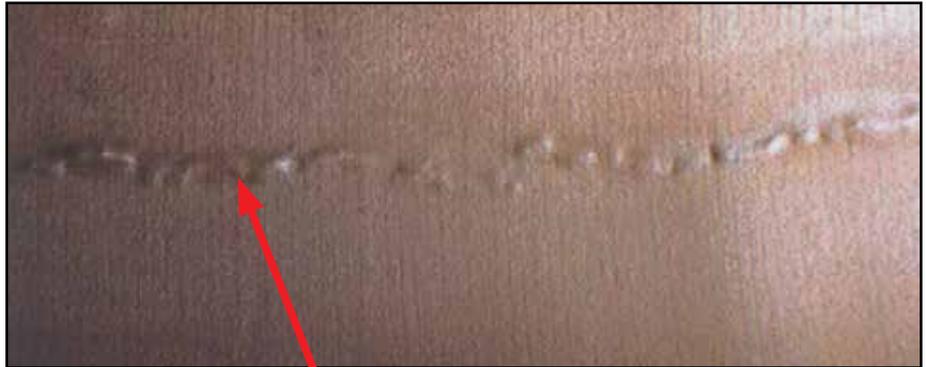
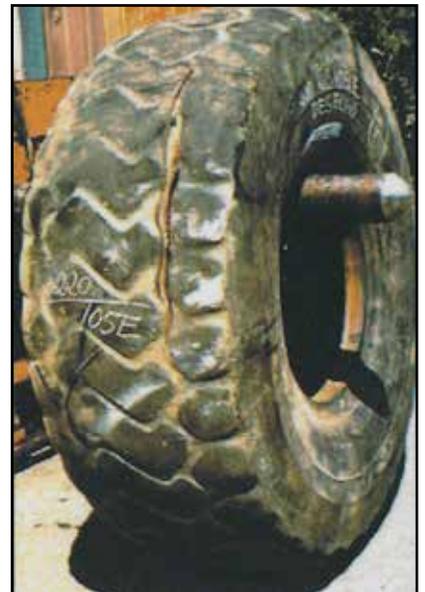
DESCRIPTION	Circumferential rupture of the casing ply in the crown.
--------------------	--

OBSERVATION	Circumferential rupture of the casing ply under the crown, without traces of shock.
PROBABLE CAUSES(S)	Crown fatigue resulting from exceeding the tire's nominal load capacity, accompanied by excessive flexing and lateral scrubbing. Use of wide tire at low pressure on hard surface.
EVOLUTION	May lead to tire leaking.
RECOMMENDED ACTION	Scrap.
PREVENTION	Adapt the pressures to the load. If possible, increase the radius of bends on haul roads.
DO NOT CONFUSE WITH	NA

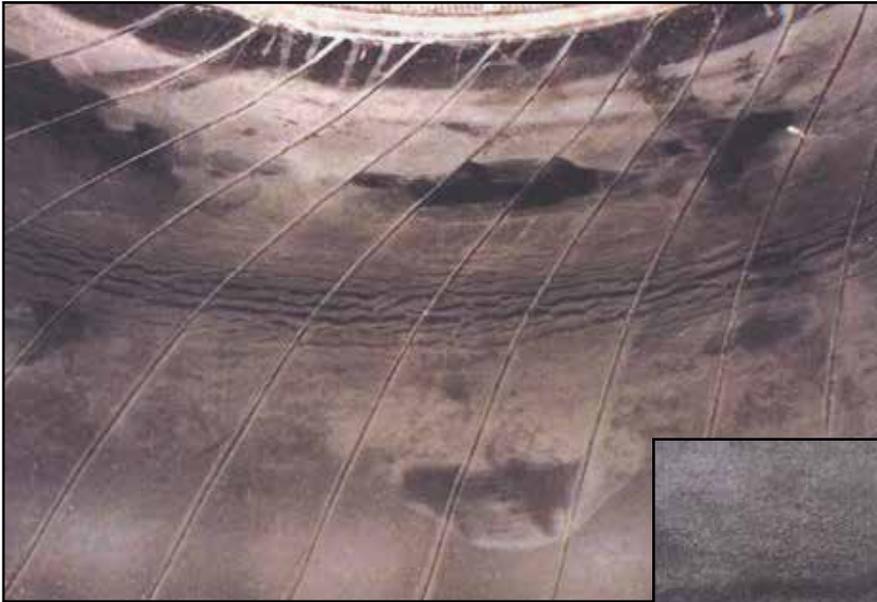
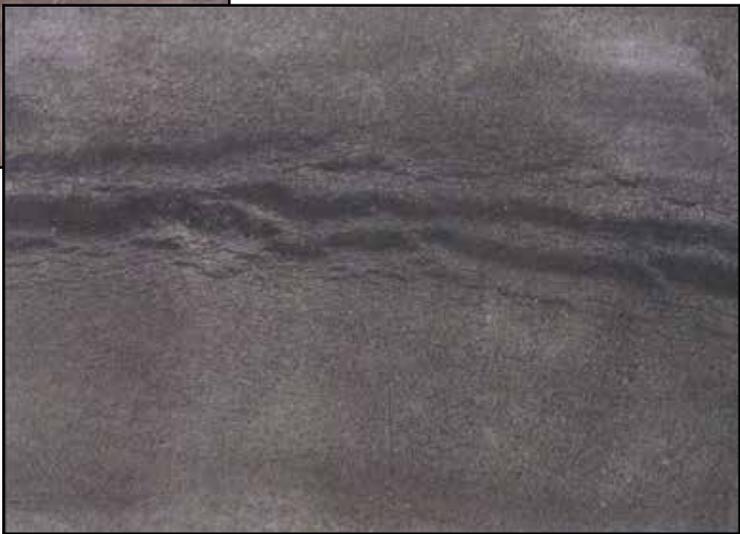
DESCRIPTION	Marbling/creasing of interior rubber due to over-deflation (runflat).
<div style="display: flex; justify-content: space-between;"> <div style="width: 45%;">

</div>	
OBSERVATION	The marbling is located in the flex zone. In the region of the marbling, the internal rubber is darkened in a wide band.
PROBABLE CAUSES(S)	Running continually under-inflated or continually exceeding the tire's nominal load or both. Perforation. All damages leading to a loss of pressure.
EVOLUTION	Cracking of the inner liner leading to air infiltration.
RECOMMENDED ACTION	If cracks are deep, scrap.
PREVENTION	Look for the cause of under-inflation (puncture, valve seal, valve extension, cracked rim). Adapt the pressures to the load. Check pressures regularly.
DO NOT CONFUSE WITH	NA

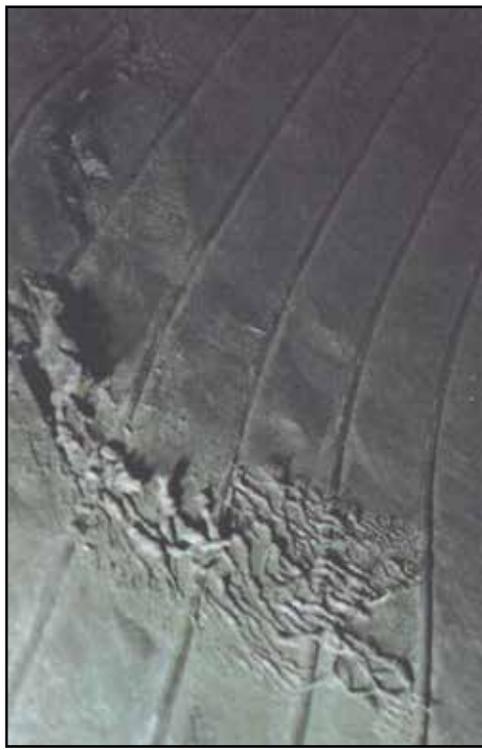
First stage

DESCRIPTION	Scrubbing/abrasion of interior rubber due to runflat.
--------------------	--

OBSERVATION	Chafing of the internal rubber as a result of excessive deflection in the sidewalls.
PROBABLE CAUSES(S)	Running flat.
EVOLUTION	Rupture of the casing.
RECOMMENDED ACTION	Scrap.
PREVENTION	Check pressures regularly to detect a source of leakage (puncture, valve seal, valve extension, cracked rim). Do not run on flat tire. Adapt pressures to the load.
DO NOT CONFUSE WITH	NA

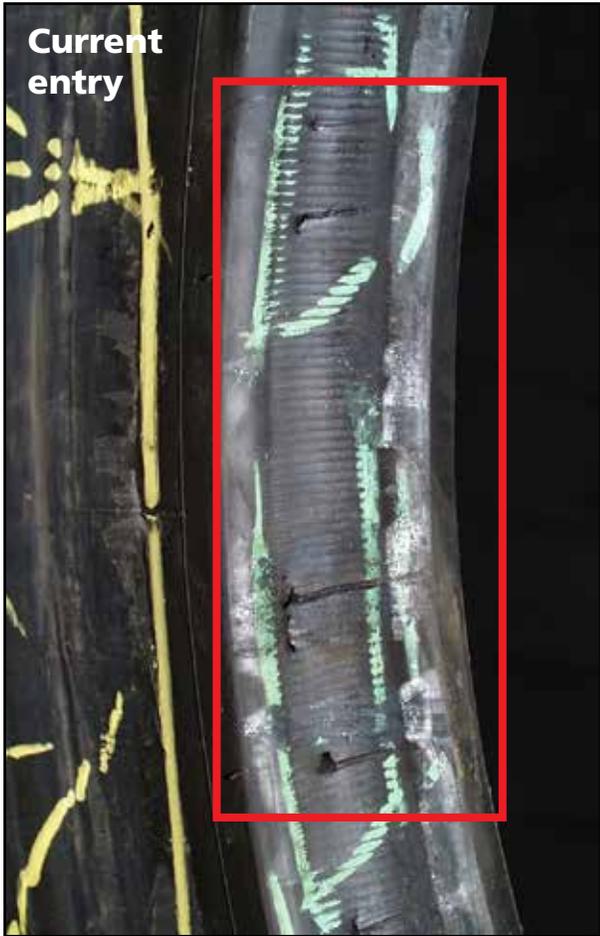
Bead

DESCRIPTION	Electrical discharge.
-------------	-----------------------

OBSERVATION	Damage due to electrical discharge.
PROBABLE CAUSES(S)	Electrical discharge caused by lighting or by a high-tension line.
EVOLUTION	Internal combustion, rupture of casing and/or rapid deflation.
RECOMMENDED ACTION	Scrap.
PREVENTION	If there are high tension lines nearby, make machine operators aware of the need to keep all parts of the machine a safe distance away from them; an electric arc can form without the machine touching the line.
DO NOT CONFUSE WITH	NA

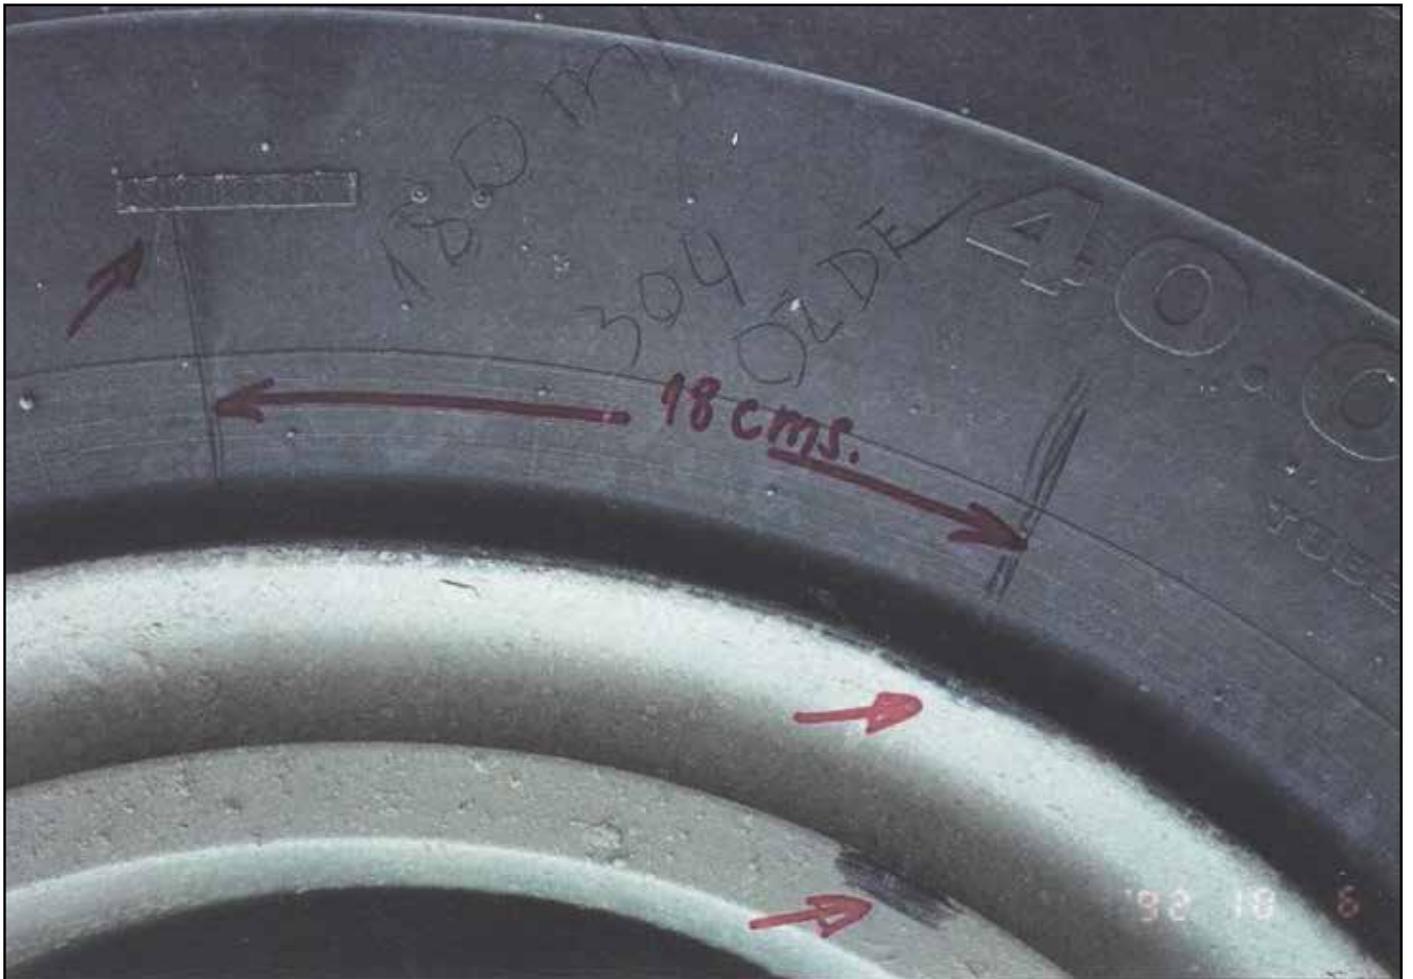
Tire indexing on rim.

Tire indexing, turning, rotating on rim.

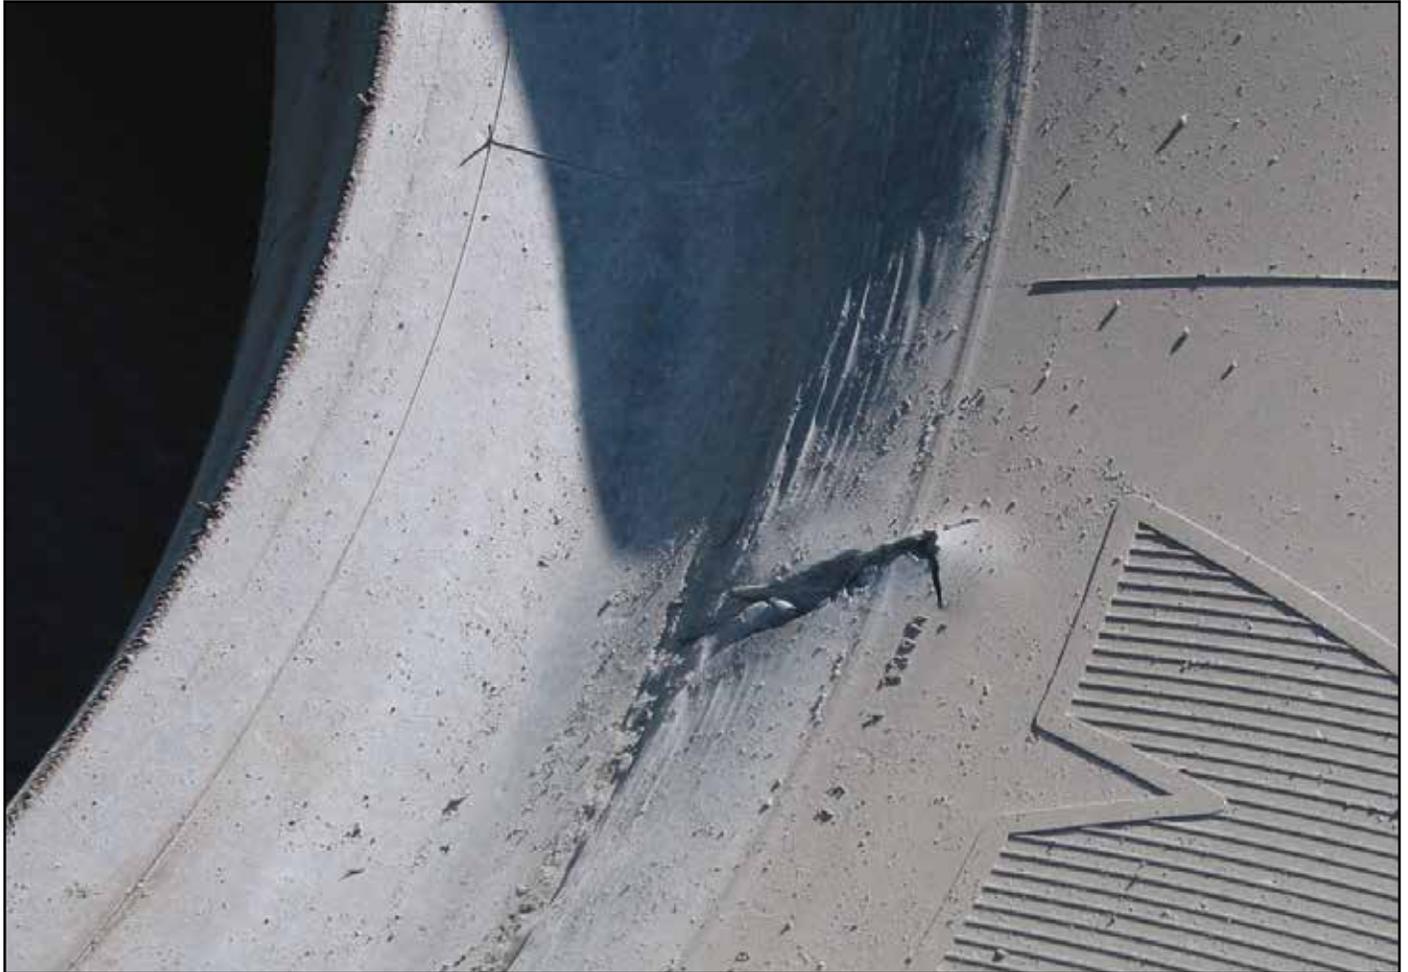
Loss of adhesion of the bead protector joint in the bead area.

Loss of adhesion of the bead protector joint.

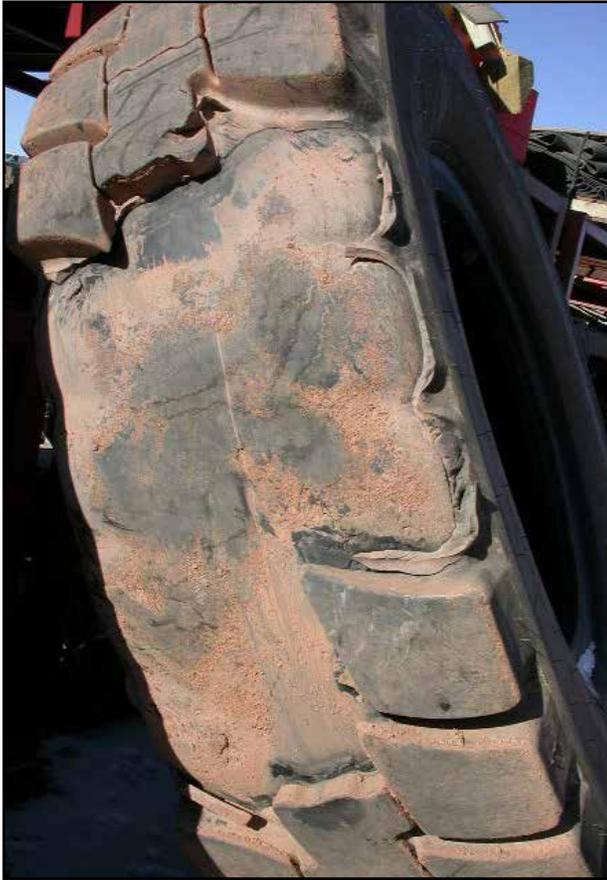
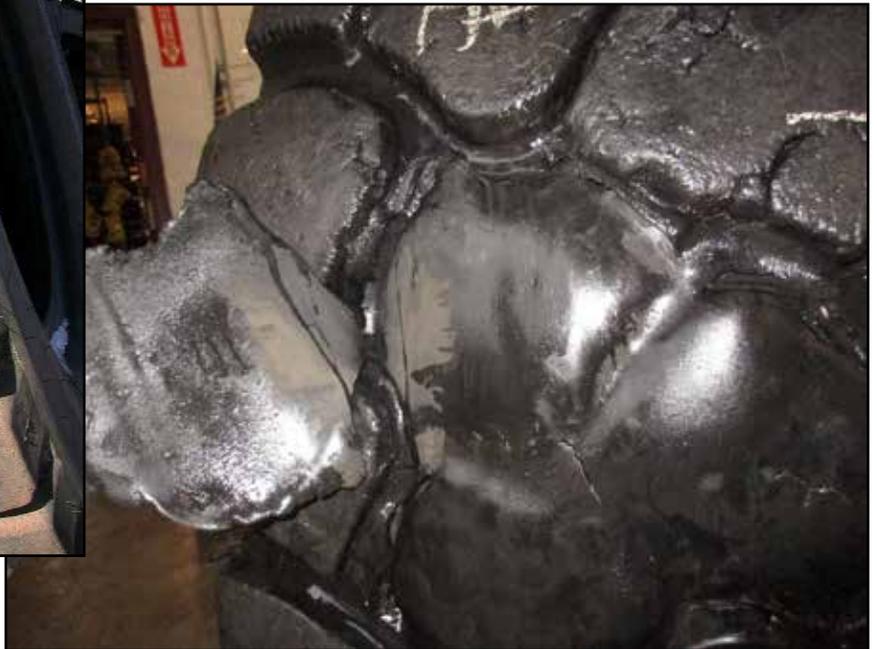
Unsticking of tread rubber.

Loss of adhesion in the tread or between tread and undertread rubber.

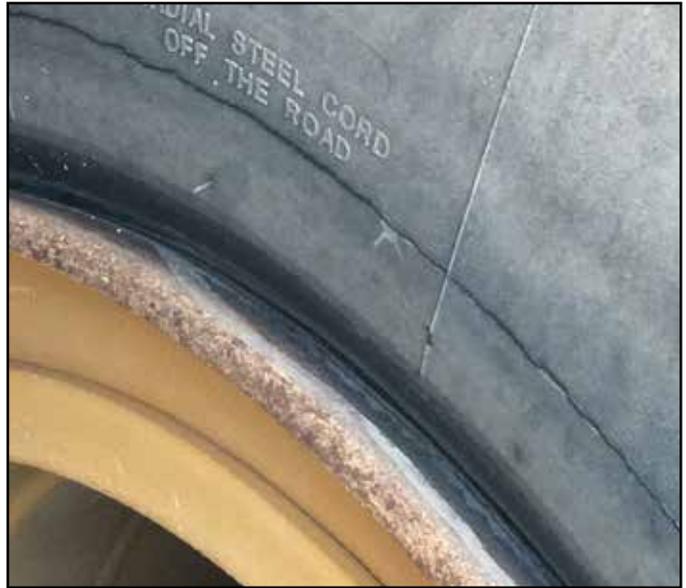
DESCRIPTION	Loss of adhesion of the FE/PT.
-------------	--------------------------------

OBSERVATION	Unsticking between sidewall rubber and the bead protector rubber.
PROBABLE CAUSES(S)	Weakness of the bond.
EVOLUTION	The separation will grow circumferentially and down to the point in contact with the rim.
RECOMMENDED ACTION	Leave running.
PREVENTION	None.
DO NOT CONFUSE WITH	Pages 36, 54

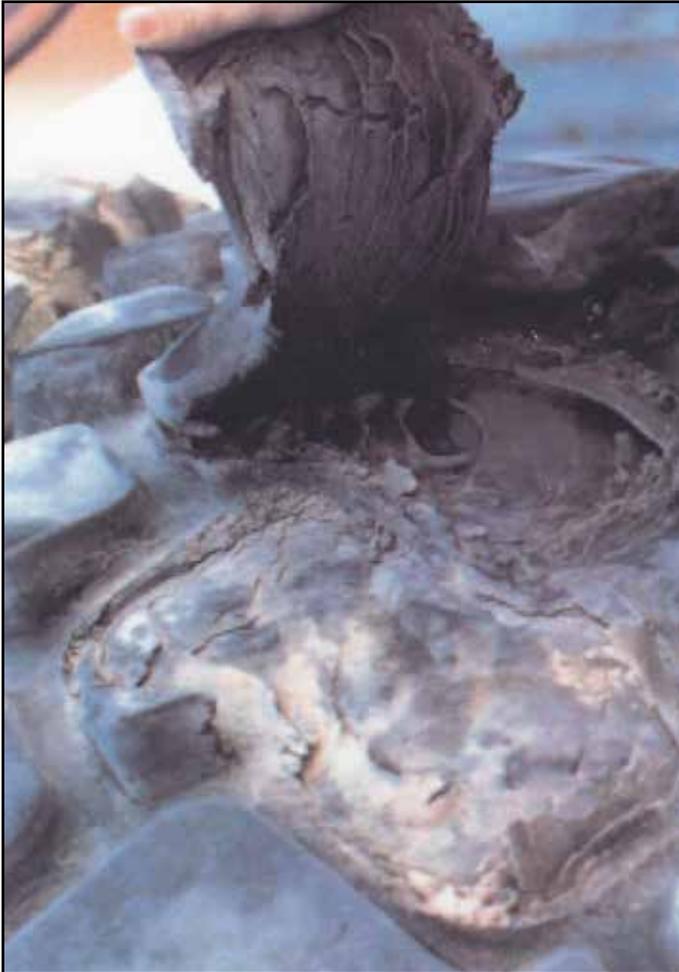
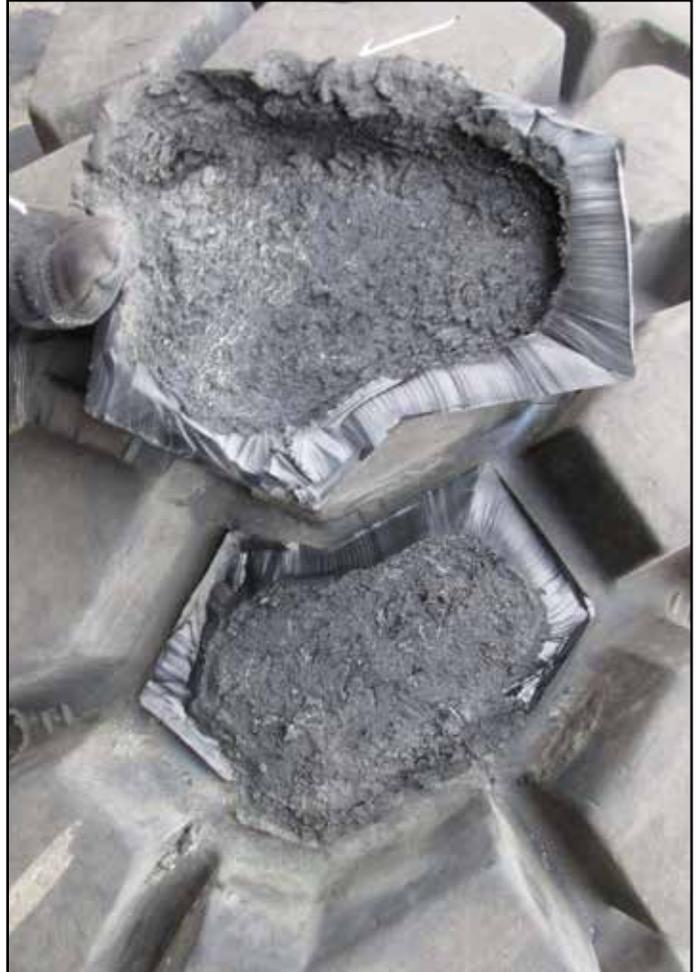
Tread rubber delamination.

Loss of adhesion between tread layers. Separation between different parts of the same rubber in the tread or smooth separation between different part of the tread.
